A real-time alert system for predicting and managing
short-term pollution and bathing water quality at
Enniscrone beach

Submitted for the Degree of Master of Science (Research)

Submitted to the Institute of Technology, Sligo, September 2019

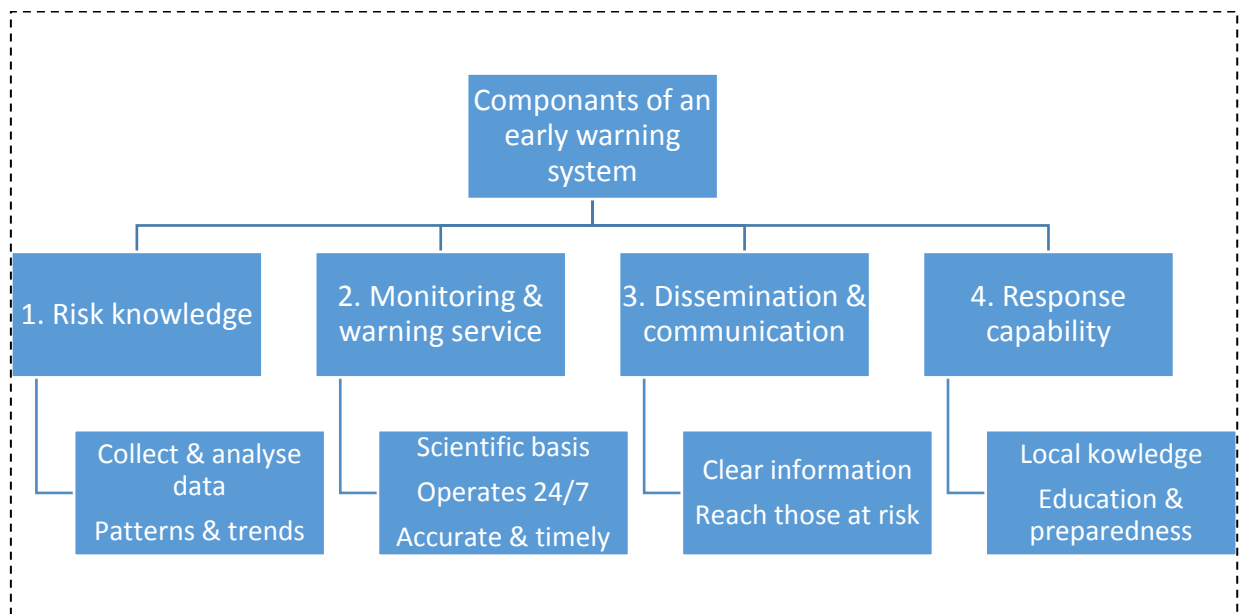
Figure 9: The 4 inter-related elements contained in an effective early warning system (United Nations Inter-Agency Secretariat of the International Strategy for Disaster Reduction (UN/ISDR), 2006)

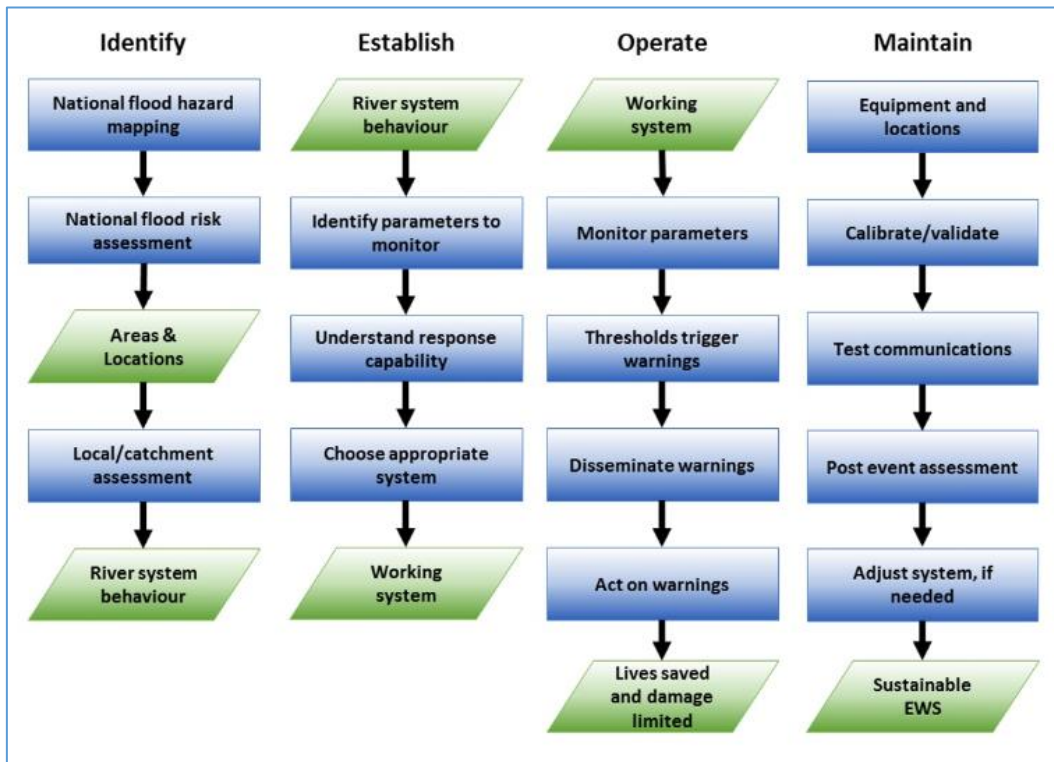
Figure 10: Schematic representation of the 4 elements and their components in use in an early warning system (Caribbean Handbook on Risk Information Management ACP-EU Natural Disaster Risk Reduction Program, 2014)

The UN/ISDR go on further to state that a weakness in any one part could result in a failure of the whole system. The process diagram shown in Fig. 10 below shows how the 4 elements in Fig. 9 above can be used to set up and operate a local early warning system. Some stages may operate in parallel and not sequentially. This example of an effective system described below is taken from the *Caribbean Handbook on Risk Information Management* which was developed by an EU funded consortium led by the University of Twente. It is used for flood forecasting but can be applied to any other natural hazard (ACP-EU Natural Disaster Risk Reduction Program, 2014). As was described earlier in the literature, hydro-meteorological conditions analogous to those that can cause flooding events (intense rainfall etc.) influence strongly the fluxes of faecal indicator organisms from catchments to bathing waters which cause the hazard to bathing.

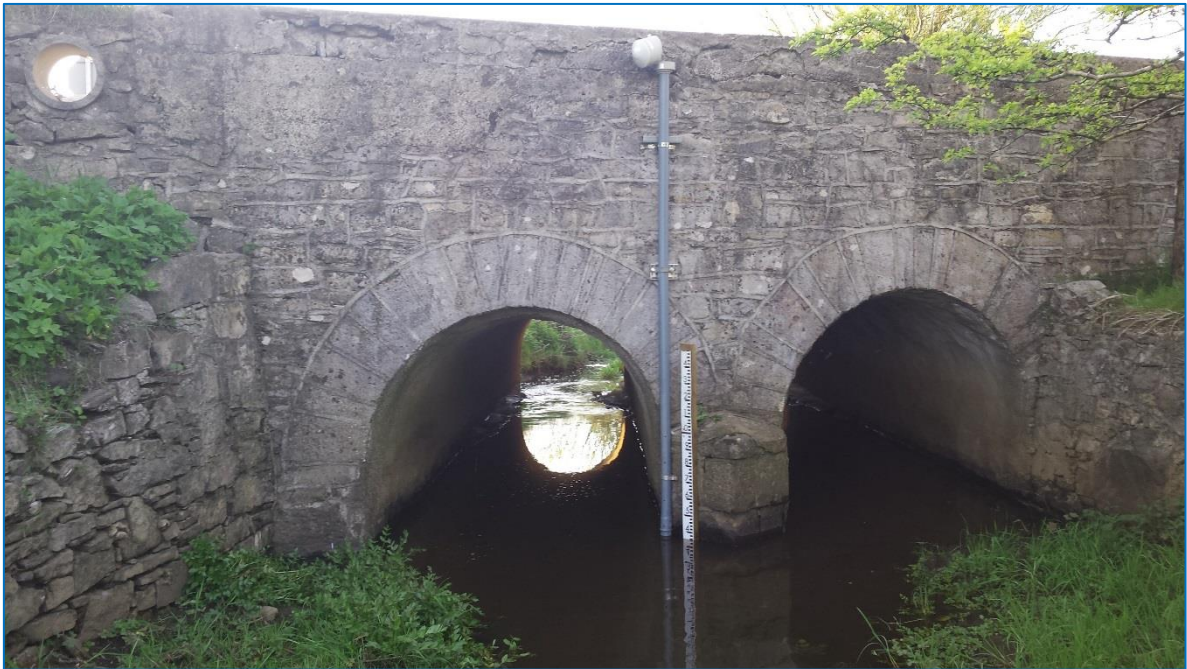
Figure 35: Hydrometric station installed at MP5 (Tullylinn) in early 2016

logger (OTT® Thalimedes) here was replaced by an OTT® Orpheus Mini data-logger in early 2016 for this project. After the monitoring point location (PIP) analysis above, two new hydrometric stations were constructed and installed also in early 2016. One was installed at Tullylinn Bridge on the main (northern) river channel and the other on the much smaller southern branch at Stokane (Figs. 35, 36 & 37 below).

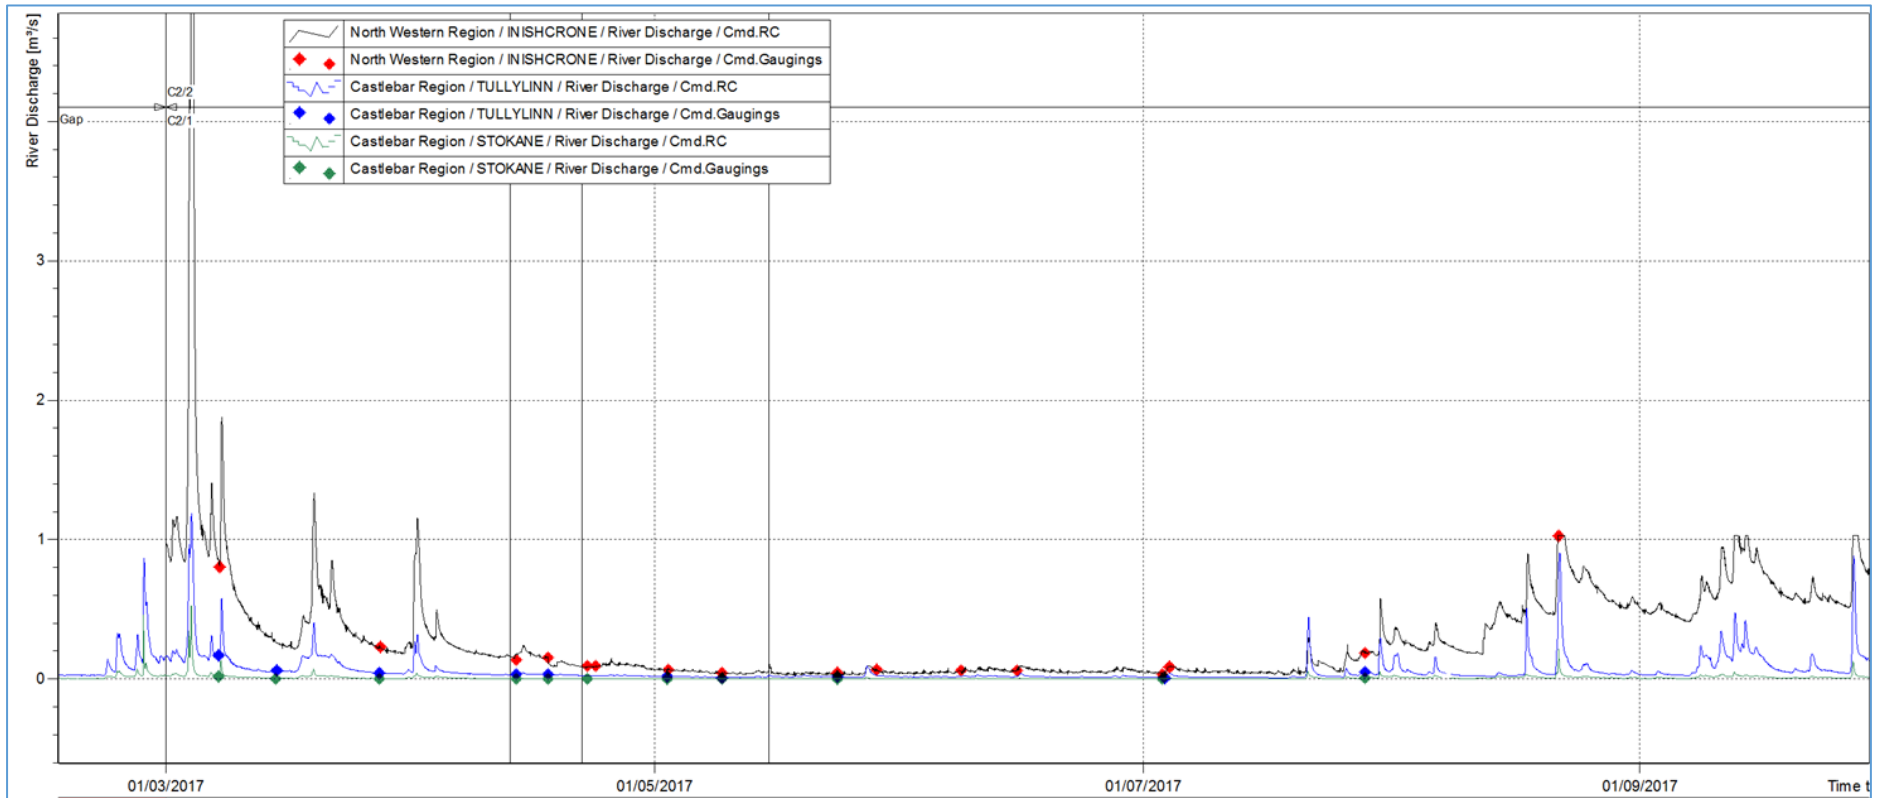
Figure 40: Discharge hydrographs for the 3 river stations MP3(green), MP5(blue) and MP6(black) showing individual flow measurements (icons) for 2017

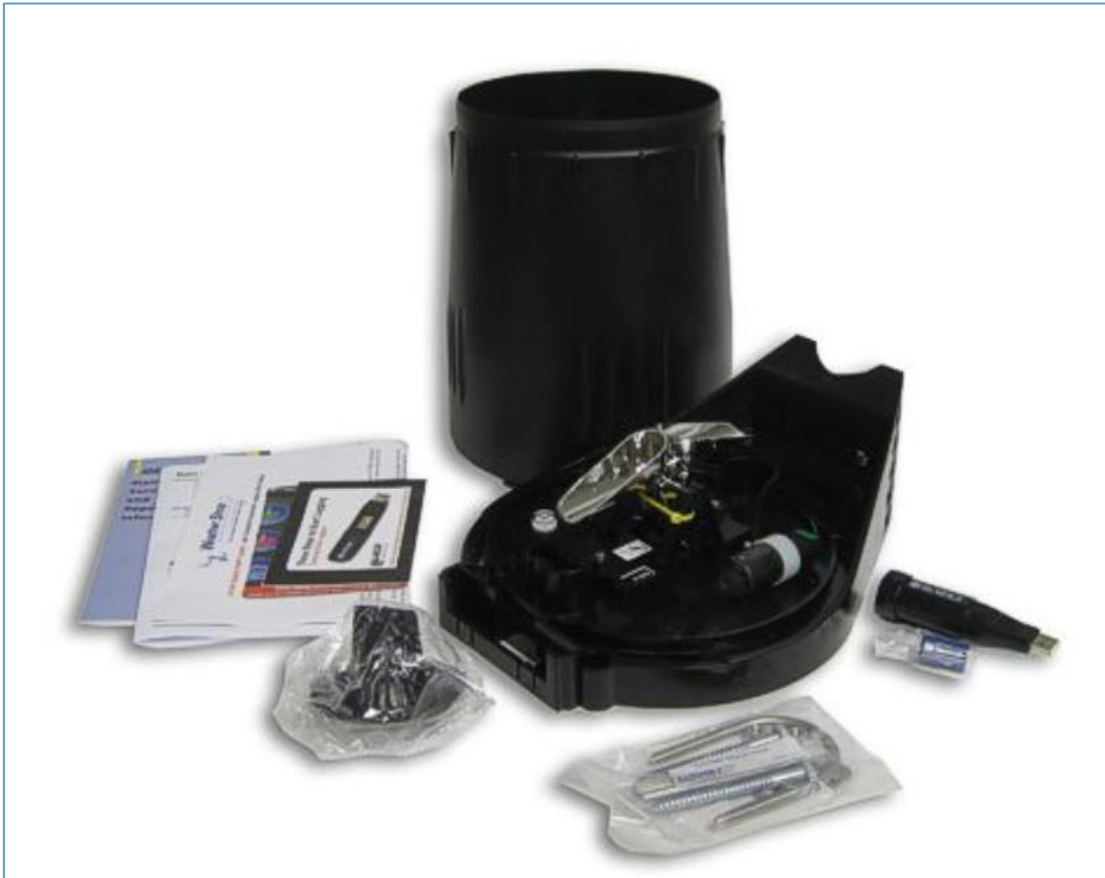
Figure 50: Davis Instruments® self-contained automatic logging rain gauge with rain cone in background and base with bubble level and tipping spoons in foreground. Source: www.weathershop.com

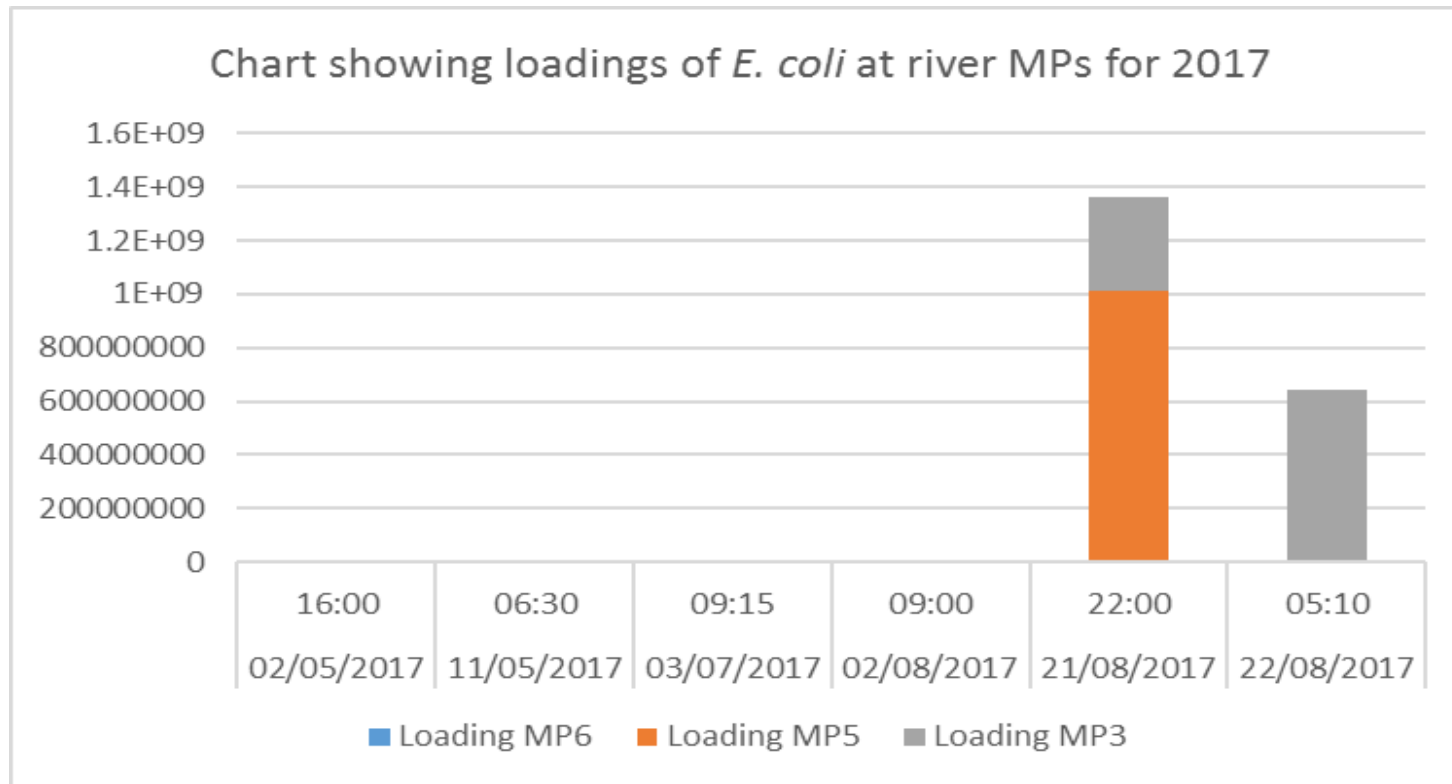
Figure 57: Chart (based on Table 13) of loadings of *E. coli* at river MPs for 2017.
