The construction, survival, and use of Signal Defensible Guard Houses on the Irish Coast

Volume II of II

Ph.D. Thesis (Archaeology)

IT Sligo

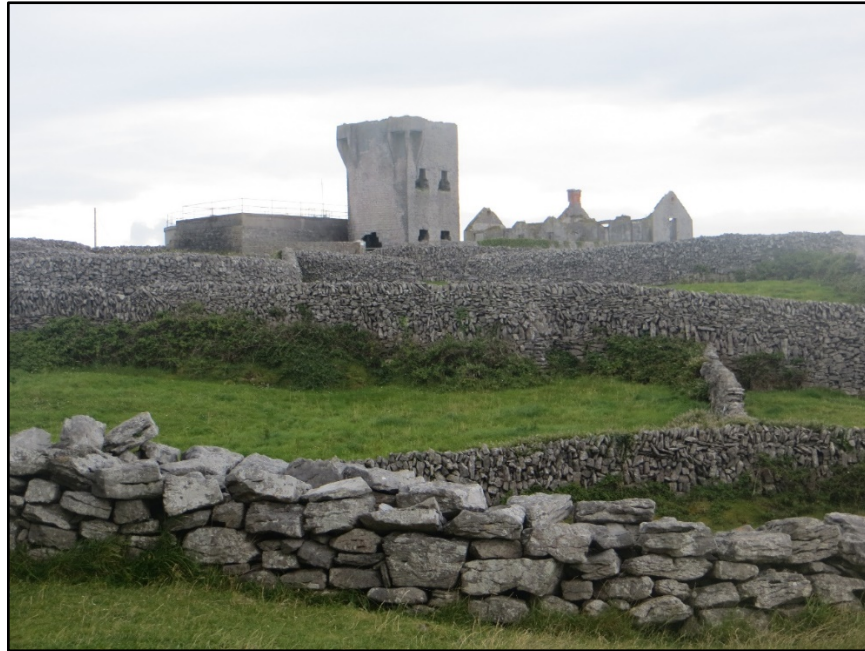
Figure A.5. View of Inisheer Signal Station from the north, showing the dense stone walled landscape in the foreground, the signal tower in the centre, the schoolhouse to the right of the signal tower and the rectangular water tank to the left of the signal tower.

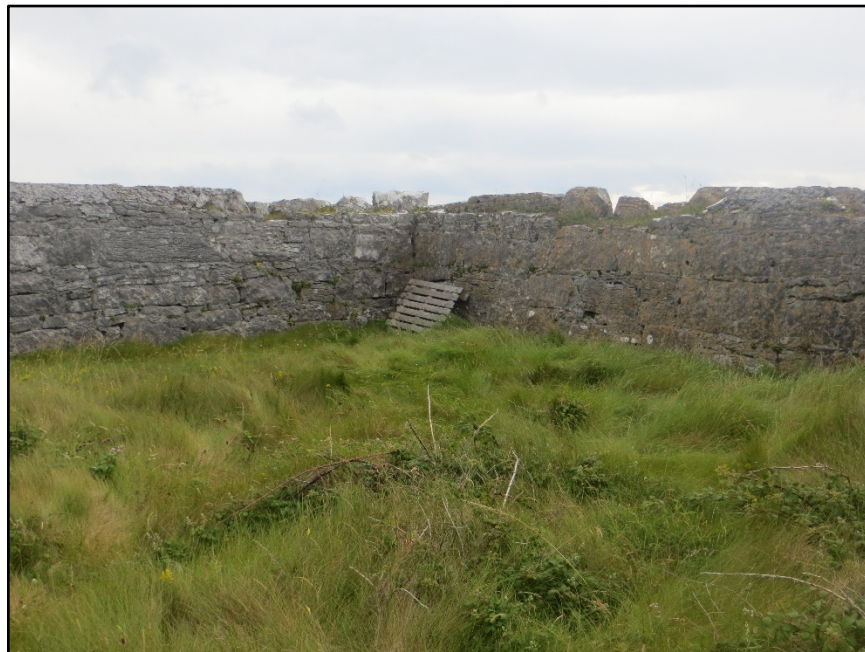
Figure A.6. The south corner of the enclosure, with the stepped feature at the top of the wall visible. A building was shown in this corner of the enclosure on the 1st edition Ordnance Survey map, but no traces of it could be identified through the long grass.

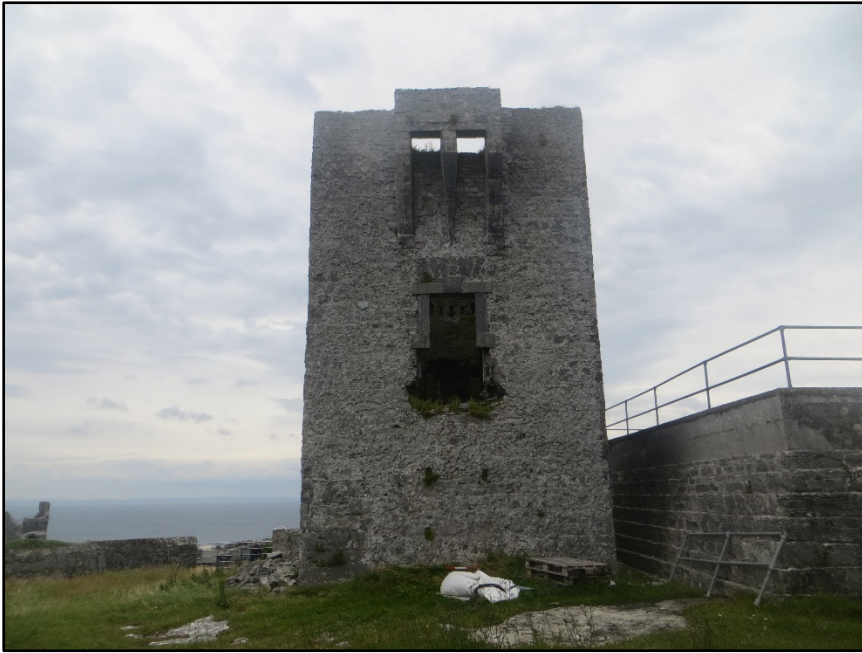
Figure A.7. View of the south-west wall of the signal tower, showing the first floor door and the machicolation which protected it. Note the absence of the stone surround on the lower half of the door.

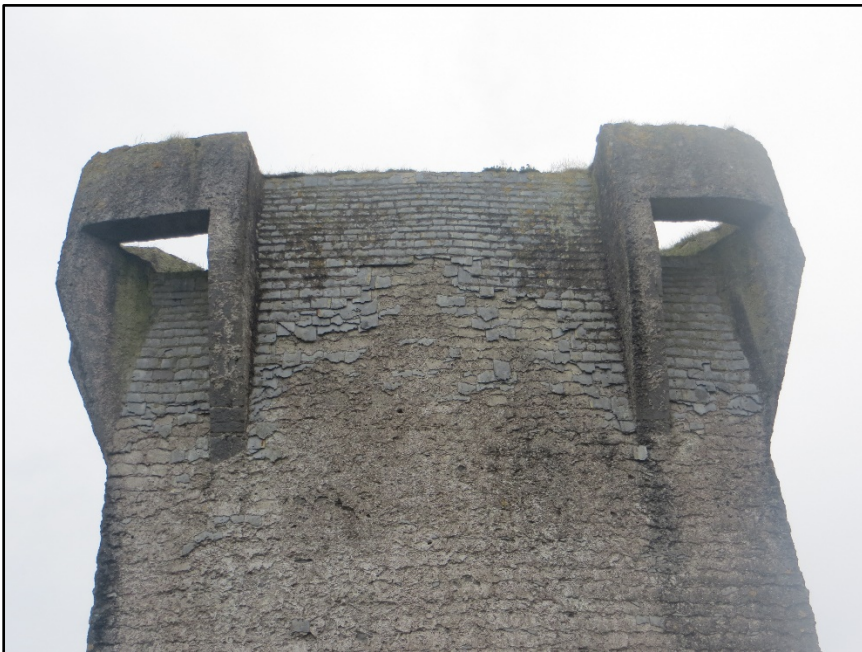
Figure A.8. The parapet level of the north-east wall showing the bartizans and patches of weather-proof slates.

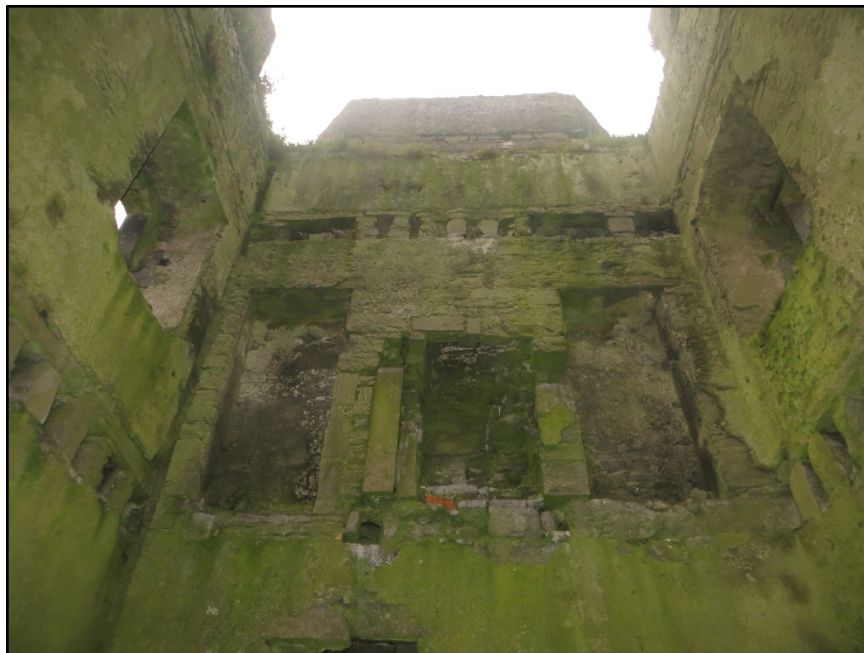
Figure A.9. The damaged area of the ground floor level of the internal face of the north-east wall. The damaged alcoves can be seen at either side and the curving flue that would have connected to the largely removed fireplace can be seen. The row of joist holes from the south-east mezzanine level can be seen at the right of the wall.

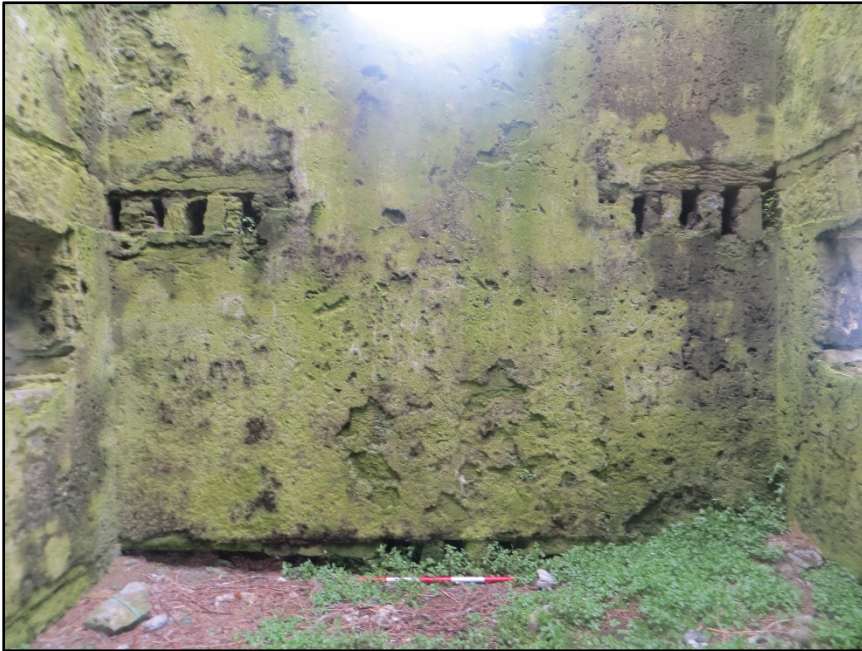
Figure A.11. The ground floor level of the internal face of the south-west wall, showing the two sets of joist holes from the split mezzanine level and the base of the first floor doorway.

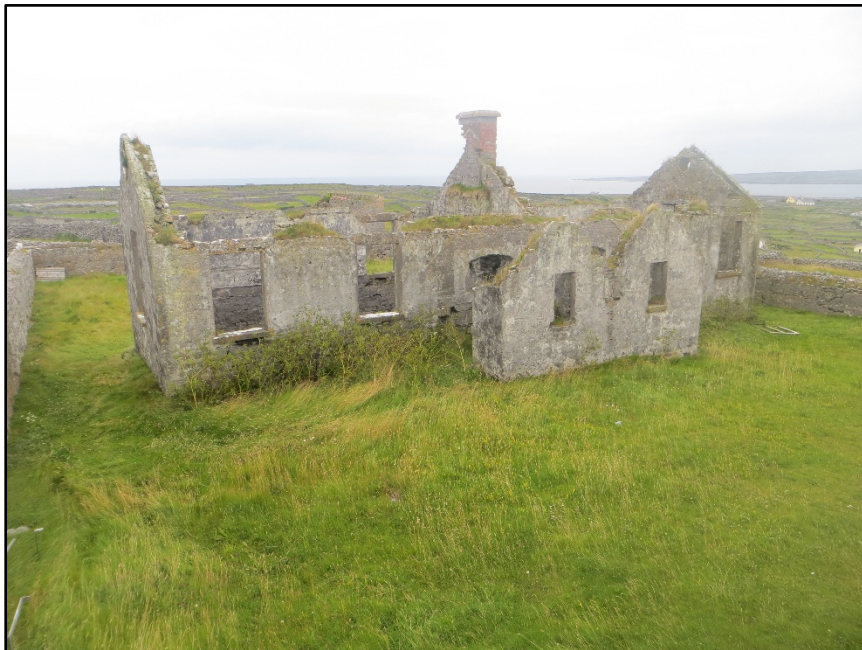
Figure A.12. View of the schoolhouse, looking west. The double entrance is in the foreground, projecting from the front wall of the building, and the brick chimney can be seen extending from the peak of the central gable.

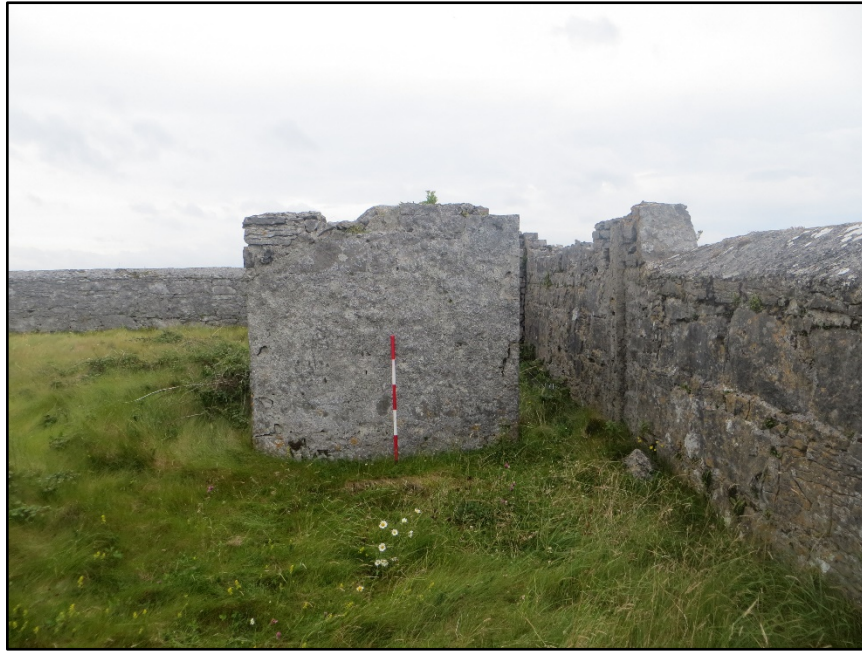
enclosure. This wall was featured on the 3rd edition Ordnance Survey map, surveyed 1915-1920. The outbuilding was rectangular in plan and measured 4.8 m (15' 9") by 3.12 m (10' 3"), with a doorway on the north-west wall and a now blocked doorway on the south-east wall. The shed roof of this building sloped downwards into the enclosure. It is highly likely that this building was the toilet block for the schoolhouse.

Figure A.13. The north-west side wall of the toilet block, with the door opening to the right. He enclosure wall was used as the rear wall of the building.

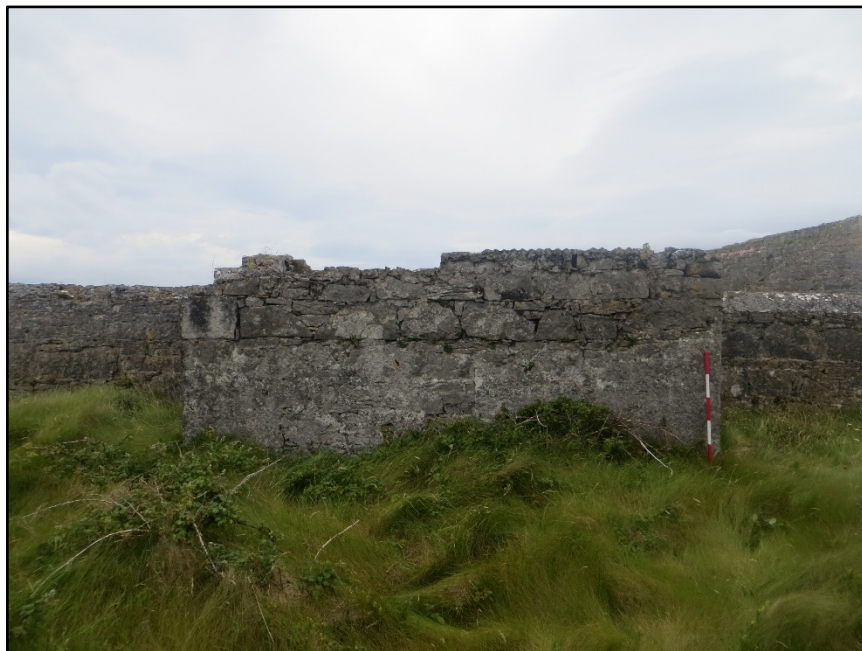
Figure A.14. The north-east front wall of the toilet block.

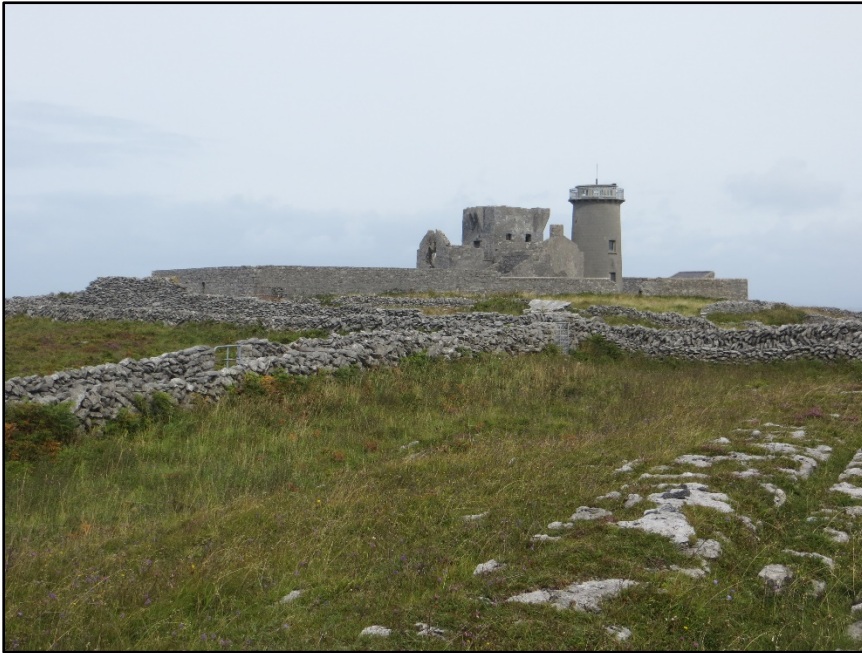
Figure A.26. View of Inishmore Signal Station from the south, showing the expanded enclosure wall, signal tower and cylindrical lighthouse.

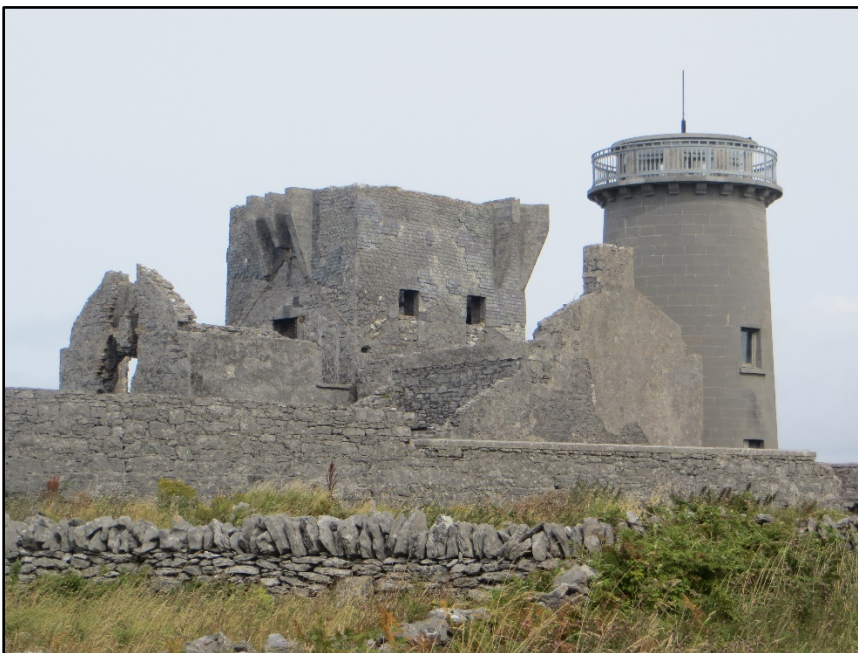
Three later 'wings' had been added to the signal tower, when the signal tower was initially converted into a lighthouse. Two of the additions, on the south-east and south-west walls, had survived to their full heights, although both were missing their roofs.

Figure A.27. Detail of the signal tower showing the south-west addition to the left, the south-east addition to the right and the cylindrical lighthouse in the background.

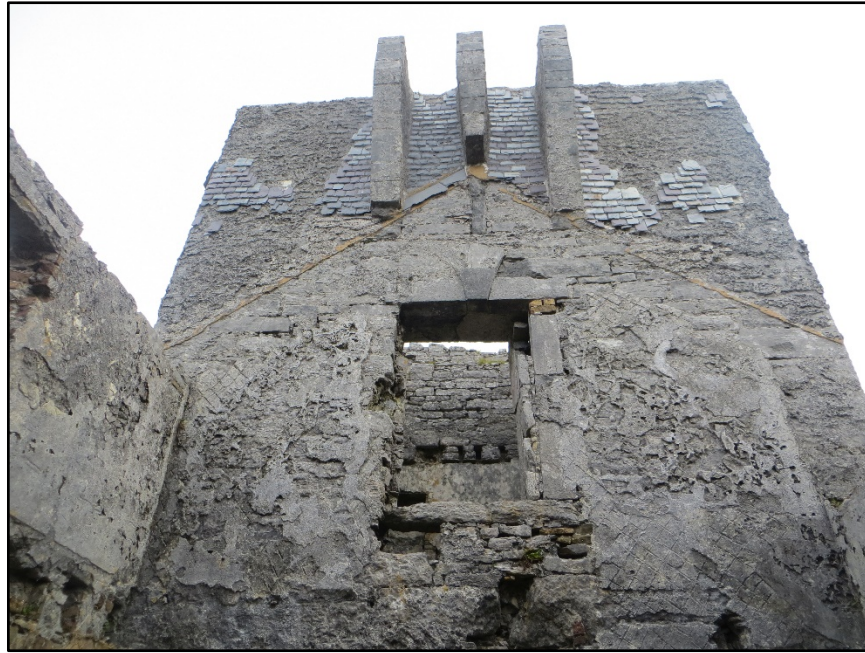
Figure A.28. The upper part of the south-west wall of the signal tower, showing the first floor door, the corbels and piers of the machicolation reaching the reduced top of the parapet wall, patches of weather-proof slate and the impression of the roof line of the two storey south-west addition.

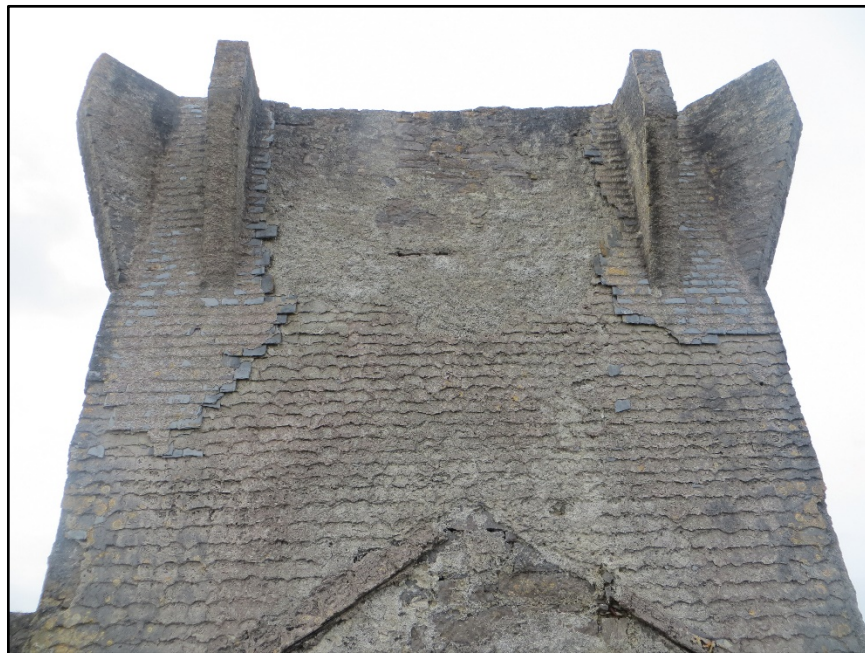
Figure A.29. The upper part of the north-east wall of the signal tower, showing the corbels and piers of the bartizans reaching the reduced top of the parapet wall, patches of weather-proof slate and the impression of the roof line of the single storey north-east addition.

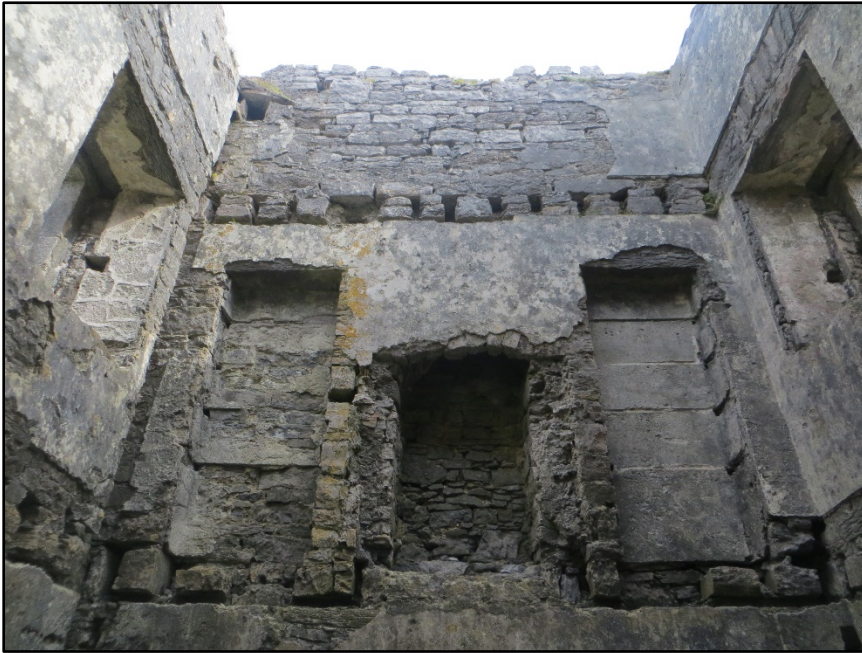
Figure A.30. The upper part of the internal wall face of the north-east wall, showing the central fireplace flanked by alcoves bearing the impressions of shelves. The row of joist holes of the attic level run above the tops of the alcoves. In the top left the edge of the diagonal stone marking the entrance to the north bartizan can be seen.

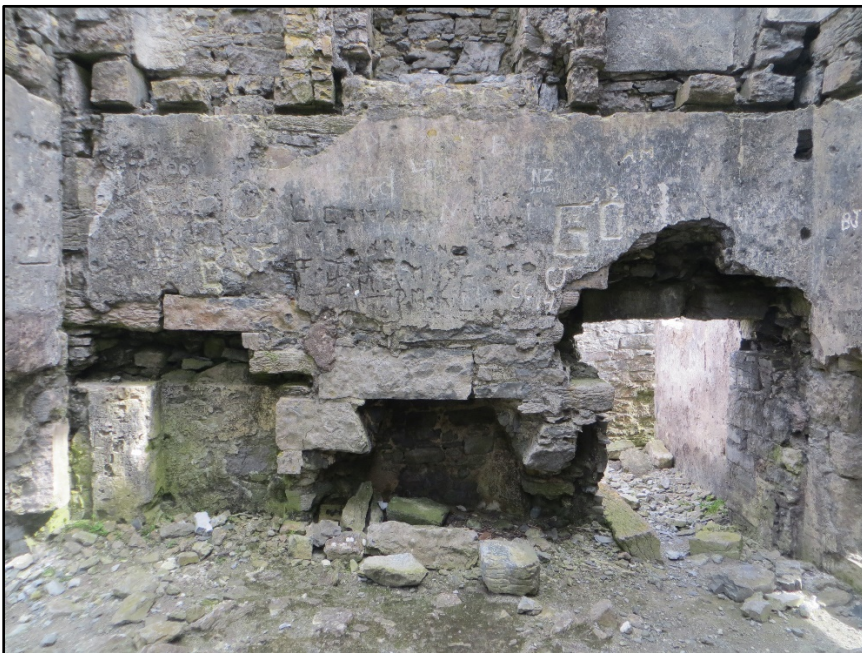
Figure A.31. The lower part of the internal wall face of the north-east wall, showing the top of the central fireplace flanked by alcoves, the right hand alcove having been opened up into a ground level entrance. The extent to which the ground floor level has been infilled is clearly visible.

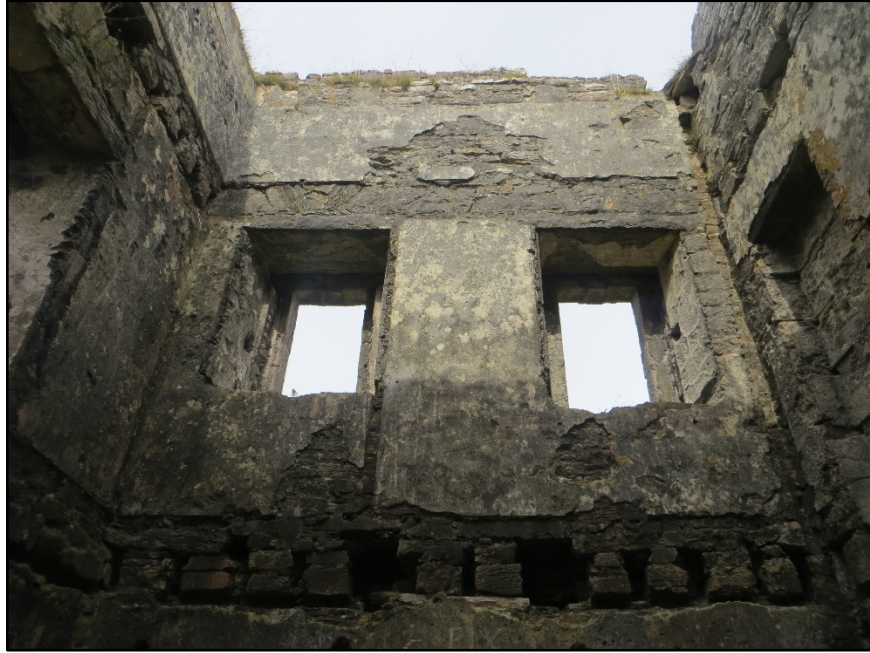
Figure A.32. The upper part of the internal wall face of the north-west wall, showing the joist holes of the first floor, the first floor windows, the impression of the attic level and the reduced parapet wall.

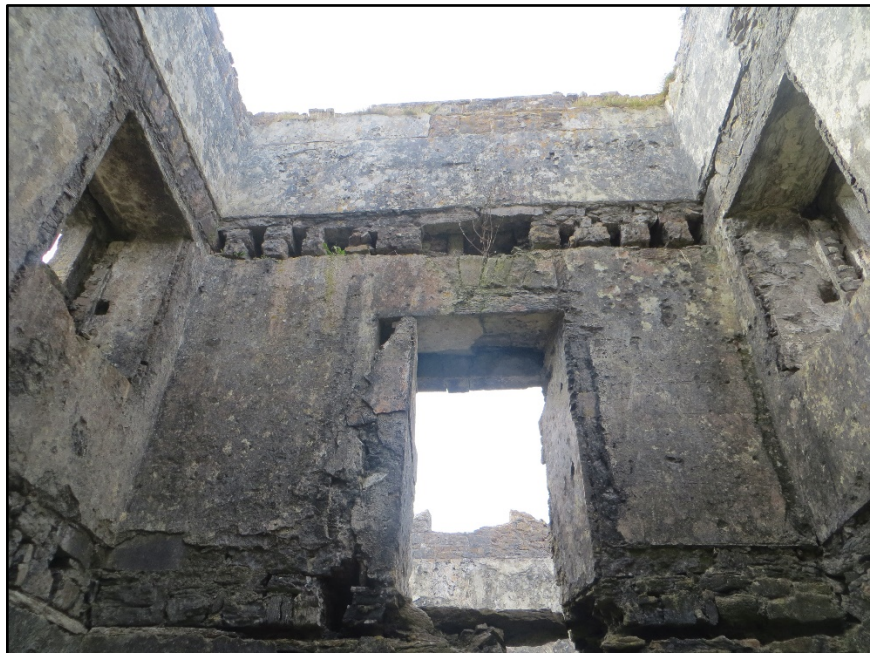
Figure A.33. The upper part of the internal wall face of the south-west wall, showing the first floor door, the joist holes of the attic level and the reduced parapet wall.

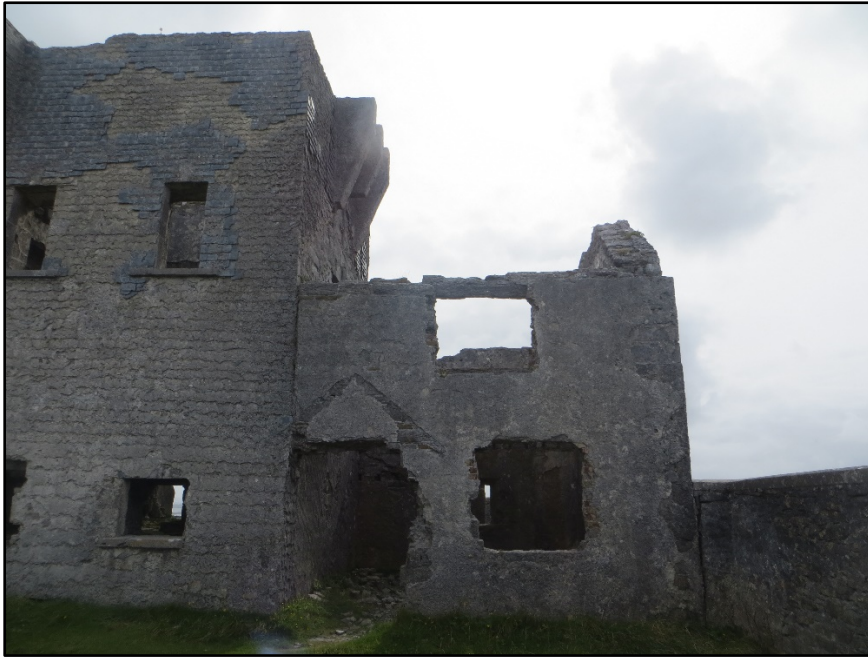
The main part of the south-east addition was one and a half storeys tall, with a chimney on the south-east end wall. A single storey room was located on the south-west side of the addition. The south-west addition was two stories tall and had an entrance on the north-west wall protected by a now absent gabled porch. The additions had featured steep gabled roofs, which were missing. The north-east addition had been demolished but the position of a gabled roofline was visible on the surface of the signal tower's wall, and it appeared to have been a single storey building with a steep gabled roof. Low sections of wall to the north-east of the tower may have been parts of this addition that were retained when the circular lighthouse was constructed to shelter the entrance, but this was uncertain. The three additions were made around 1818, several years after the signal station system had been abandoned c.1815. When the signal station was first converted into a lighthouse it is assumed that a lantern was added to the roof of the signal tower, in common with the upgrading of early 'beacon type' lighthouses which occurred at the start of the 19th century (O'Sullivan & Downey 2013). The removal of the parapet wall may have occurred during this period of use, potentially because the parapet wall hindered visibility to the lantern, and because its defensive purpose had become redundant.

Figure A.34. The north-west wall of the two storey addition to the south-west of the signal tower, with the impression of the porch over the entrance visible on the wall adjacent to the signal tower.

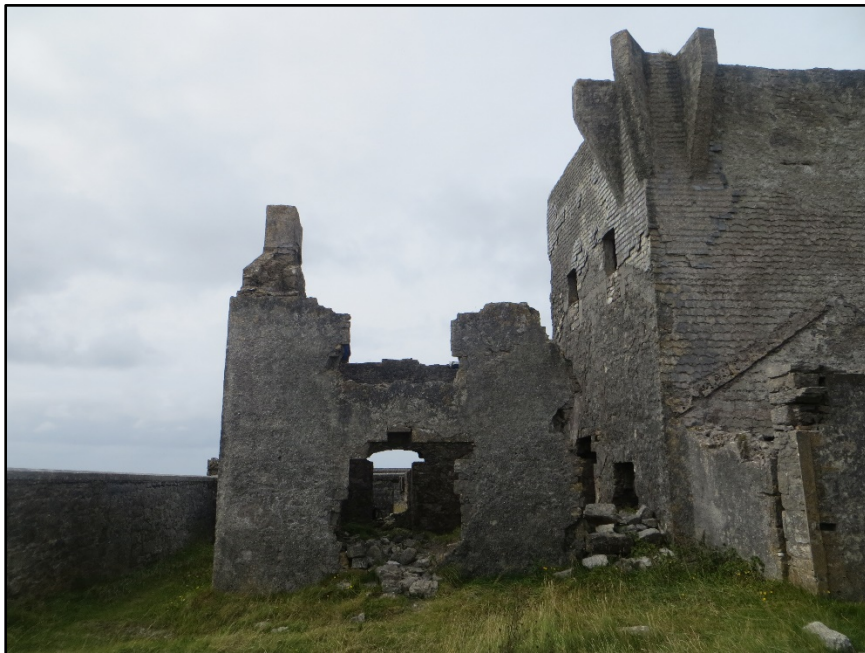
Figure A.35. The north-east wall of the one and a half storey addition to the south-east of the signal tower, with the chimney on the end wall visible at the left of the picture.

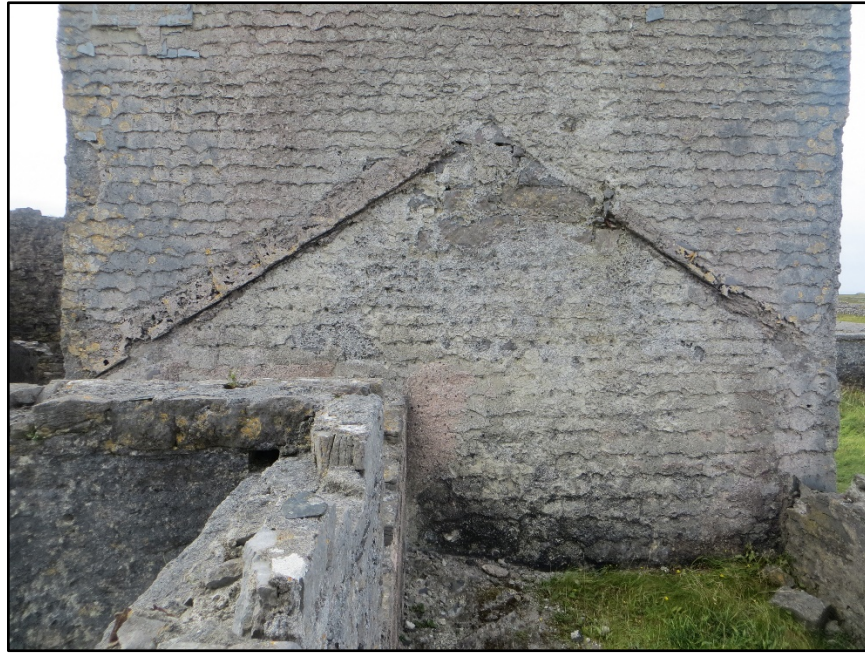
Figure A.36. The impression of the roof of the single storey addition on the north-east wall.

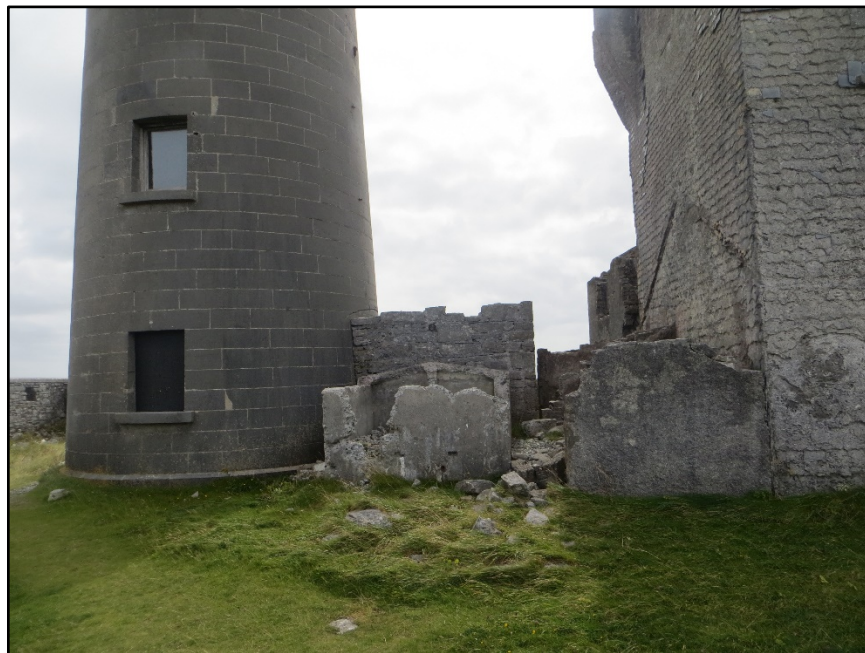
Figure A.37. The demolished and altered remains of the north-east addition, between the signal tower and the cylindrical lighthouse.

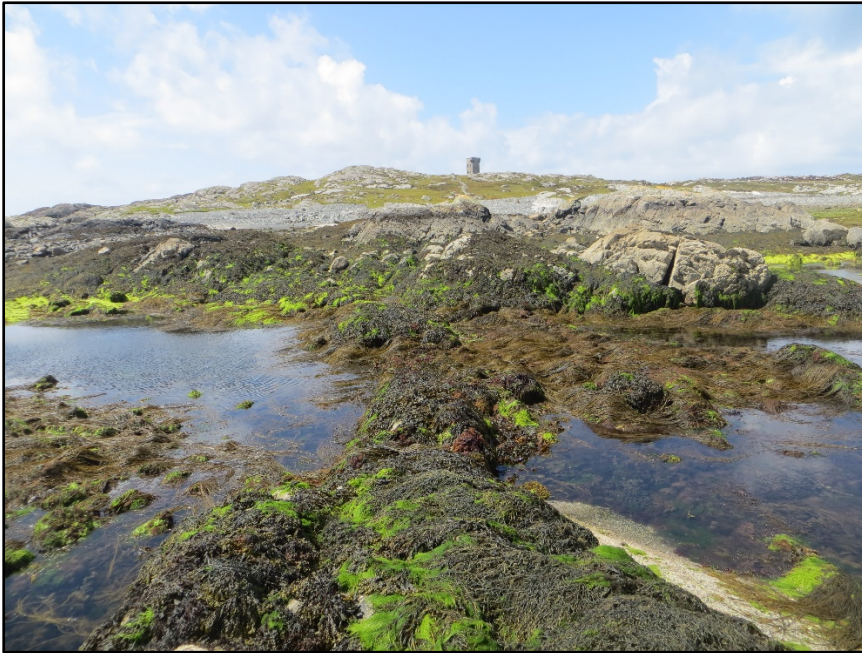
Figure A.51. A view of the signal tower at Golam Head, from the tidal channel that separates Golam from the rest of the island. The low band of rocks in the foreground seemed to be a natural feature, rather than a constructed causeway.

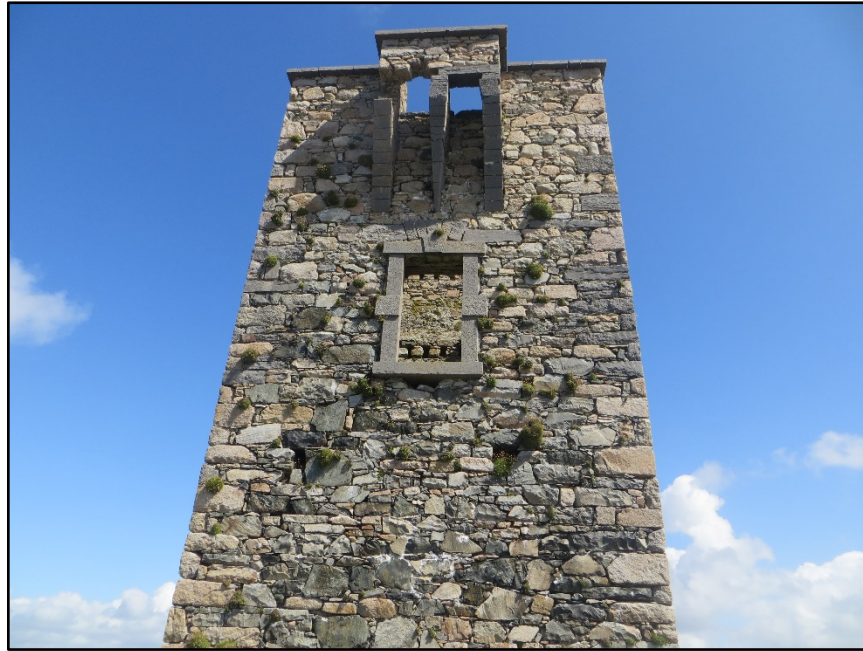
Figure A.53. The upper portion of the south-west wall of the signal tower at Golam Head Signal Station, showing the first floor door with its intact stone surround, the machicolation and the coping stones on top of the wall.

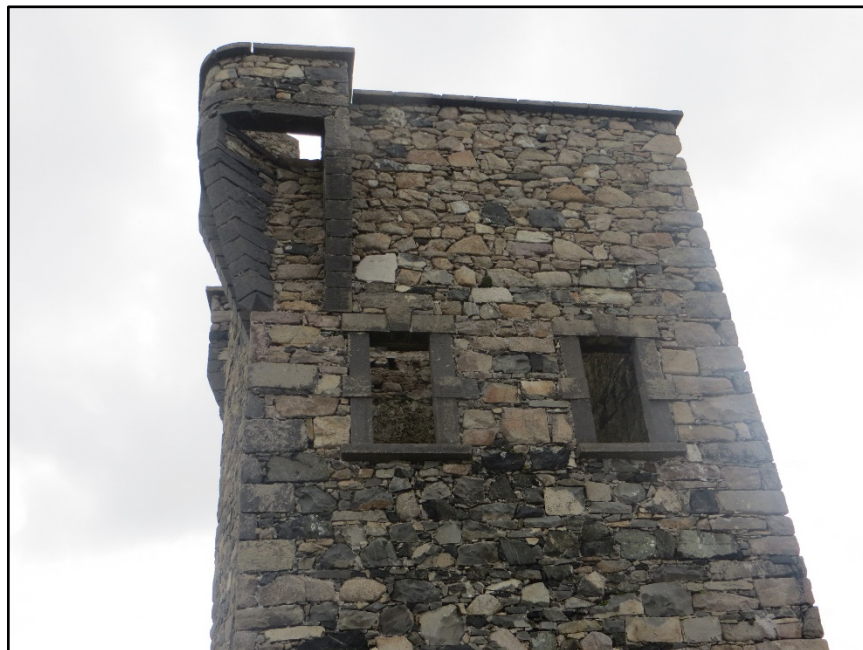
Figure A.54. The upper portion of the north-west wall of the signal tower at Golam Head Signal Station, showing the first floor windows with their intact stone surrounds, the northern bartizan and the coping stones on top of the wall.

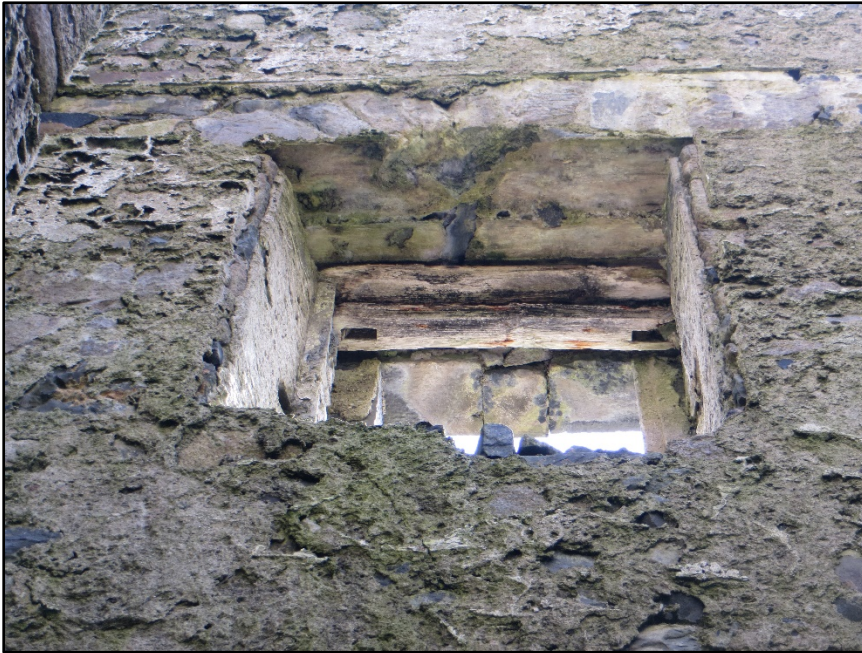
Figure A.55. First floor window on the south-east wall, showing surviving parts of the timber framing and the square holes cut into the splayed sides.

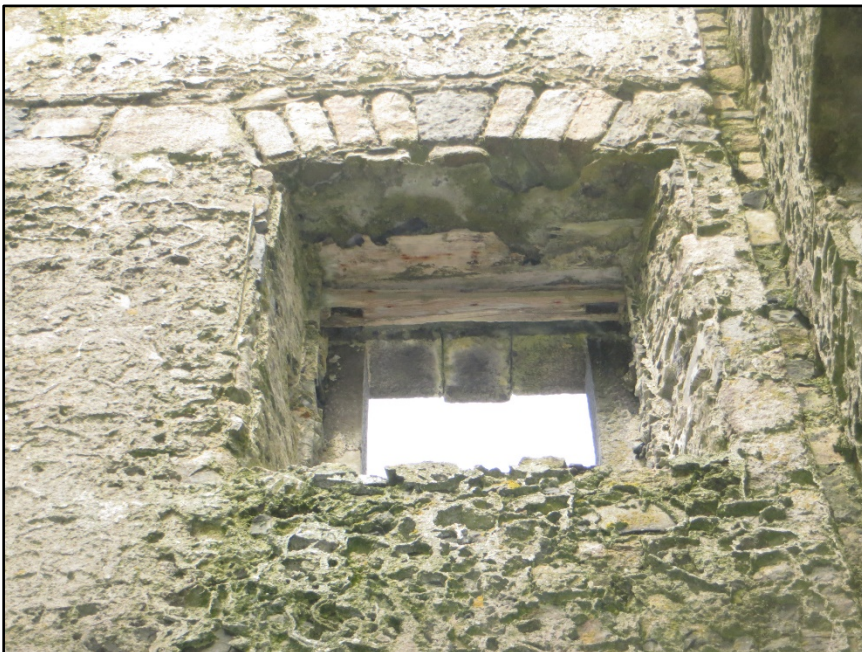
Figure A.56. First floor window on the north-west wall showing surviving parts of the timber framing.

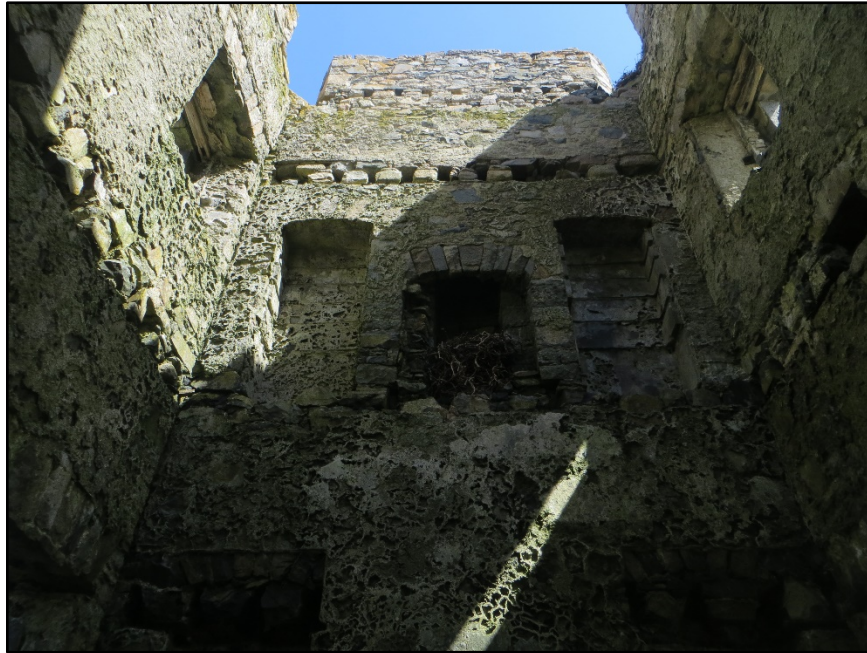
Figure A.57. The upper portion of the internal face of the north-east wall, showing the central fireplace flanked by two alcoves with the impressions of shelves, the joist holes of the attic level, the stepped parapet with joist holes for the roof, and the entrances to the bartizans.

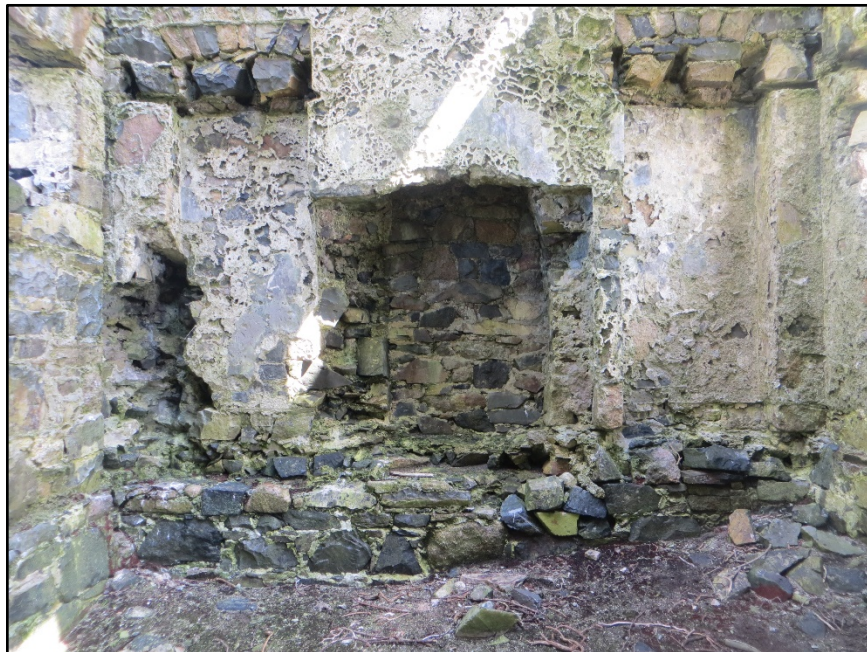
Figure A.58. The lower portion of the internal face of the north-east wall, showing the central fireplace flanked by alcoves and the joist holes of the split mezzanine level.

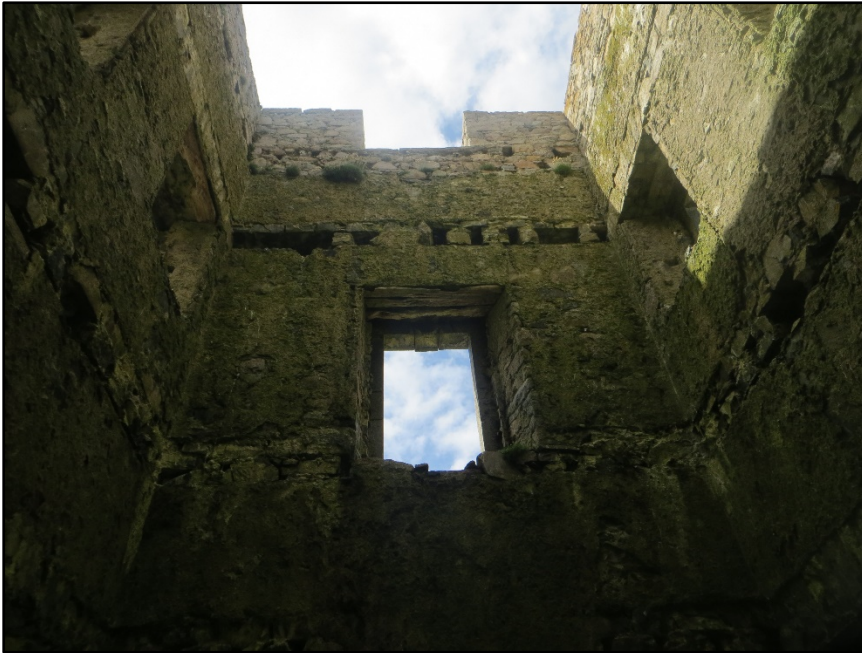
Figure A.59. The upper portion of the internal face of the south-west wall, showing the joist holes of the first floor, the doorway with traces of its timber framing, the joist holes of the attic level, the instep of the parapet and the entrance to the machicolation.

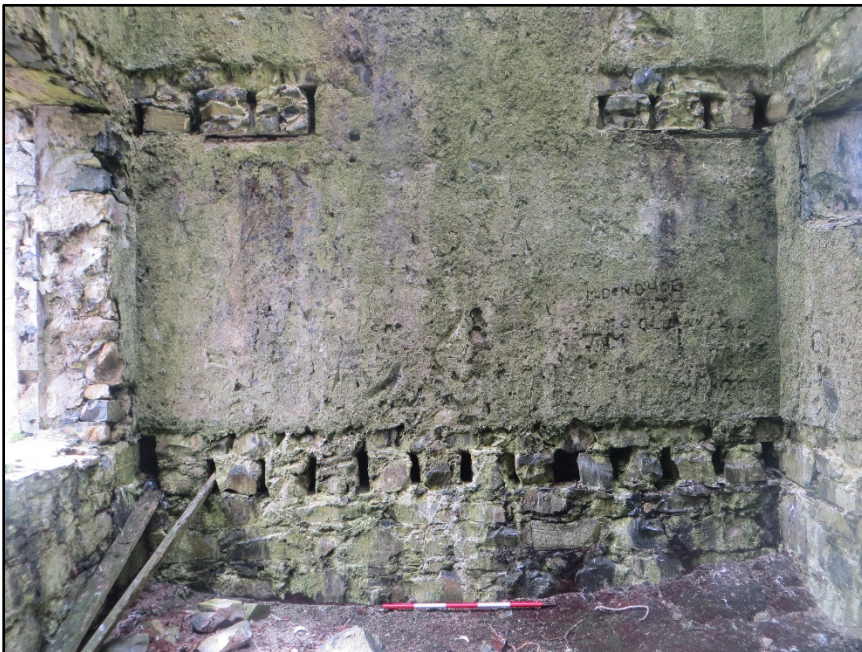
Figure A.60. The lower portion of the internal face of the south-west wall, showing the joist holes of the ground floor level and the joist holes of the split mezzanine level.

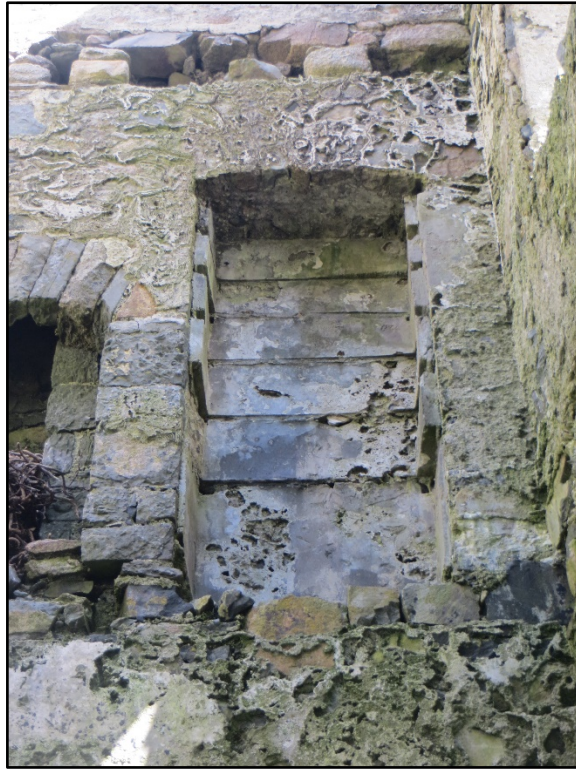
Figure A.61. Detail of the east first floor alcove on the north-east wall, showing the impressions of shelves in the render.

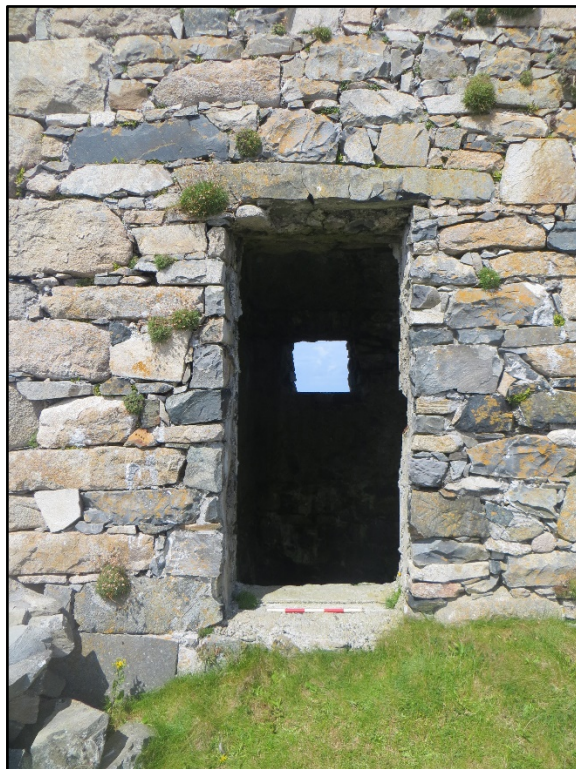
On the north-west and south-east walls, the ground floor windows had all had their dressed stone surrounds removed. The ground floor windows on the north-west wall had subsequently been repaired and cement sills added to their base. The ground floor window at the north-east of the south-east wall had undergone the same treatment, but the window at south-west of this wall has been carefully opened up to form a neat doorway with a cement doorstep. The impression of a door frame was visible in the cement that ran up the sides and across the top of the doorway. The stone surrounds of the first floor windows and the door were intact.

Figure A.62. Detail of the ground floor window on the south-east wall which had been converted into a neat ground level door.

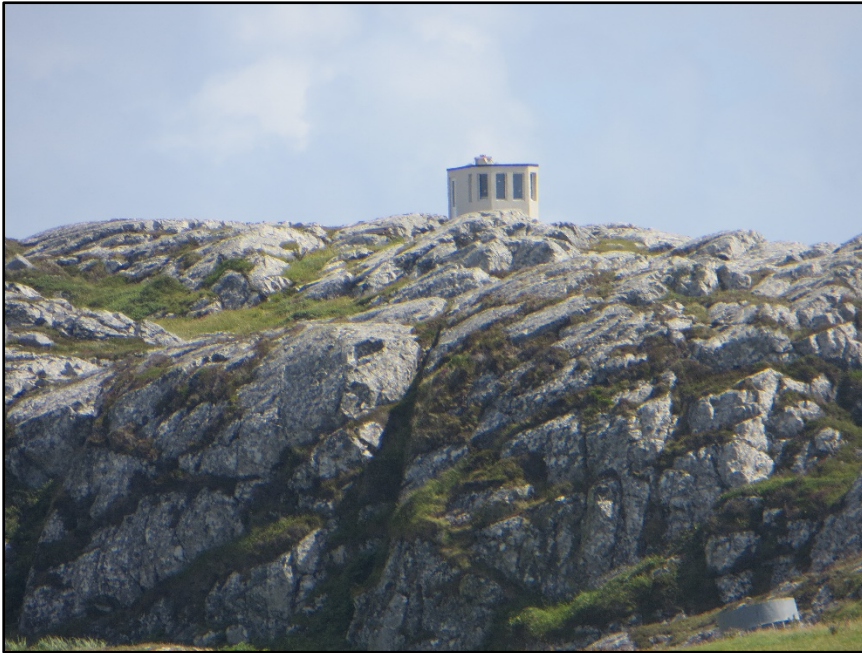
Figure A.63. View of the restored Look Out Post (L.O.P 51) on Lettermullan Island.

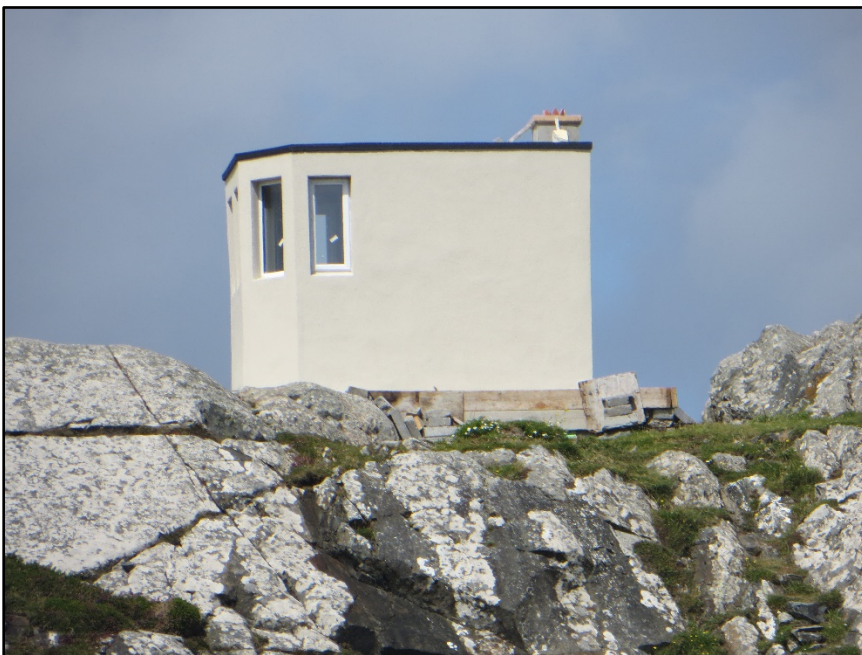
Figure A.64. Detail of the restored Look Out Post (L.O.P 51) on Lettermullan Island.

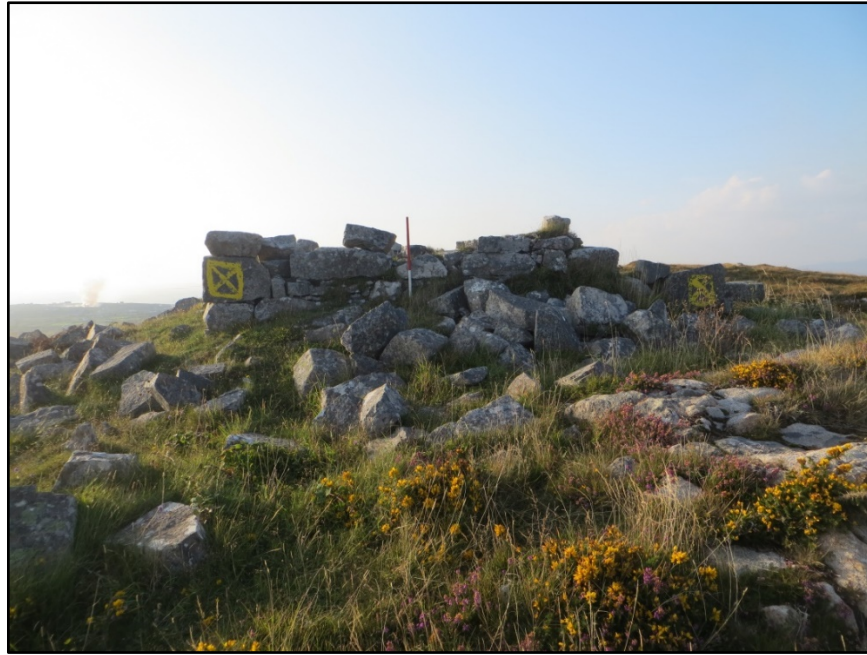
Figure A.76. The external face of the south-east wall of the low ruin of the signal tower at Cuileen Hill Signal Station.

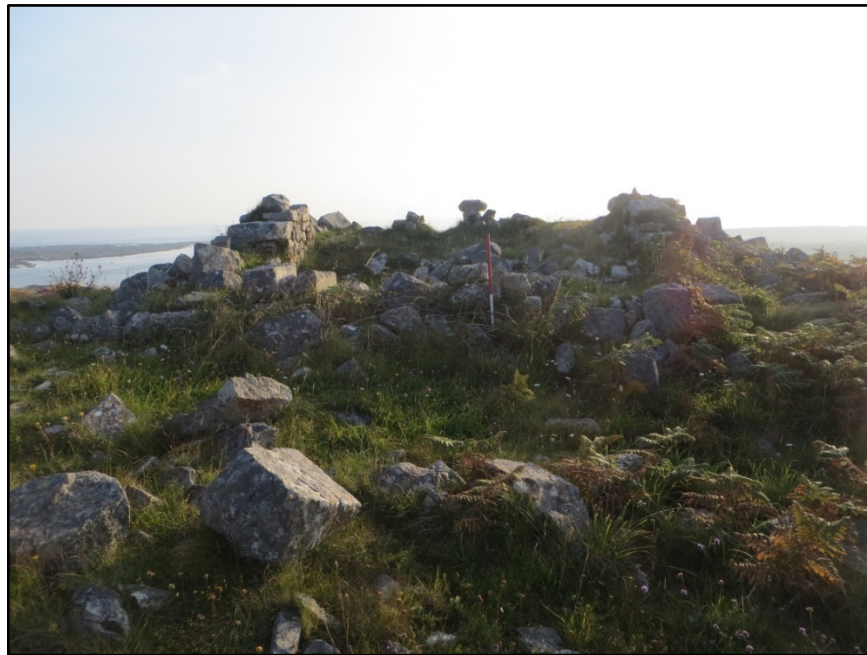
Figure A.77. The external face of the north-east wall of the low ruin of the signal tower at Cuileen Hill Signal Station.
