The construction, survival, and use of Signal Defensible Guard Houses on the Irish Coast

Volume II of II

Ph.D. Thesis (Archaeology)

IT Sligo

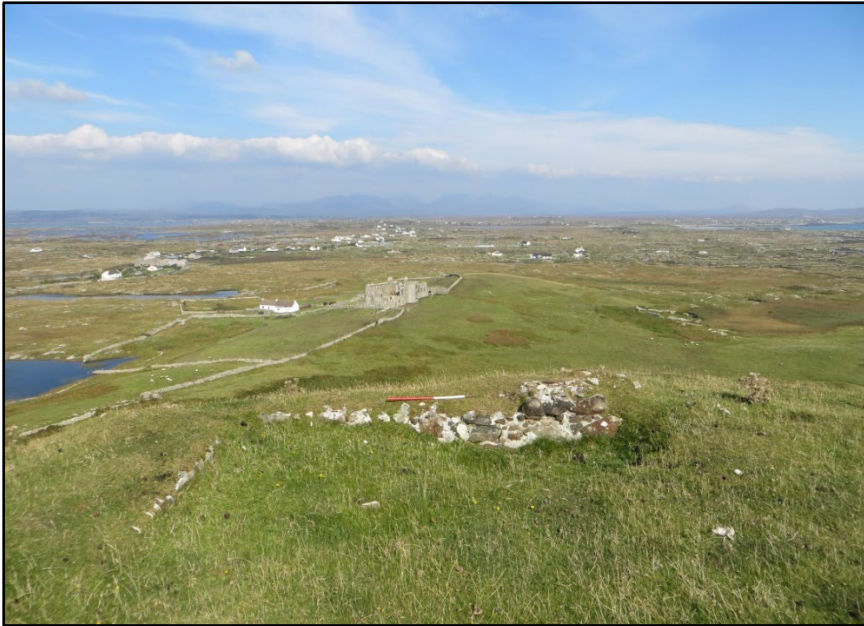
Figure A.81. This low foundation is all that remains of the signal tower at Bunowen Hill Signal Station. The ruins of Bunowen Castle (GA049-013/Reg. No 30404903) can be seen in the background.

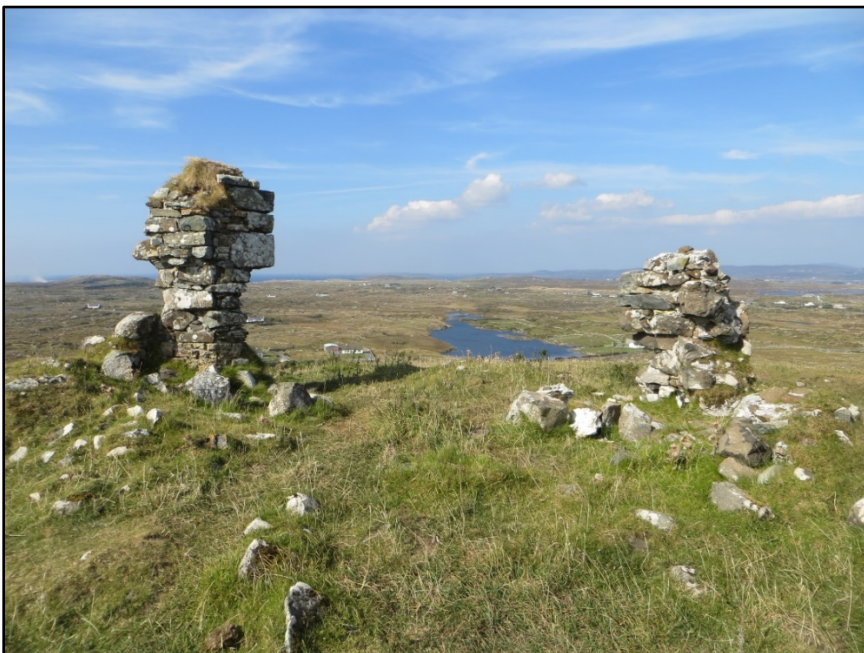
Figure A.82. The remains of a structure thought to be a secondary building rather than an original component of the Bunowen Hill Signal Station.

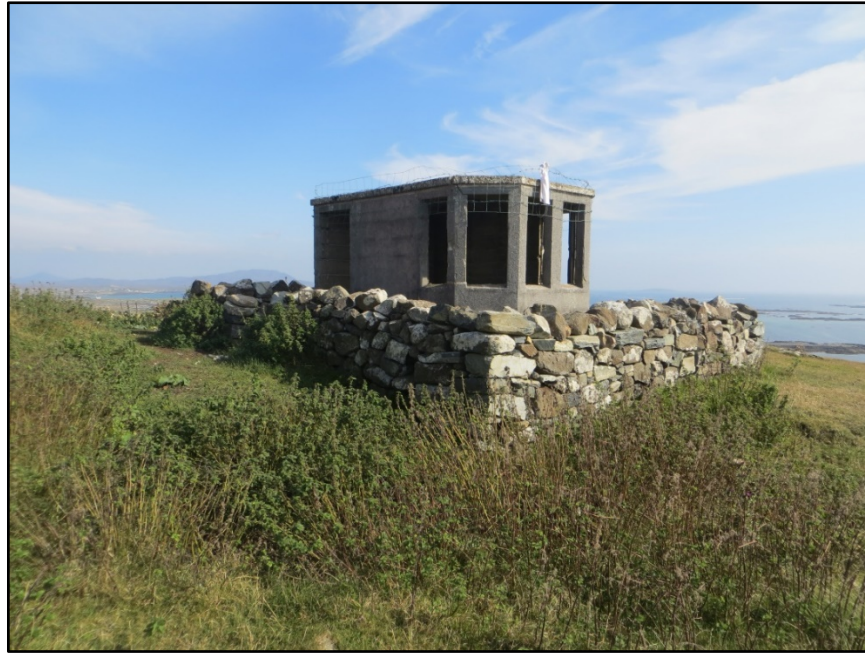
Figure A.83. The well-preserved Look Out Post close to the site of Bunowen Hill Signal Station.

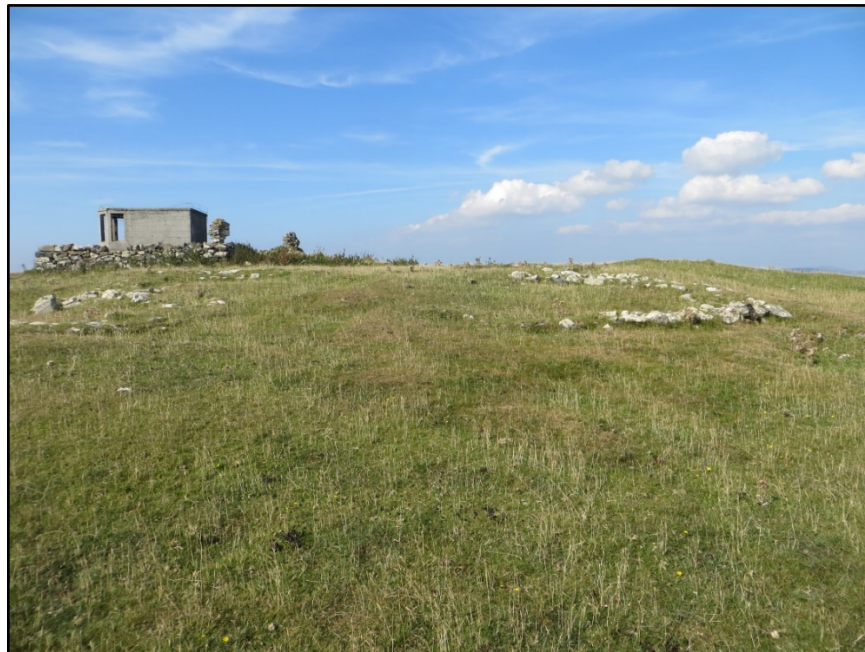
The Look Out Post (L.O.P. 53) was in good condition. It was located 22 m (72' 3") west of the signal tower and, unusually, it was surrounded by a low walled enclosure that measured approximately 9 m (29' 6") east to west, by 5 m (16' 6") north to south. Approximately 6 m (19' 6") south of L.O.P. 53, a well-defined number 53 was marked out in stone, all that remained visible of 'Eire Sign 53'.

Figure A.84. The remains of the 'Eire Sign 53', associated with Look Out Post 53, to the immediate south of the site of Bunowen Hill Signal Station.

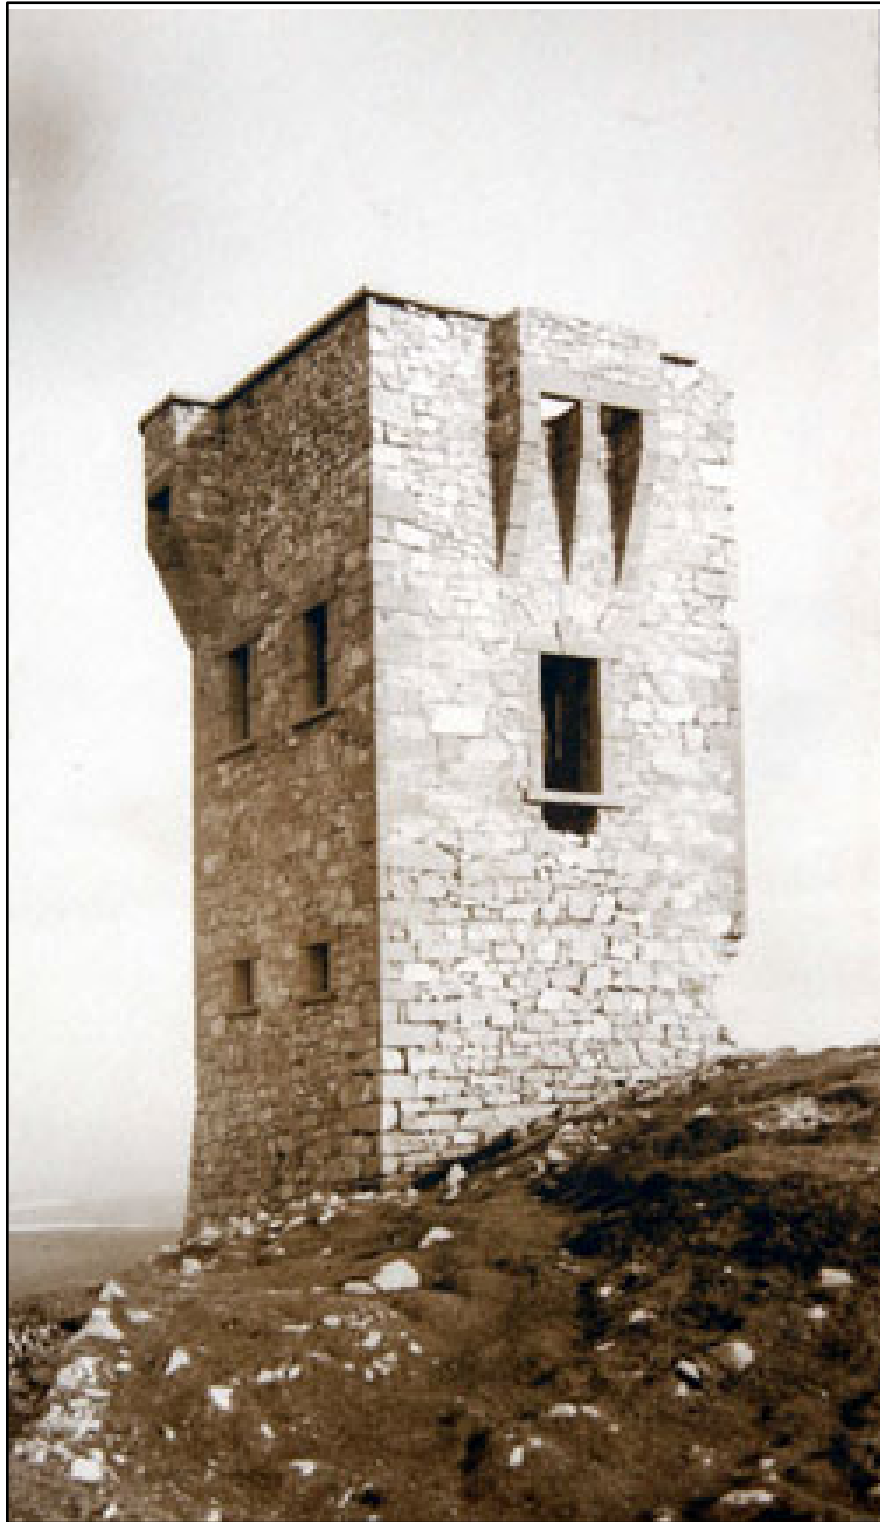
Figure A.88. Historic photograph of Cleggan Hill Signal Tower, looking south-east. The signal tower is clearly of the standard design and closely resembles the signal tower at Lettermullan Signal Station (A.52). Note the suggestion of a collapsed enclosure wall at the bottom left of the image, which would be north-west of the signal tower (The Signal Towers of Ireland 2006).

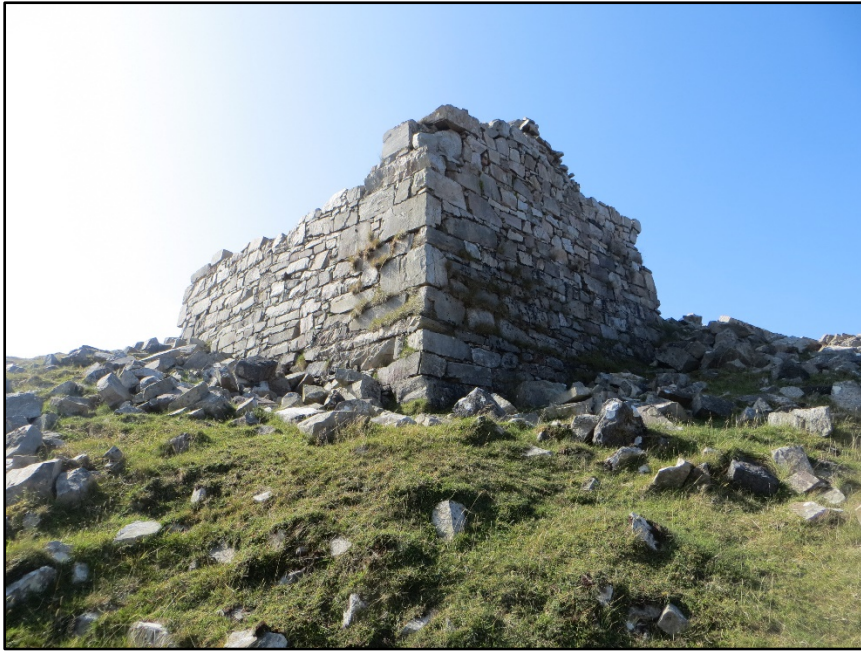
Figure A.89. View of the north-east corner of the of the collapsed signal tower at Cleggan Hill Signal Station.

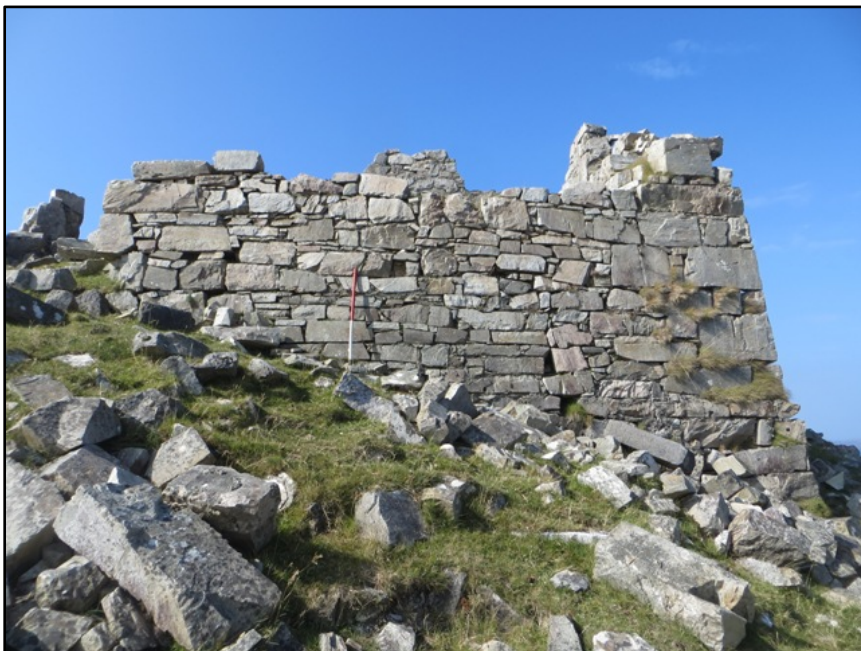
Figure A.90. The surviving portion of the external face of the east wall of the collapsed signal tower at Cleggan Hill Signal Station.

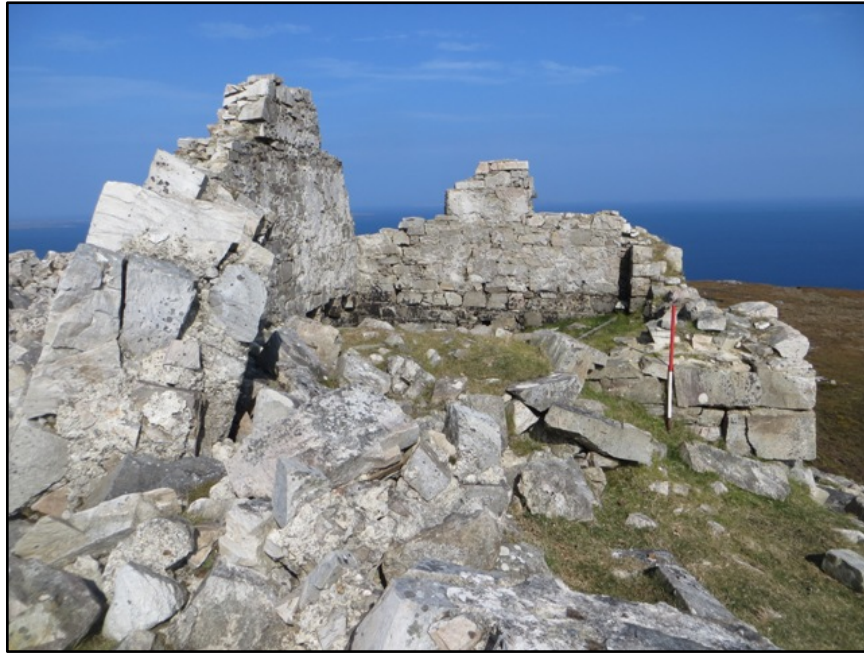
Figure A.91. View of the collapsed west wall with the internal face of the north wall of the collapsed signal tower at Cleggan Hill Signal Station in the background.

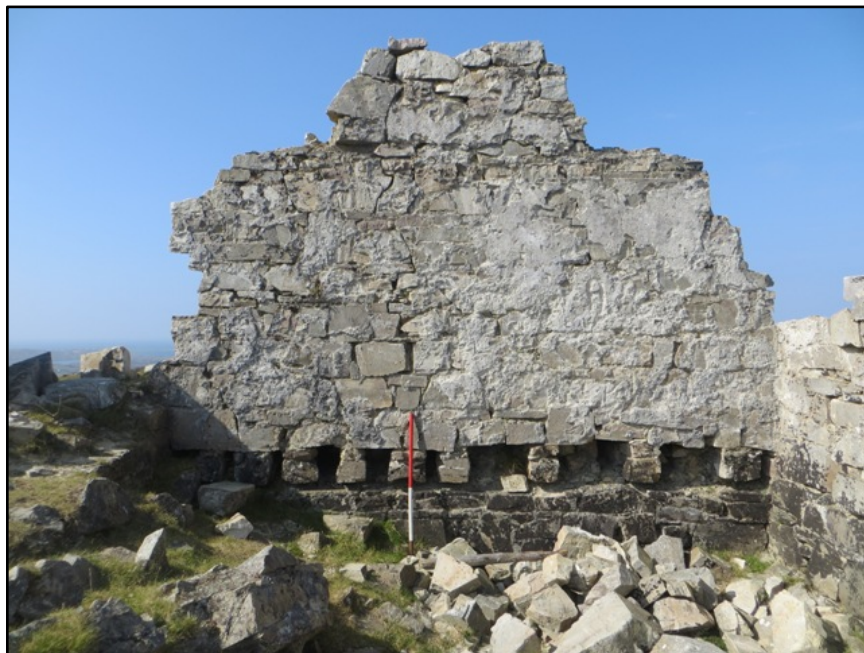
Figure A.92. The internal face of the west wall of the collapsed signal tower at Cleggan Hill Signal Station.

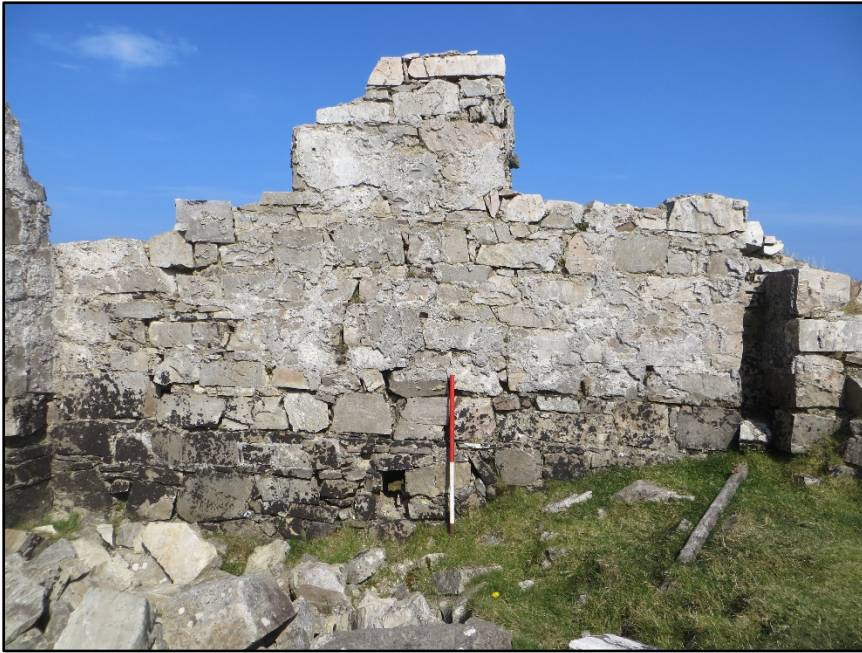
Only the east and north walls had surviving internal wall faces. The north wall featured a pillar of stonework in the centre that was identified as the dividing wall between two ground floor windows. At the east end of the north wall there was a square sectioned drainage channel. These two features suggested that the north and south walls were the side walls featuring the windows, that the east wall would have been the rear wall with the fireplaces and alcoves, because the drainage channel was typically found on or adjacent to that wall, and that the west wall would have been the front wall featuring the doorway. The only feature that was visible on the west wall was a row of joist holes very close to the internal ground level which marked the position of the ground floor. It is possible that an infilled semi-basement was present below the ground surface. The signal tower was constructed from light- and mid-grey medium-grained stone, possibly schist.

Figure A.93. The internal face of the north wall of the collapsed signal tower at Cleggan Hill Signal Station.

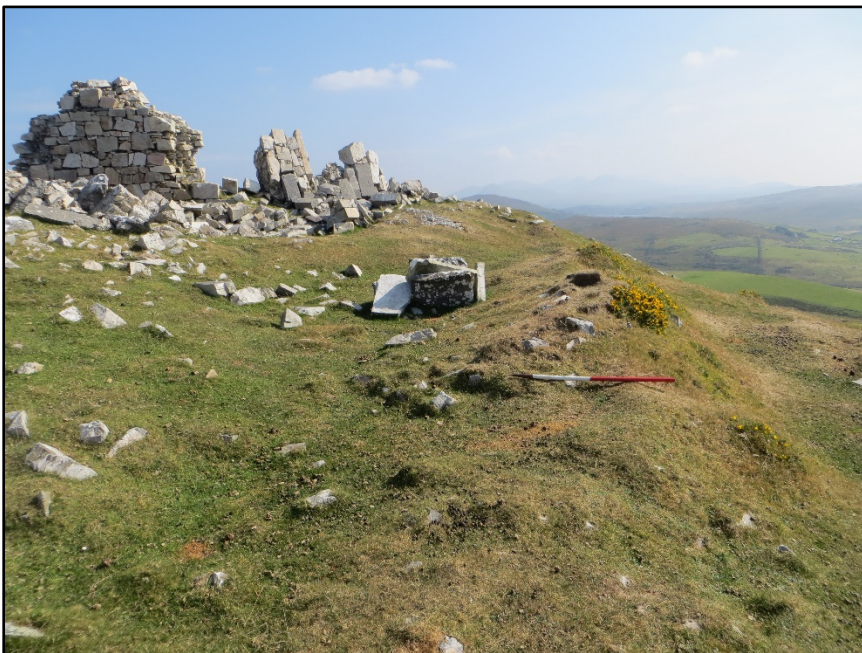
north-west of the signal tower. At the east, the enclosure wall could also be concealed by the rubble but given the steep nature of the ground in that area, no wall may have been required on that side and the enclosure may only have extended as far as the east edge of the signal tower. The enclosure would have been much smaller than was typical for the signal stations in the main study area.

Figure A.94. Looking east along the possible enclosure wall at Cleggan Hill Signal Station.

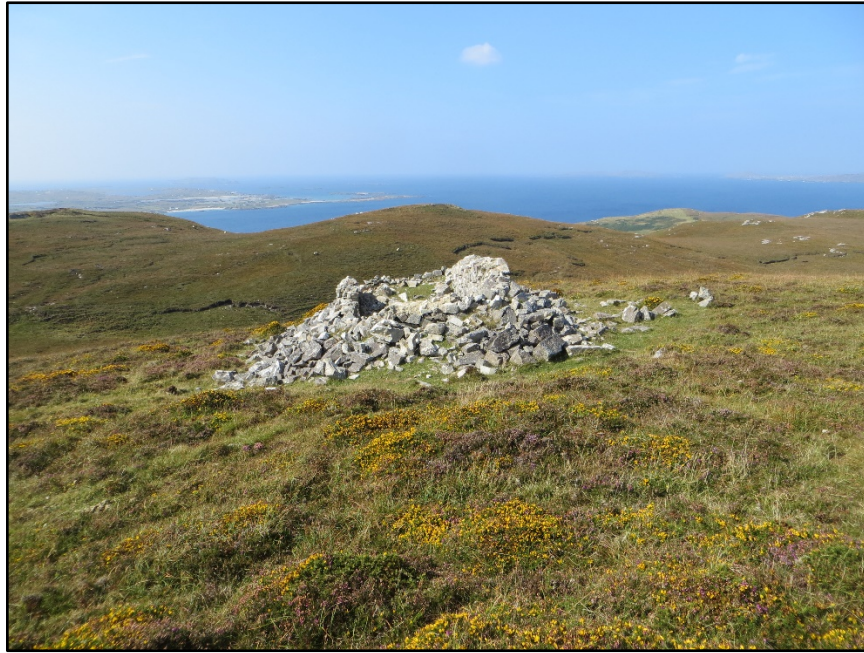
A rectangular building was located 39.8 m (130' 7") west of the signal tower. It was constructed of mortared rubble walling and measured 7.7 m (25' 3") east to west and 4.4 m (14' 6") north to south. The walls survived to a maximum height of 1.22 m (4') and were around 0.45 m (1' 6") wide. The building was surrounded by a dense rubble spread measuring 14.1 m (46' 3") east to west by 7.95 m (26') north to south. The building must have originally been quite substantial for its collapse to create such a large spread of rubble. The building was constructed from the same light- and mid-grey fine-grained stone as the signal tower. The building is shown on the 1st edition Ordnance Survey map, surveyed 1838-1839, and likely dates to the early 19th century. It may have been a contemporary element of the Cleggan Hill Signal Station.

Figure A.95. View of the eastern end of the collapsed adjacent building, looking west.

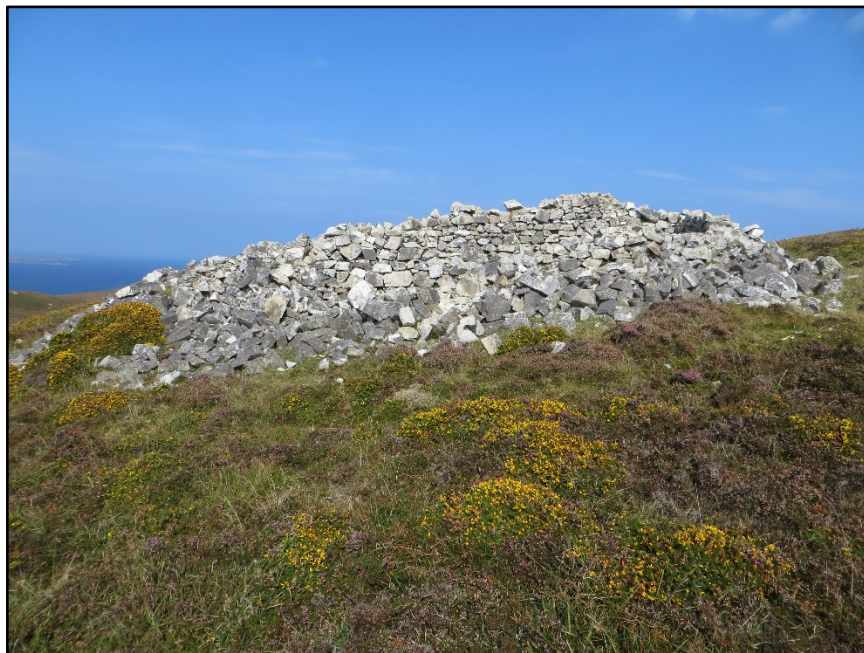
Figure A.96. View of the southern wall of the collapsed adjacent building, looking north.

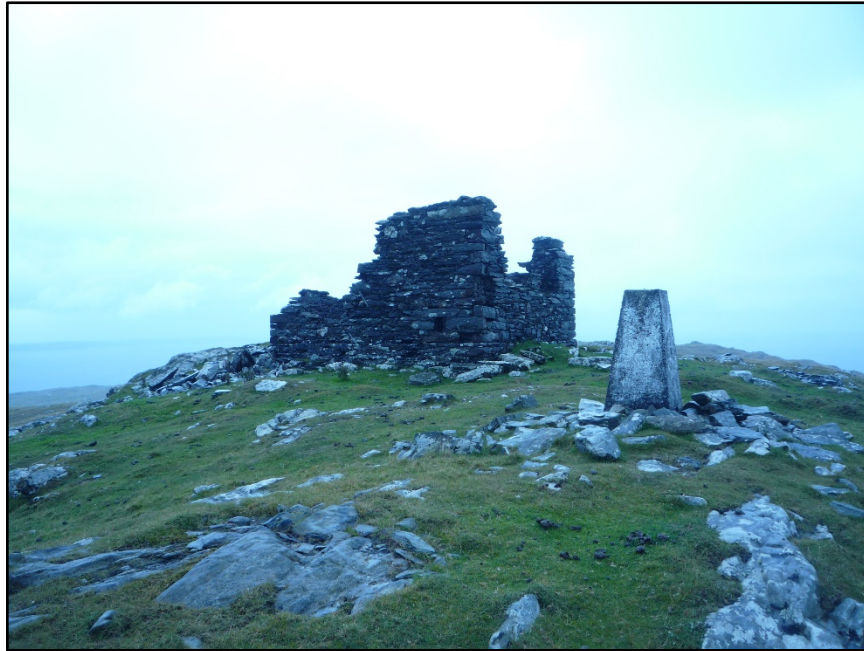
Figure B.8. View of the base of the signal tower at Inishturk Signal Station, looking south-west, with the trigonometry pillar in the foreground.

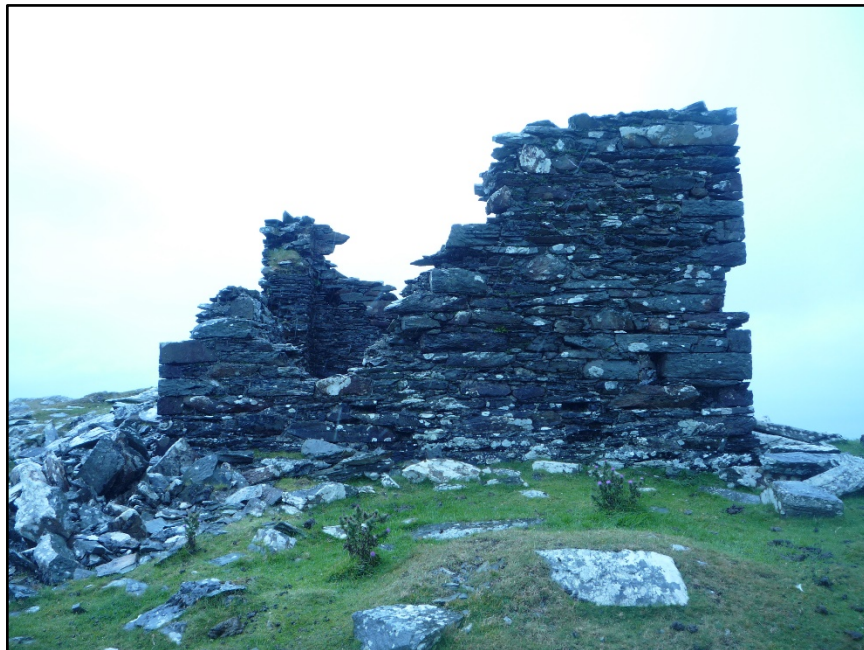
Figure B.9. The external face of the east wall of the signal tower at Inishturk Signal Station.

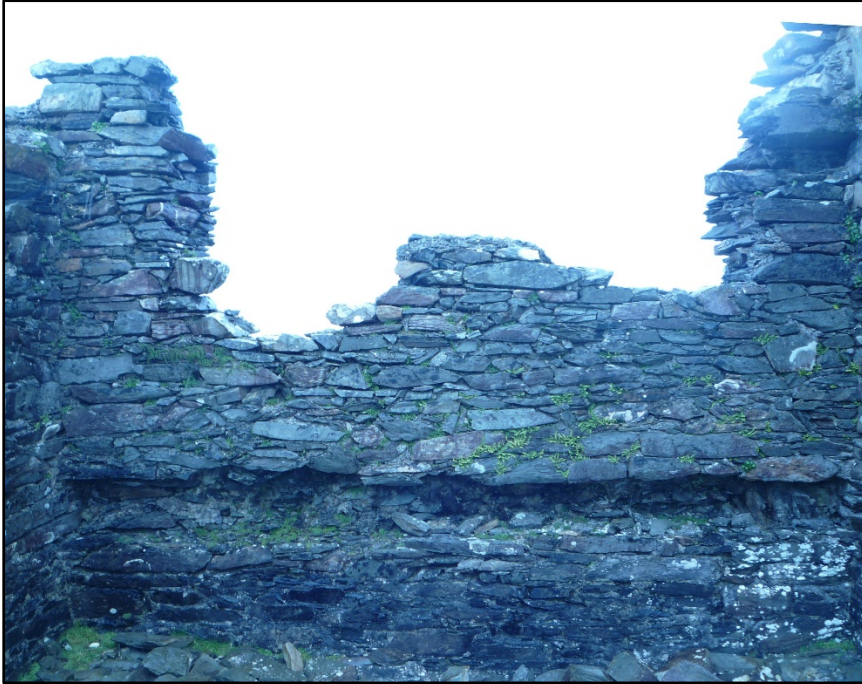
Internally the north and south walls featured slots which would have held the ground floor timbers, below the remains of the ground floor windows. The stone blocks that would have divided these slots into individual joist holes were entirely missing. The west wall was blank, and the east wall featured a central fireplace flanked by a complete alcove to the north and the lower part of an alcove to the south. There was a pair of substantial joist holes on either side of the central fireplace, set at the same height as

Figure B.10. The internal face of the north wall of the signal tower at Inishturk Signal Station.

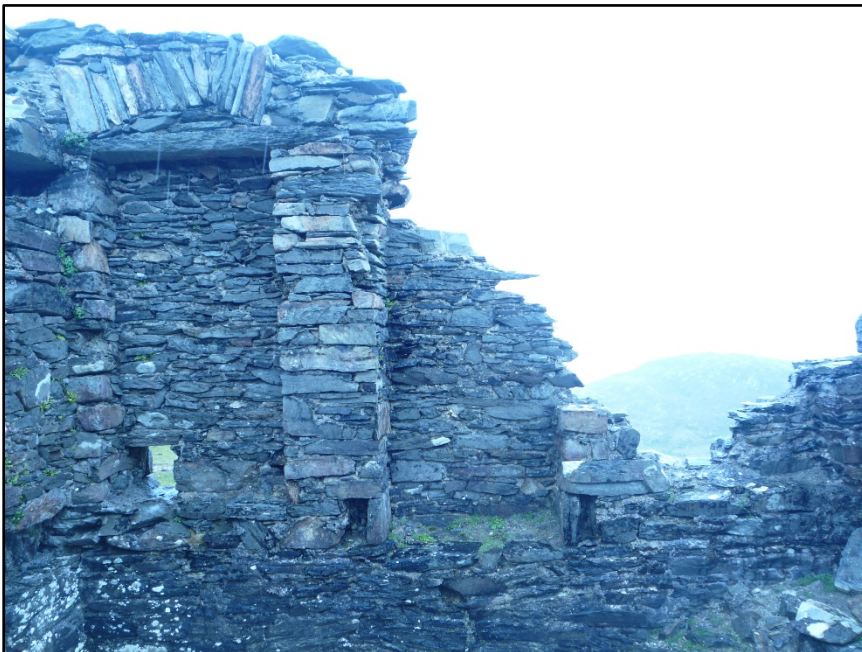
Figure B.11. The internal face of the east wall of the signal tower at Inishturk Signal Station, showing the intact north alcove with the square chute at its north edge, the damaged central fireplace and the fragments of the south alcove.

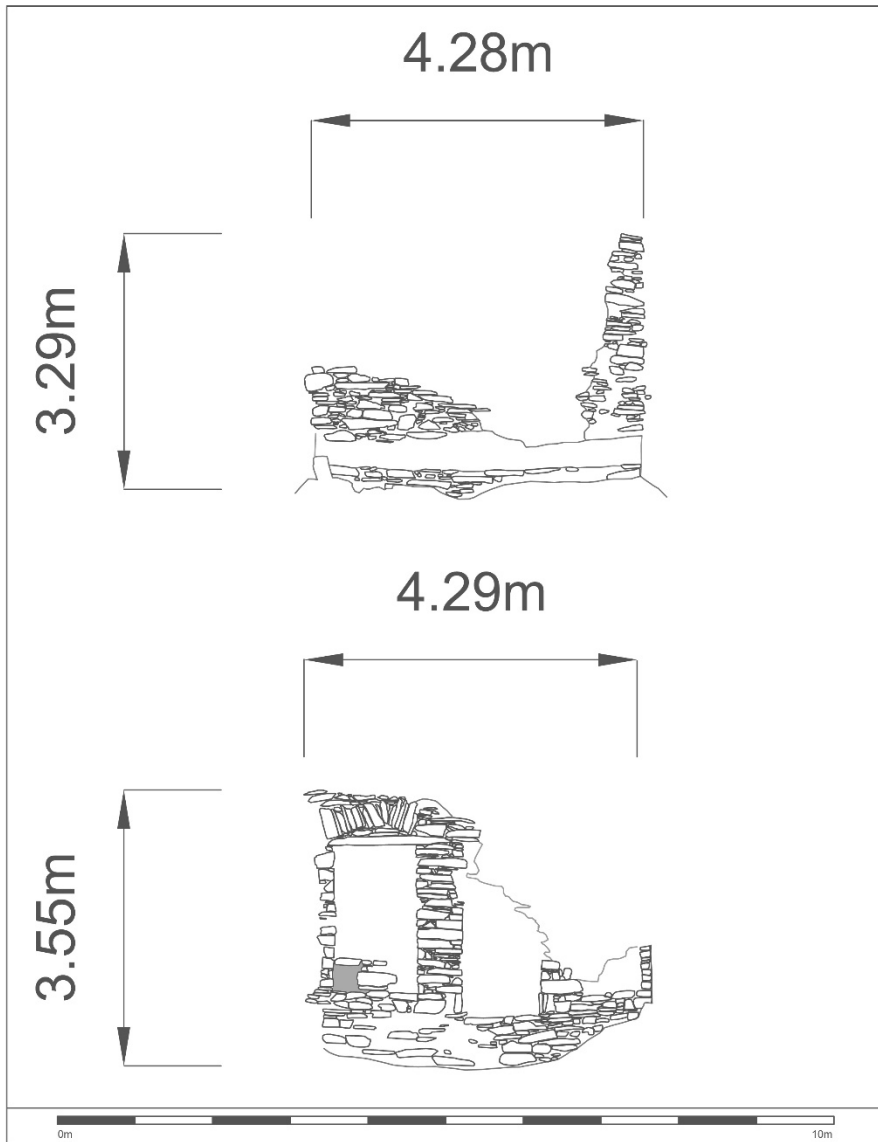
Figure B.15. Internal elevations of the south (top) and east (bottom) walls of Inishturk Signal Tower. The chute entering at the base of the ground floor alcove is shaded grey.

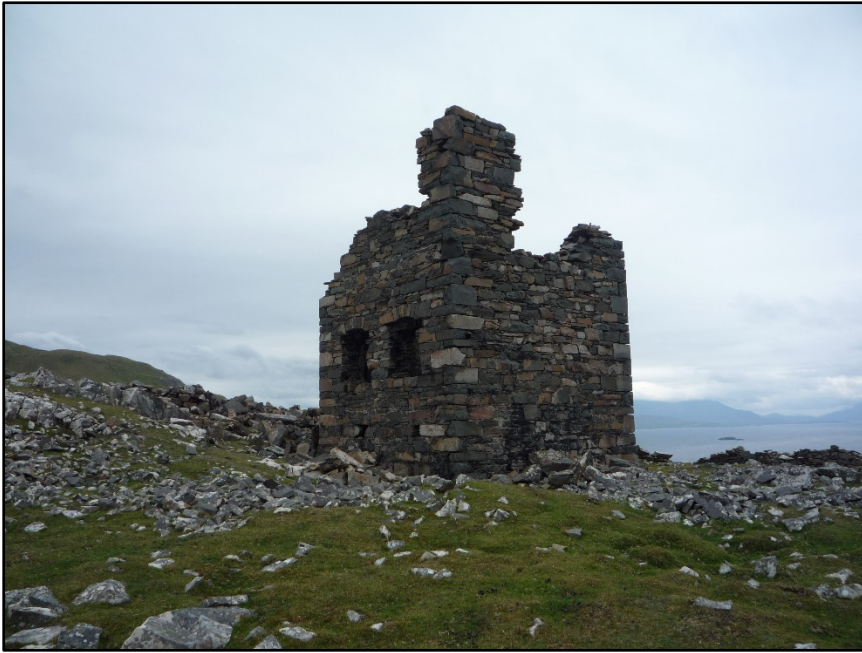
Figure B.19. View of the north-west corner of the signal tower at Clare Island Signal Station.

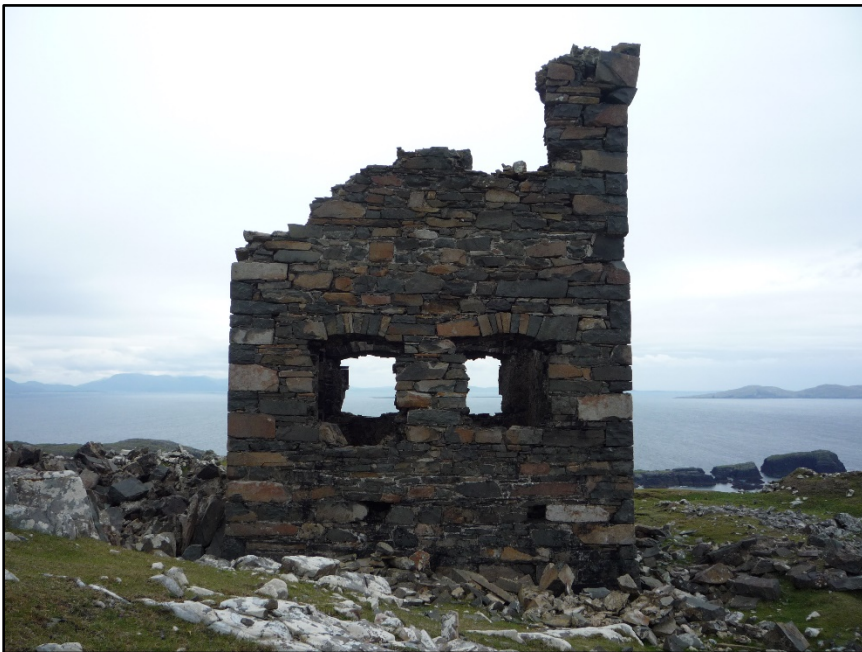
Figure B.20. The external face of the north wall of the signal tower at Clare Island Signal Station, showing the ground floor windows and traces of one first floor window at the right of the image.

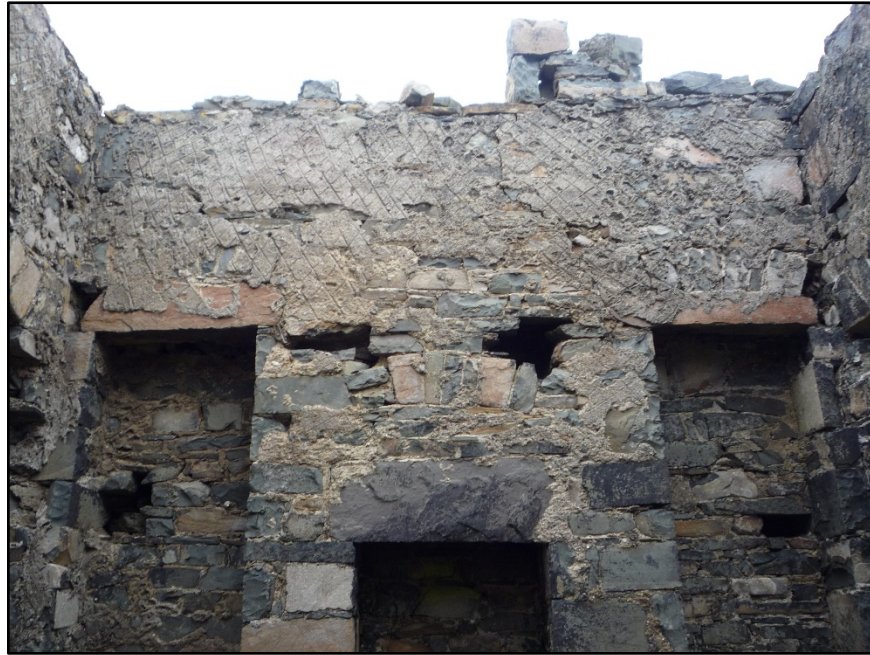
Figure B.21. The upper part of the internal face of the east wall, showing the top of the fireplace and the flanking alcoves.

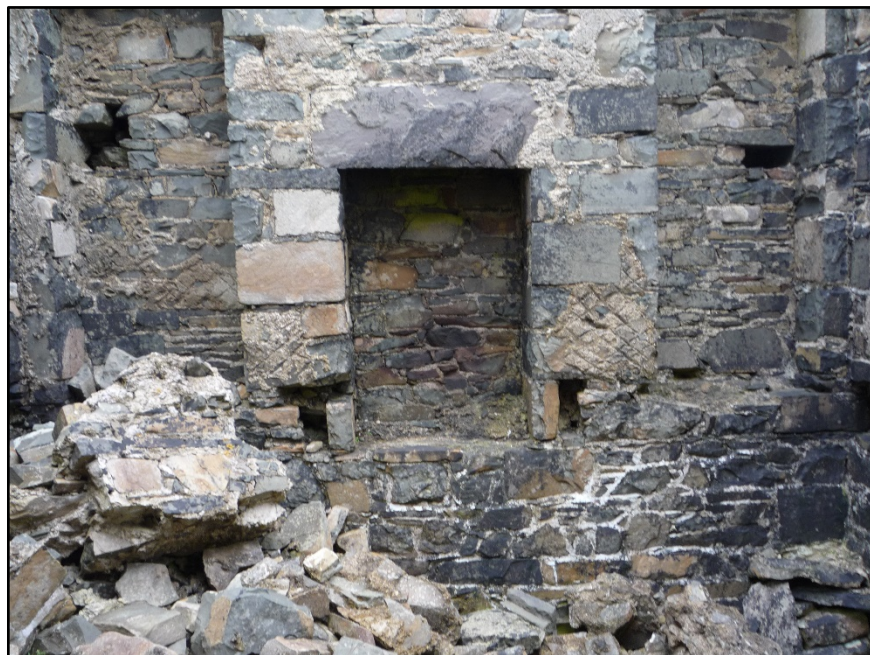
Figure B.22. The lower part of the internal face of the east wall, showing the fireplace and the bottom of the flanking alcoves.

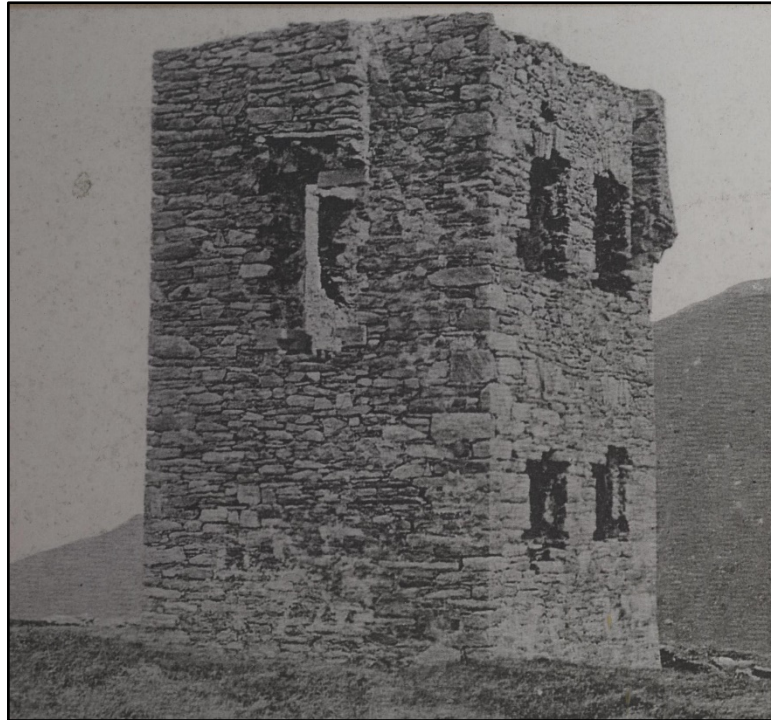
Figure B.34. An undated photograph of Saddle Hill Signal Tower, whilst the tower stood to close to its full height (From the personal collection of Michael O' Connor).

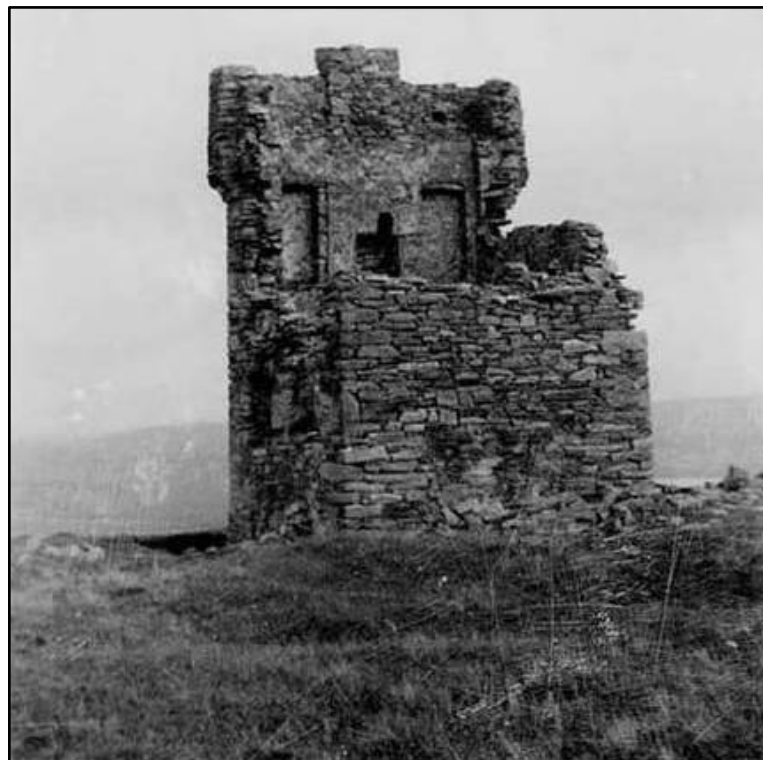
Figure B.35. A second undated photograph of Saddle Hill Signal Tower. The collapsed western walls allow the presence of first floor alcoves and fireplace on the eastern interior wall to be confirmed (From the personal collection of Michael O' Connor).

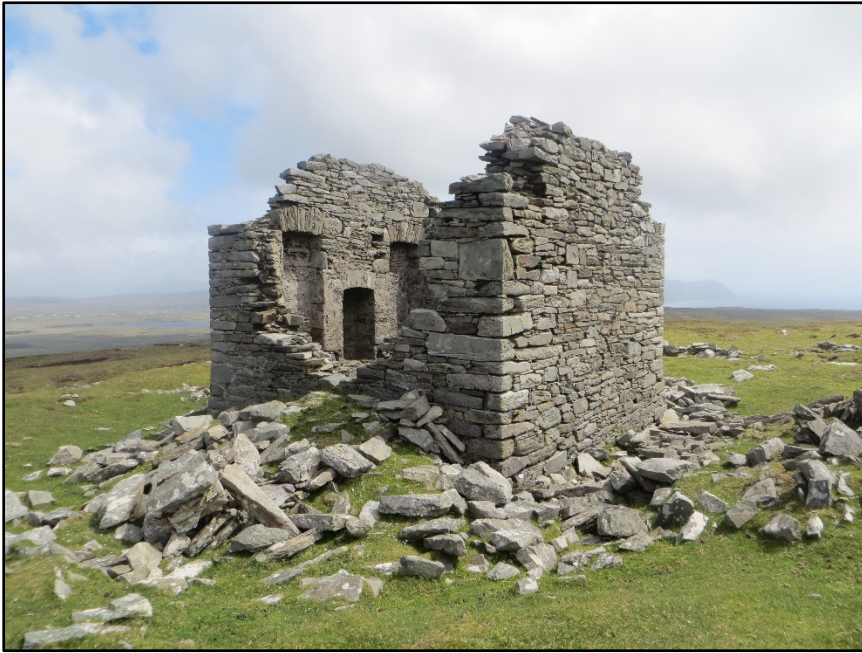
Figure B.36. View of north-west corner of the signal tower at Saddle Hill Signal Station.

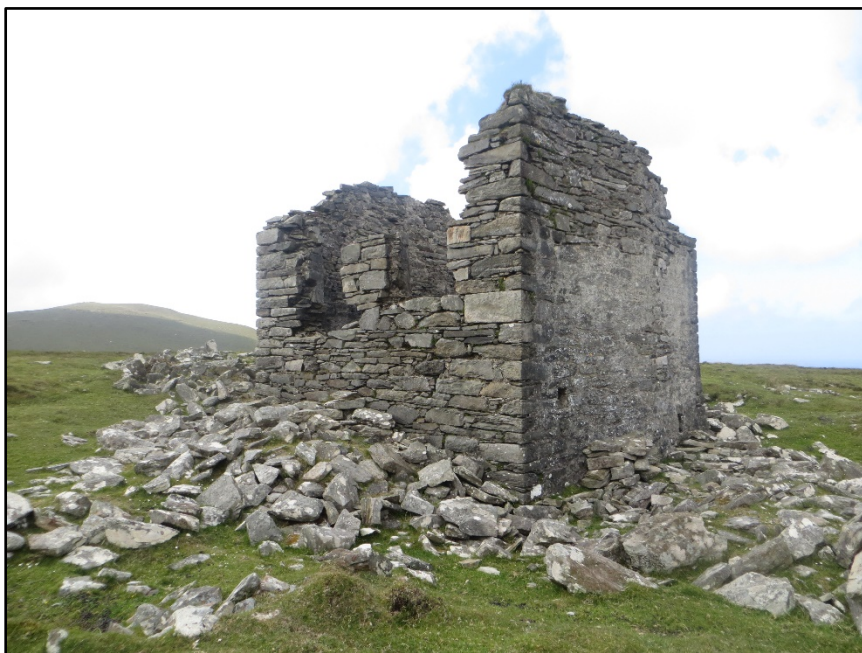
Figure B.37. View of south-east corner of the signal tower at Saddle Hill Signal Station.

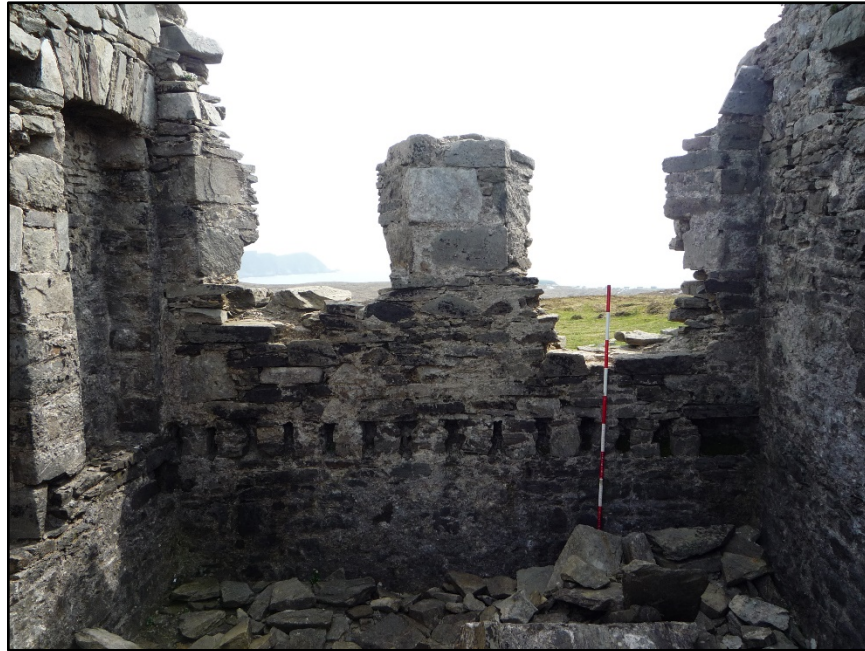
Figure B.38. View of the internal face of the south wall of the signal tower at Saddle Hill Signal Station.

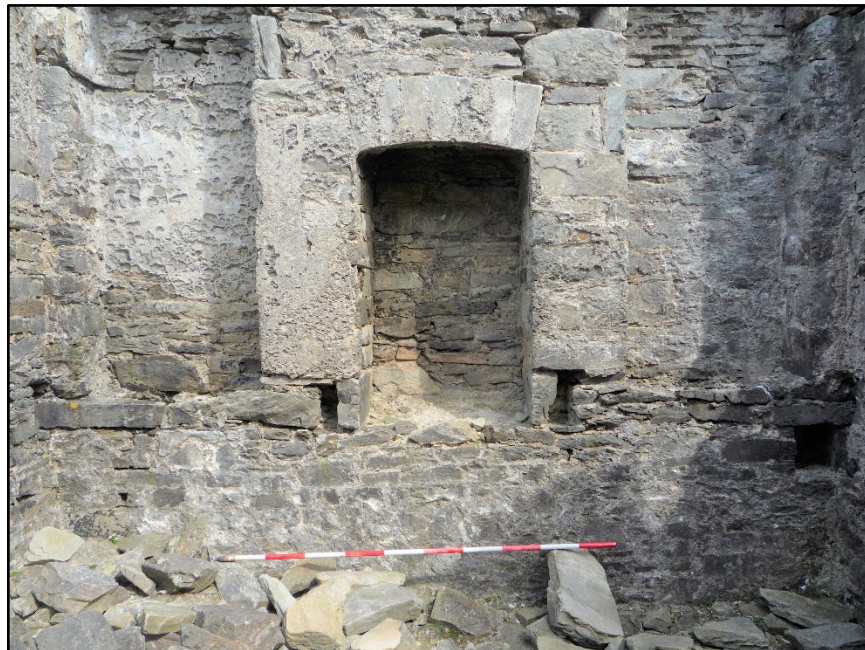
Figure B.39. View of the internal face of the west wall of the signal tower at Saddle Hill Signal Station, showing the ground floor central fireplace and the flanking alcoves. The horizontal chute can be seen at the right of the image, at the top of the semi-basement level.

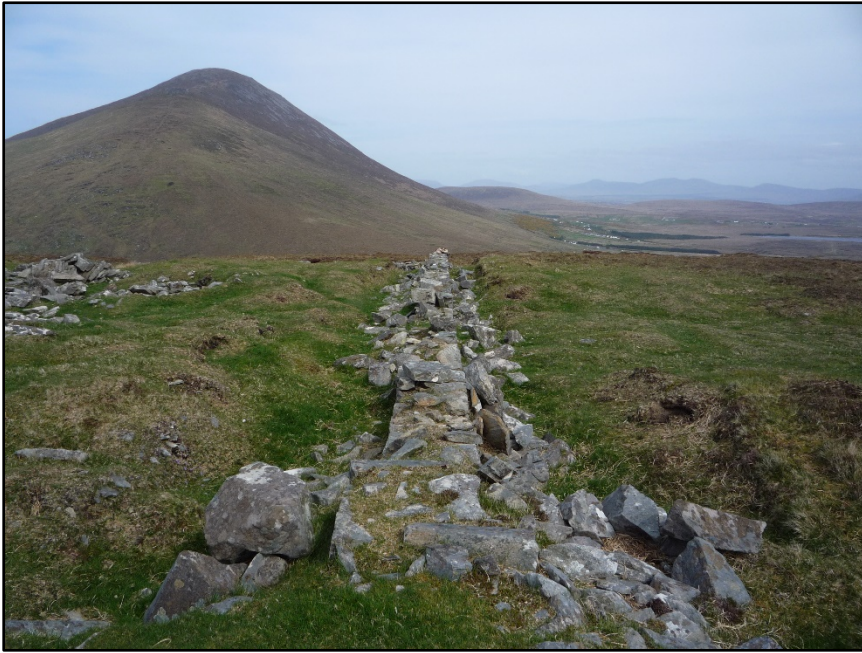
Figure B.40. The south wall of the enclosure, looking east, with the edge of the entrance visible in the foreground.

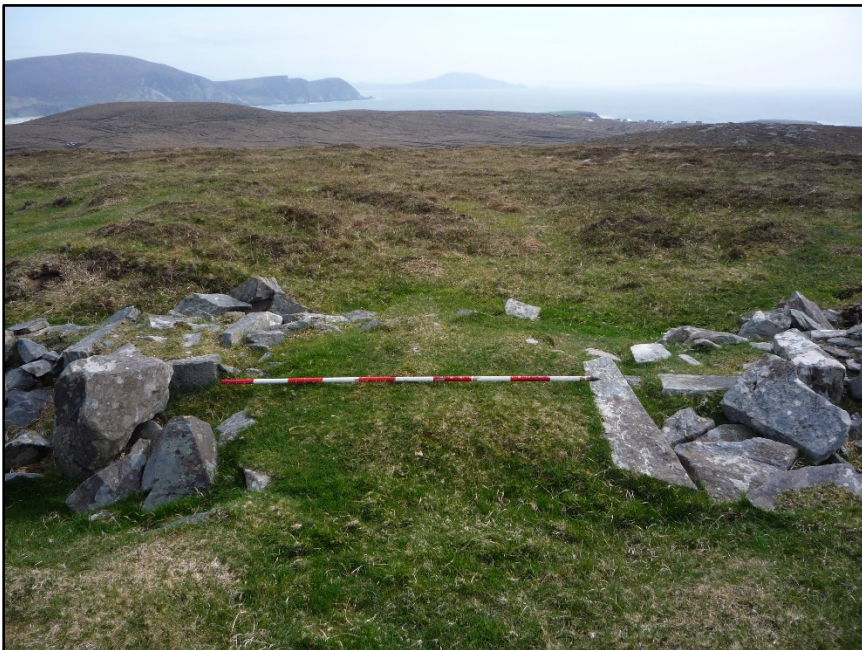
Figure B.41. Detail of the entrance on the south side of the enclosure.

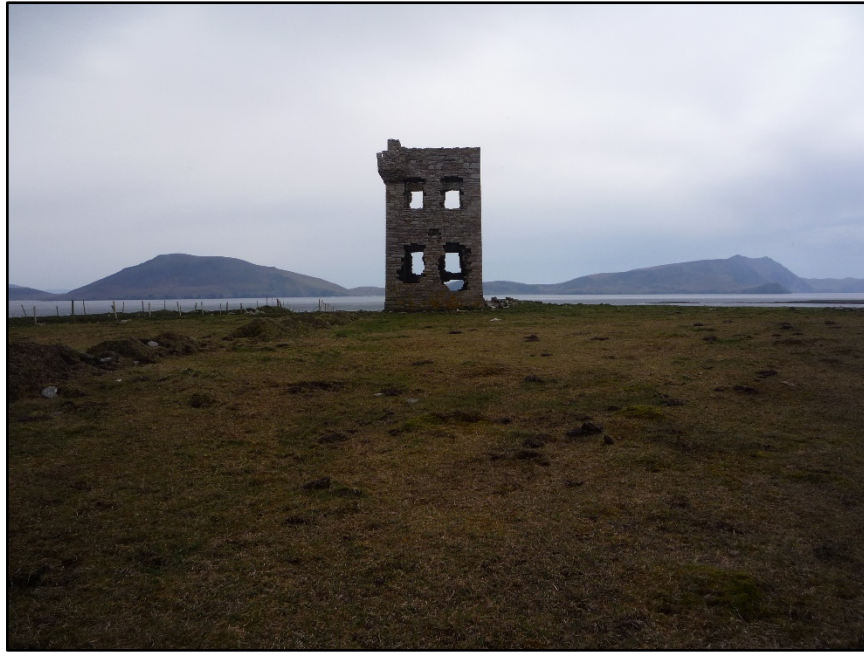
Figure B.53. The north wall of the signal tower at Glash Signal Station. Achill Island can be seen in the background.

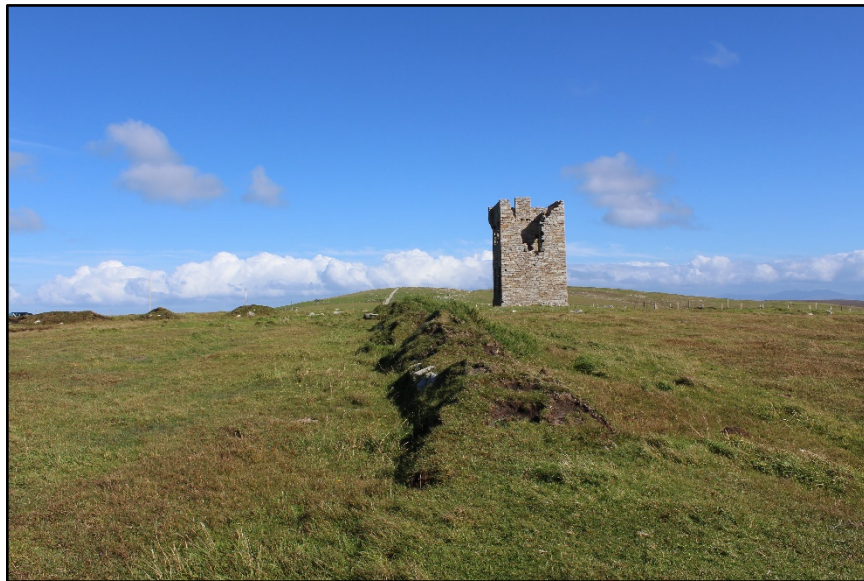
Figure B.54. The west wall of the signal tower at Glash Signal Station.

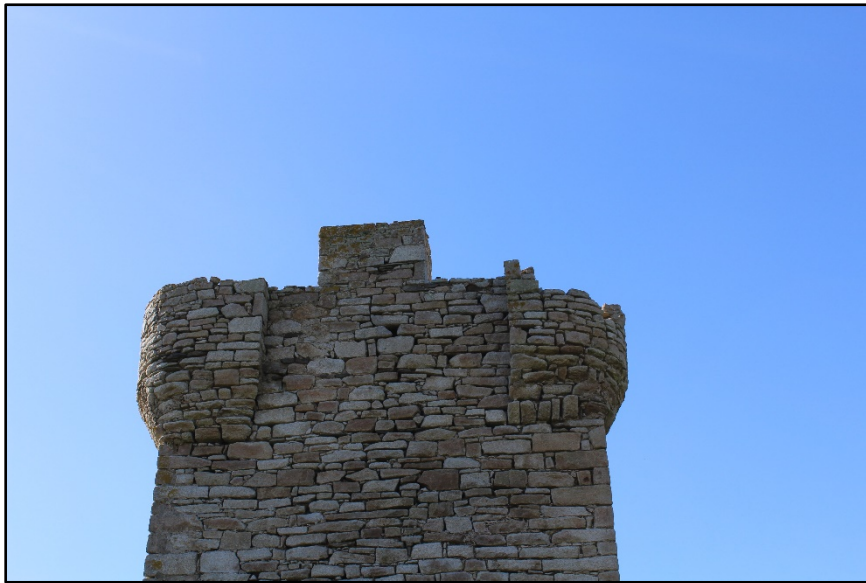
Figure B.55. The upper part of the external face of the east wall of the signal tower at Glash Signal Station, showing the curved bartizans and the well-preserved chimney.

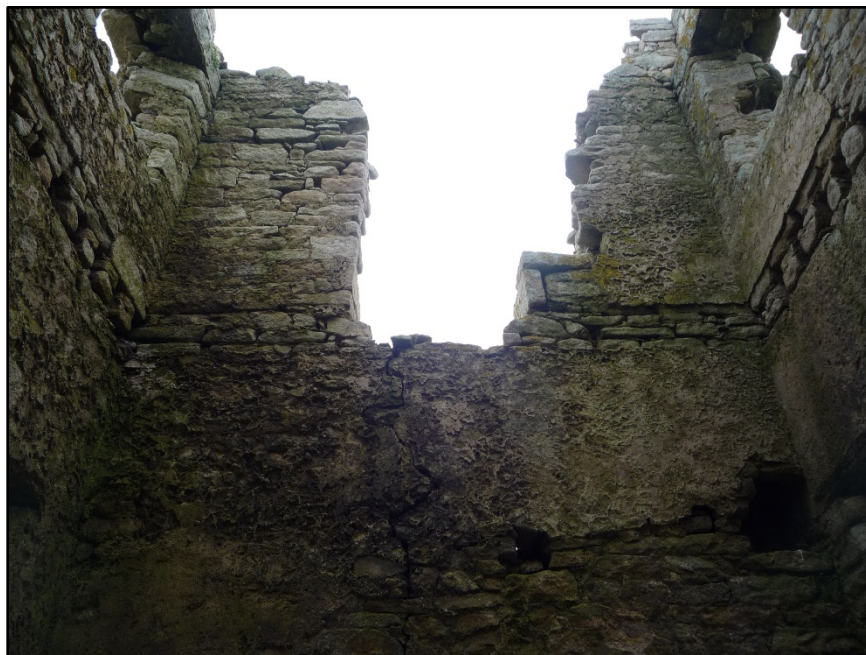
Figure B.56. The upper part of the internal wall face of the west wall of the signal tower at Glash Signal Station, showing the badly damaged first floor door.

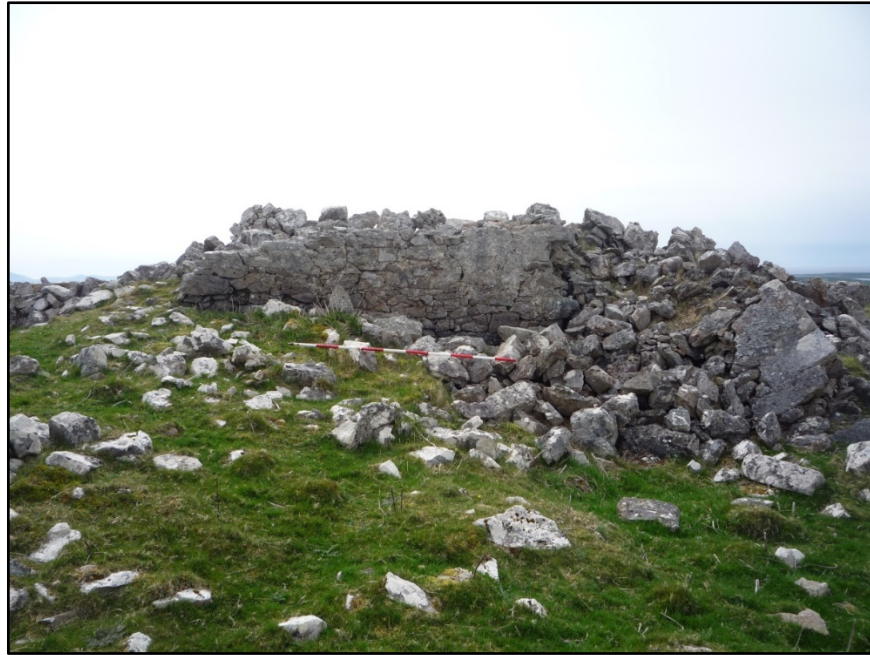
Figure B.68. The north-east side of the signal tower at Tower Hill Signal Station.
