The construction, survival, and use of Signal Defensible Guard Houses on the Irish Coast

Volume II of II

Ph.D. Thesis (Archaeology)

IT Sligo

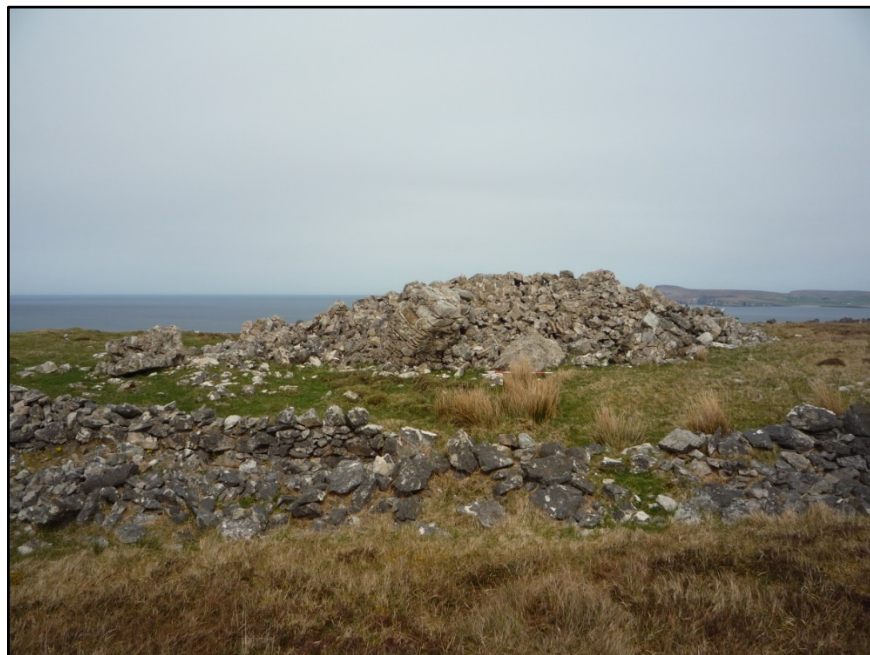
Figure B.69. The south-west side of the signal tower at Tower Hill Signal Station, with the enclosure wall in the foreground and Benwee Head visible in the background. The fallen bartizan is visible in the centre of the photograph.

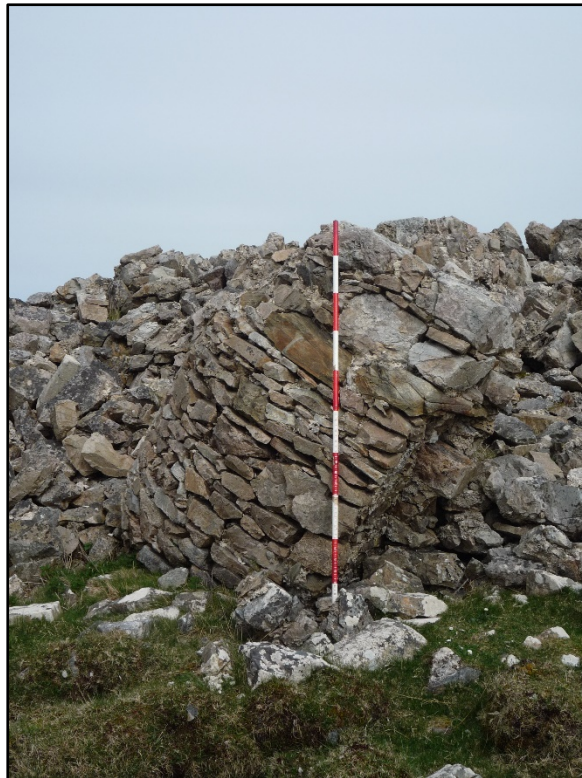
Figure B.70. Detail of the fallen bartizan in the rubble spread surrounding the collapsed signal tower.

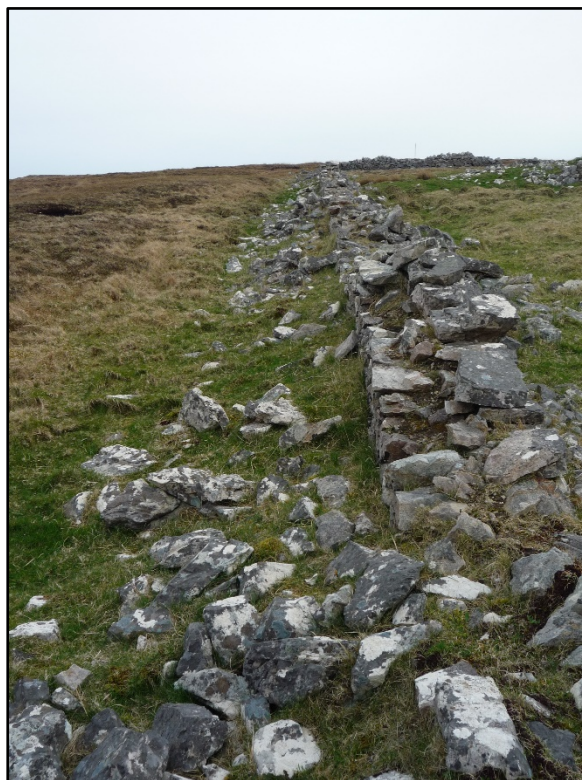
Figure B.71. Detail of the perimeter of the north-east side of the enclosure, looking south-east, showing the collapsed wall and the external ditch.

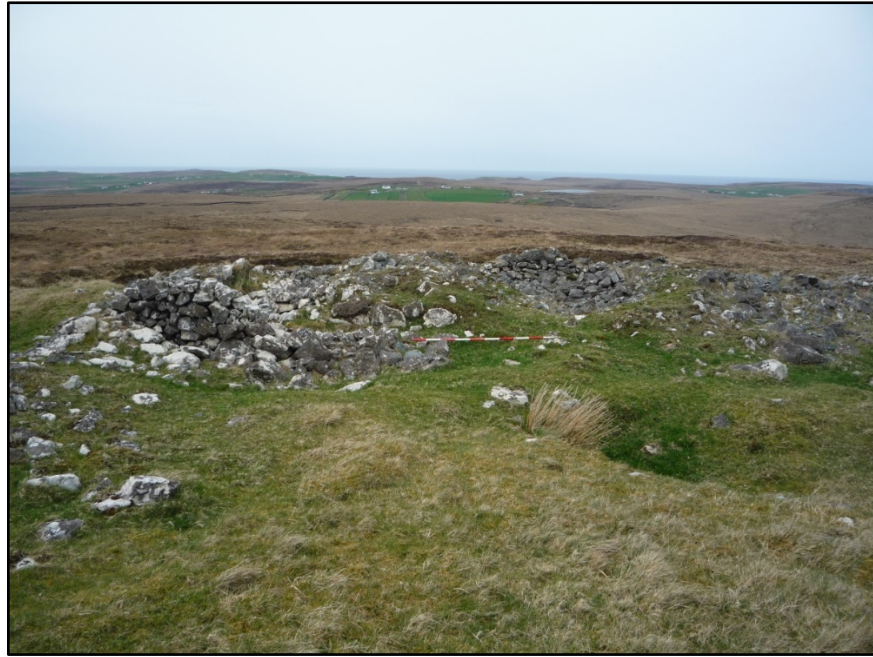
The foundation of a rectangular building was located at the north-west corner of the enclosure. The foundation measured 7.5 m by 3 m (24' 7" BY 9' 10") and was presumed to be an original element of the signal station.

Figure B.72. The remnants of the building in the west corner of the enclosure.

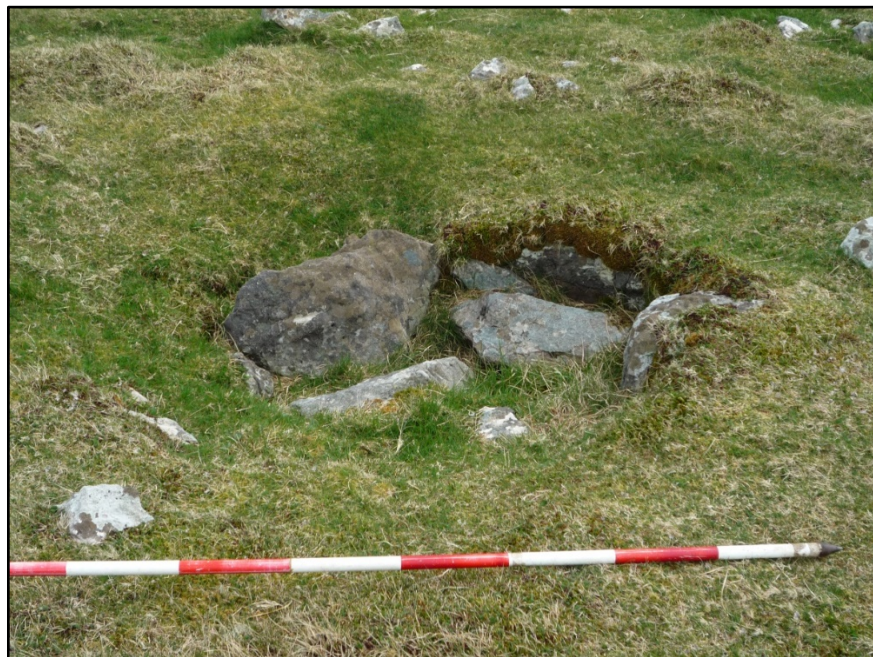
The infilled pit was located about 11 m (36') north-west of the signal tower, on the long axis of the enclosure. It was represented as a slight oval hollow 1.9 m (6' 2") in length with a cluster of large rocks in the centre. The pit may have been a lime kiln or the former position of the signal mast. Similar features were observed at Saddle Hill and Glash Signal Stations to the south.

Figure B.73. The infilled pit to the north-west of the signal tower at Tower Hill Signal Station.

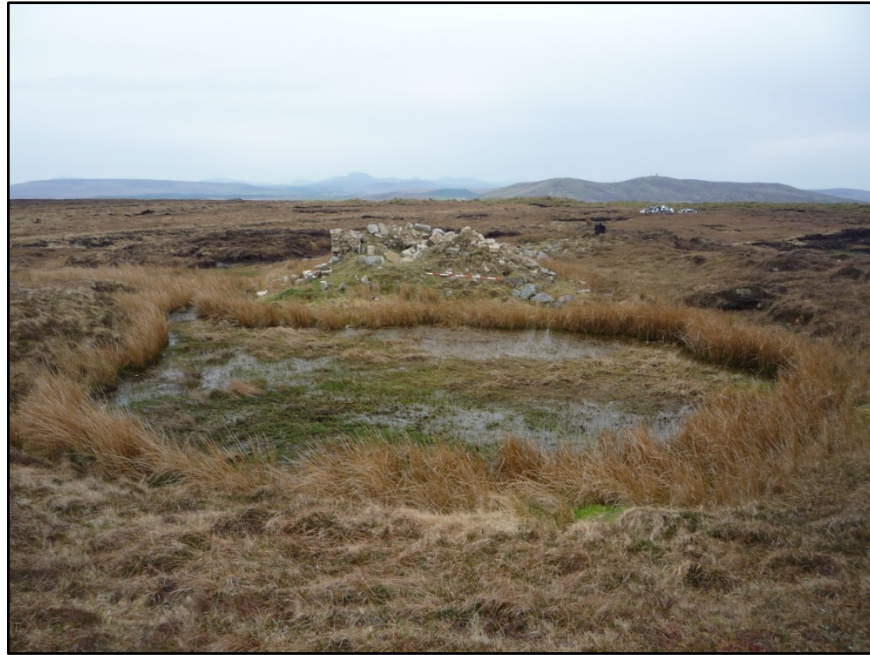
The signal tower was set within a large oval hollow that measured around 31 m by 21 m (102' by 69'). A narrow stony raised area connected the southern edge of the hollow to the signal tower. The northern part of the hollow contained a small pond. It is not clear if this hollow was an original feature that may have functioned in a similar way to the enclosures seen at other sites, or if it is a subsequent feature formed during peat extraction. If the hollow was an original feature, then the stony raised area might be an original causeway.

Figure B.77. The north side of the signal tower at Benwee Head, with the pond that fills the north of the hollow in the foreground.

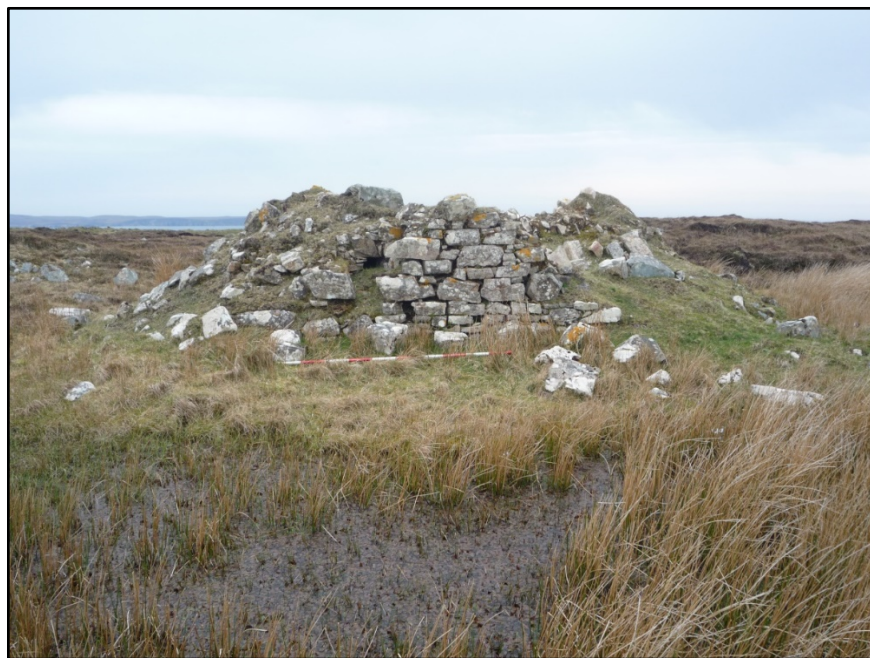
The signal tower measured approximately 6 m (19' 8") across but the lack of clear corners made it impossible to take precise measurements. The tower survived as little more than a pile of rubble, and just a few stretches of intact wall were visible. The lack of rubble around the building suggested that the stone has been removed for use elsewhere. The nearby track would have provided convenient access to the site that may have allowed for the stone's removal. The walls of the signal tower consisted of a of light-grey coarse-grained stone, possibly quartzite.

Figure B.78. The east side of the signal tower at Benwee Head Signal Station.

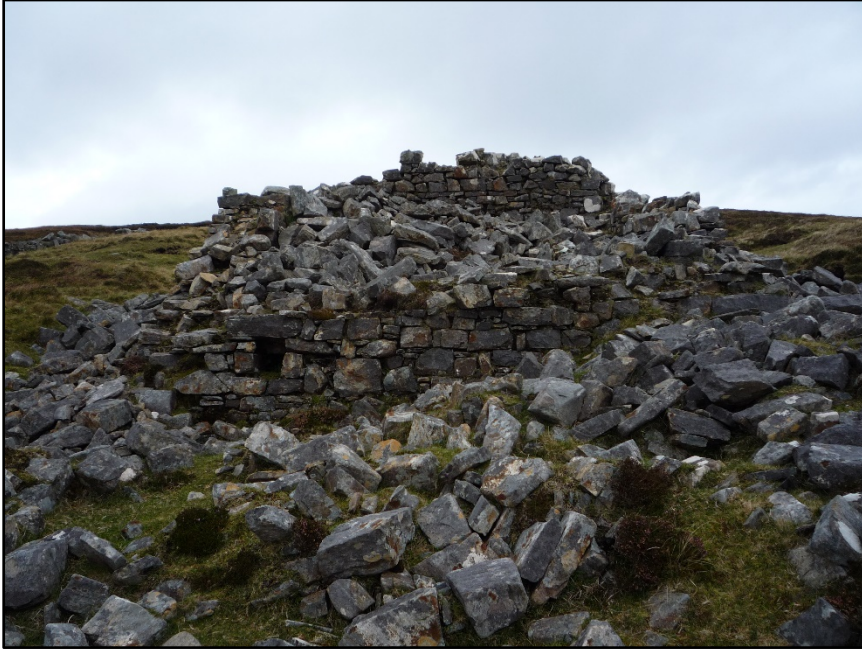
Figure B.82. The external face of the south wall of the collapsed signal tower at Glinsk Signal Station. The chute passing through the wall is visible towards the left.

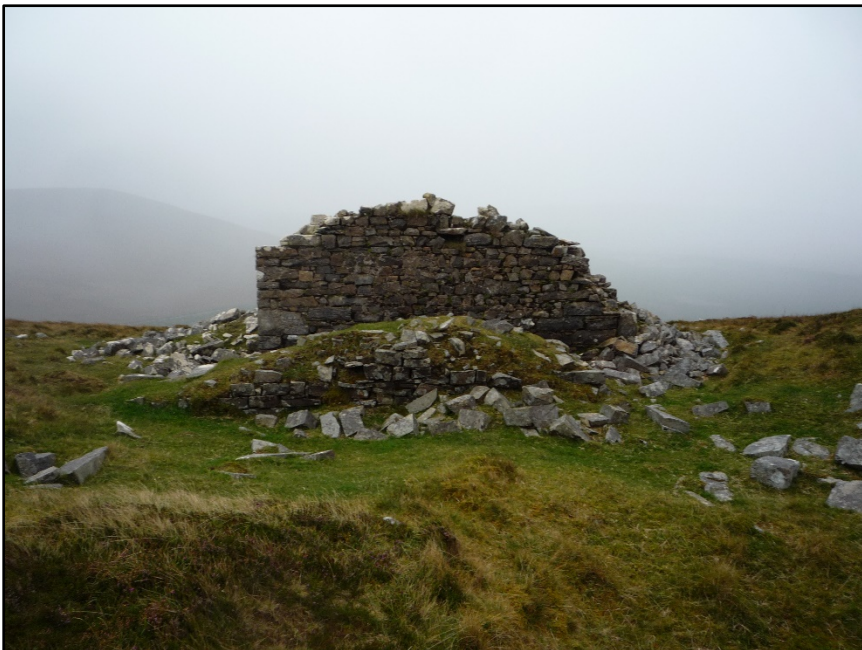
Figure B.83. The external face of the north wall of the collapsed signal tower at Glinsk Signal Station. The wide section of wall that may belong to a second building is visible in front of the tower.

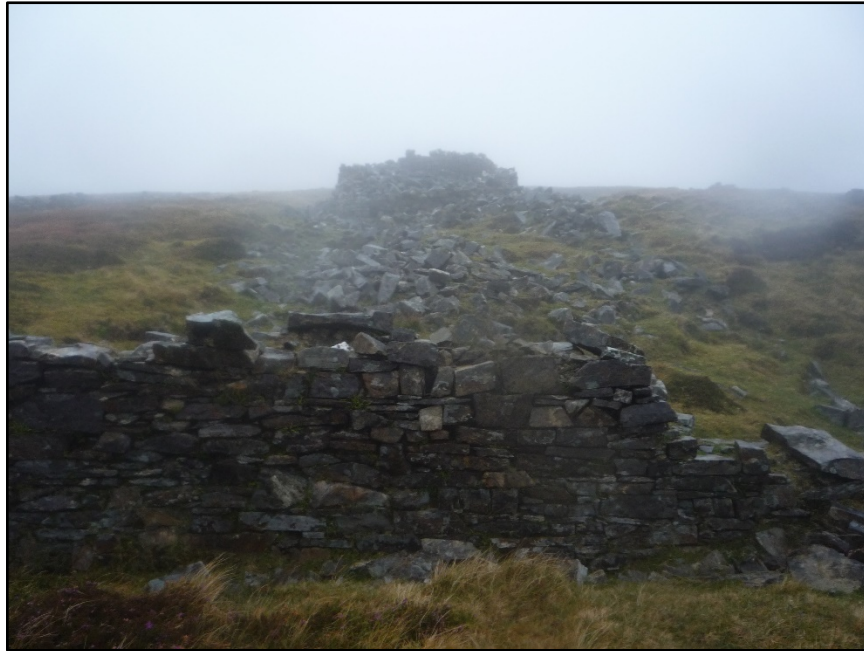
The signal tower was set within a rectangular enclosure that had its long axis aligned north to south. The enclosure was defined by a low stone wall that had suffered from a significant amount of collapse. The northern wall of the enclosure was missing entirely. The enclosure measured at least 43 m (141') in length and was around 28 m (91'10'') wide. The wall was 0.9 m (3') wide and survived to a maximum height of 1 m (3' 3'') along the western side. Given that little if any of the rubble from the collapsed tower appears to have been removed from the site, the absence of either an intact or collapsed wall along the northern side of the enclosure suggests that the perimeter of the enclosure may never have been completed.

Figure B.84. View of Glinsk Signal Station, looking north, with the wall of the enclosure in the foreground.

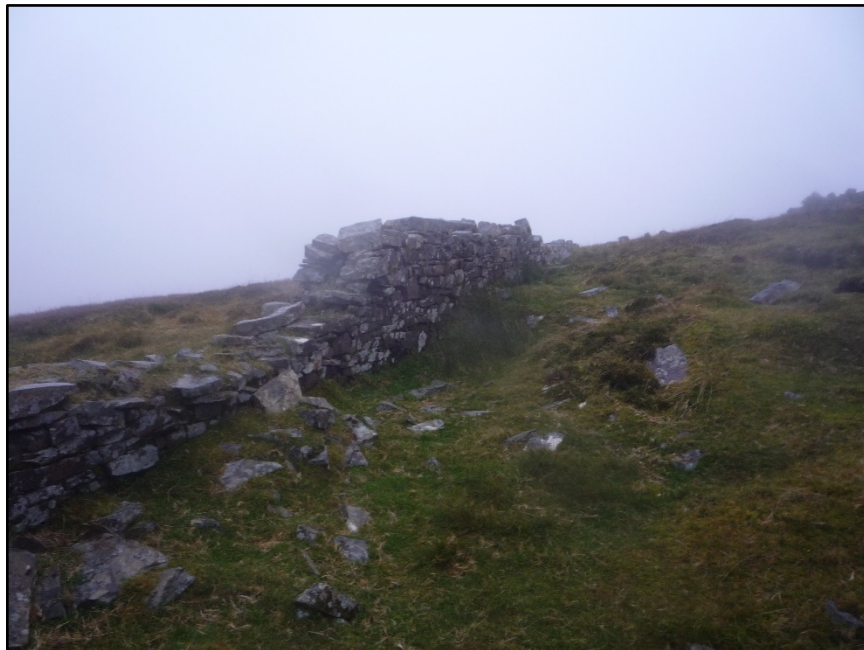
Figure B.85. View of one of the better-preserved sections of the enclosure wall, located at the south of the enclosure, looking west.

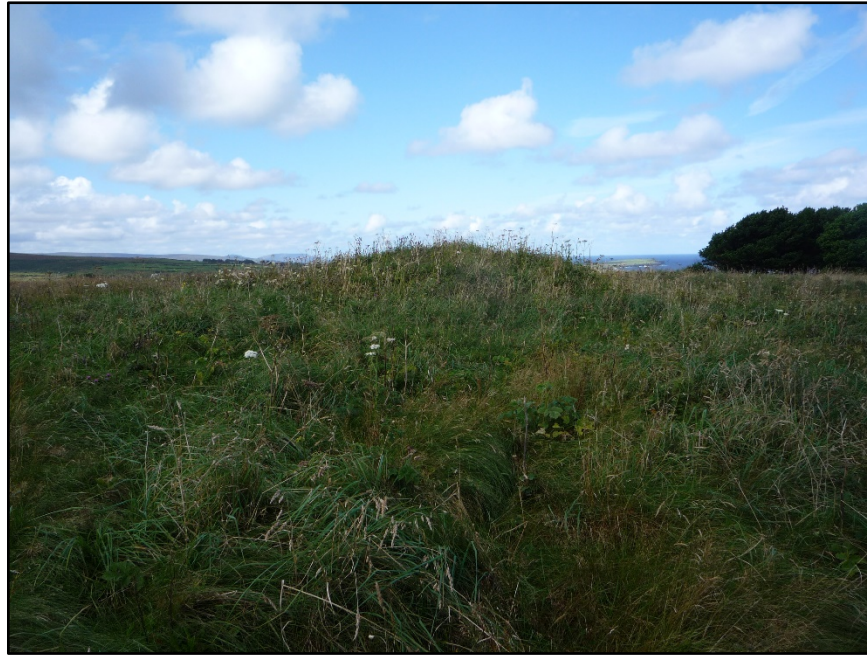
A small grassy mound was present in the area where the signal tower was depicted on the 1st edition Ordnance Survey map. The mound could consist of some leftover rubble from the signal tower. The geology around Creevagh provides high quality sandstone that is still quarried today. It is possible that the abandoned signal station was seen as a convenient source of building stone that did not require quarrying, leading to its almost total removal from the landscape.

Figure B.91. The low grassed over mound in the approximate position of the signal tower at Creevagh Signal Station.

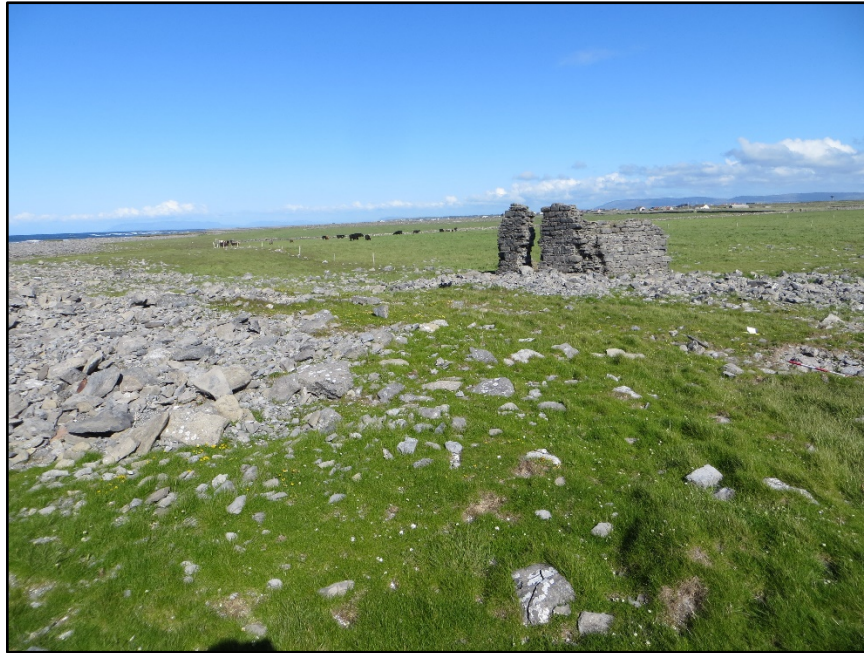
Figure C.5. View of the west corner of the collapsed or unfinished signal tower at Lenadoon Point Signal Station.

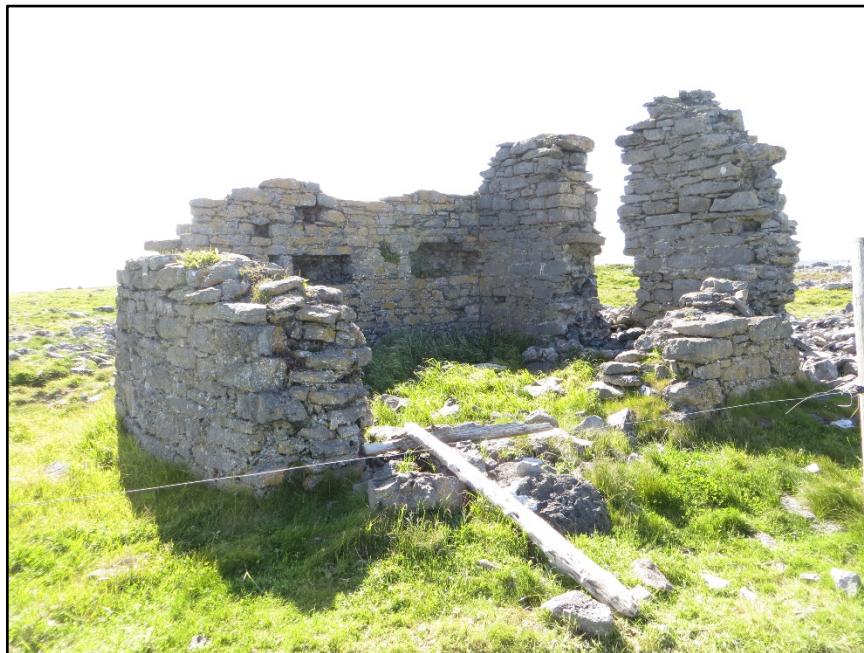
The signal tower was badly collapsed with only the semi-basement level and parts of the ground floor surviving. The entire first floor and parapet level were missing. The walls defined a slightly rectangular building, rather than the typical square plan, with the walls facing north-east, south-east, south-west, and north-west respectively. Externally the building measured 6.1 m (20') north-west to south-east and 5.8 m (19'3") north-east to south-west. Internally the building measured 4.57 m (15') north-west to south-east and 4.32 m (14'2") north-east to south-west. The south-east wall featured

Figure C.6. View of the east corner of the collapsed or unfinished signal tower at Lenadoon Point Signal Station.

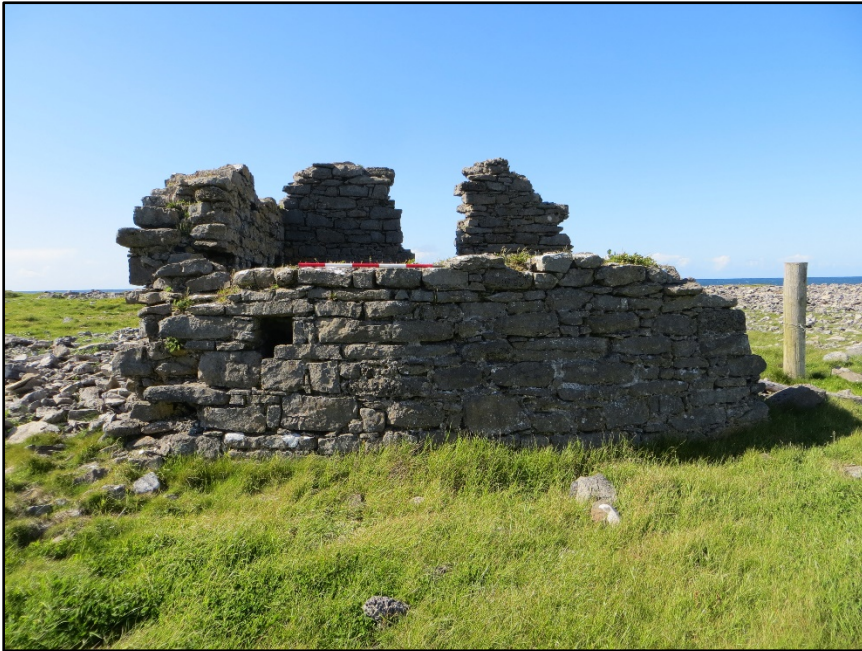
Figure C.7. View of the external face of the south-east wall of the collapsed or unfinished signal tower at Lenadoon Point Signal Station.

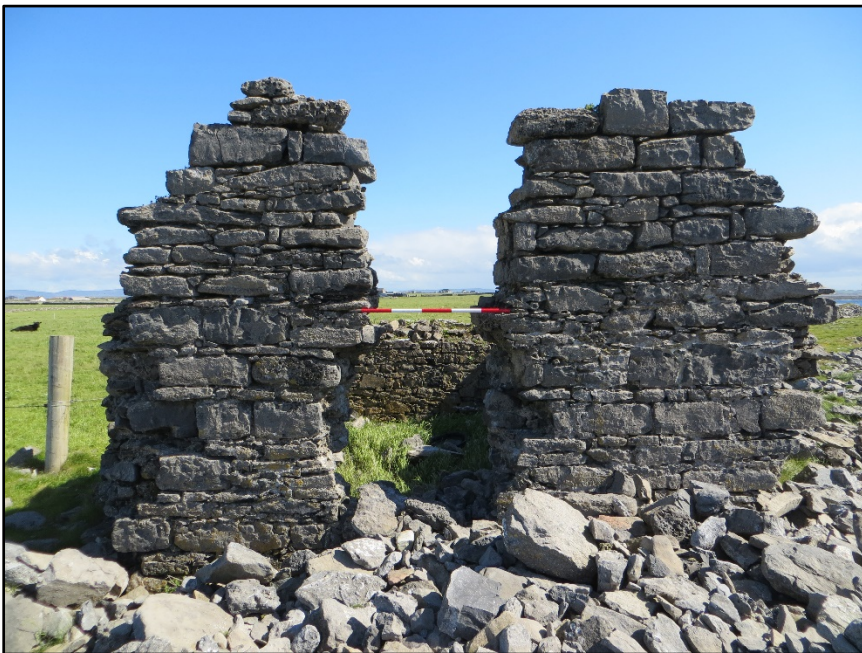
Figure C.8. View of the external face of the north-west wall of the collapsed or unfinished signal tower at Lenadoon Point Signal Station.

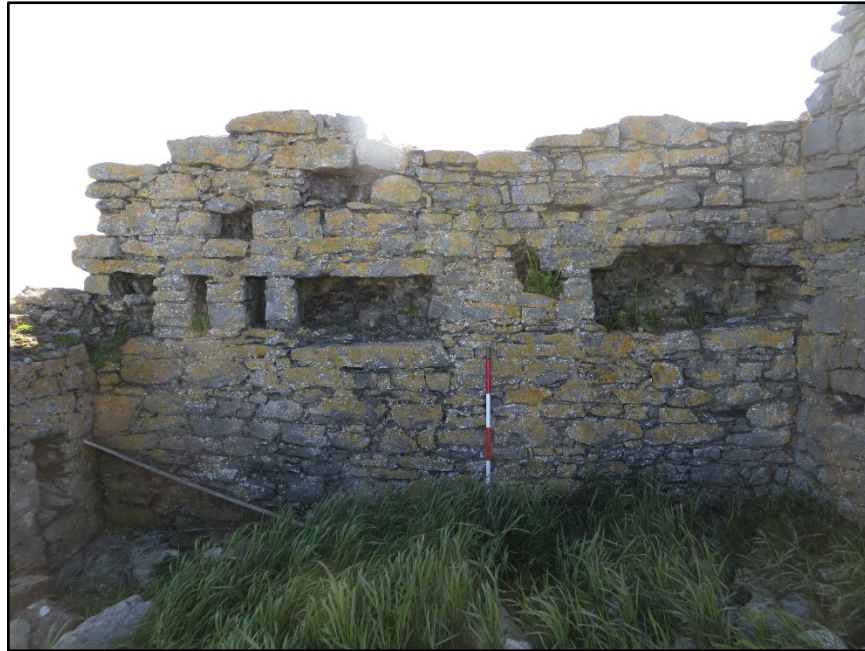
Internally the south-west wall featured a poorly preserved slot with some joist holes that would have held the ground floor. Curiously the slot was only present towards the edges of the wall, it did not extend across the central portion of the wall. This arrangement was not noted at any other site in the main study area. The north-east wall was very badly damaged and only a small section at the north-west end survived. The north-west wall had a centrally placed vertically sided opening that could conceivably have been the remains of a crude doorway, created to allow the unfinished or collapsed foundation to be entered and utilised. The south-east wall survived to the height of the base of the slot for the first floor joists. The wall had the typical bulge for a chimney that identified it as the rear wall of the signal tower. A chute passed through the south-west part of the south-east wall, opening into the semi-basement level, sloping down steeply as it passed through the body of the wall.

Figure C.9. View of the internal face of the south-west wall of the collapsed or unfinished signal tower at Lenadoon Point Signal Station.

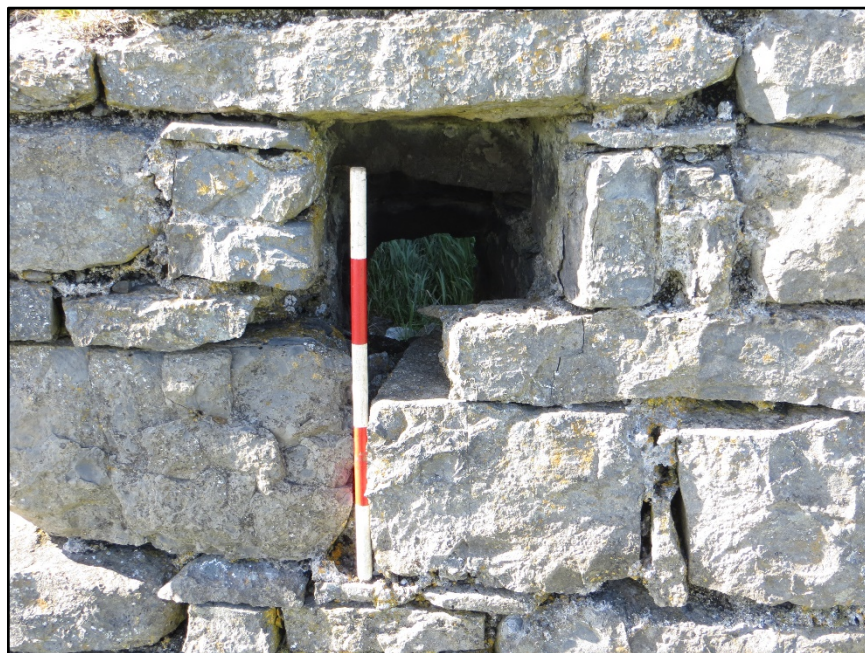
Figure C.10. Detail of the chute passing through the south-east wall of the signal tower at Lenadoon Point Signal Station.

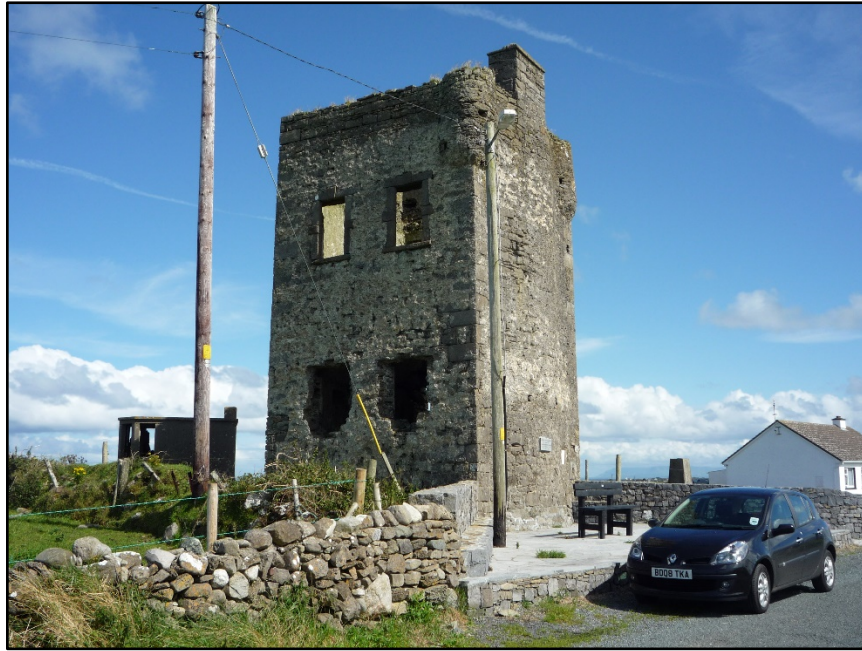
The south wall bowed slightly outwards to house the flue of the chimney. A rare example of an intact chimney stack extended from the top of the south wall. There were numerous holes in the south wall, distributed without an obvious pattern. They resembled putlog holes, but they may have had a different cause. Two of the holes passed clear through the wall and mirrored the position of the two central holes on the north wall. Fine curved bartizans were located on the south-east and south-west corners of the tower. There were no surviving coping stones on top of the walls. The northern, western and eastern walls feature extensive areas of render. The dressed stones used in the signal tower were a mid-grey coarse-grained stone, possibly limestone. The walls of the signal tower were constructed of dark-grey coarse-grained stone, possibly limestone.

Figure C.18. View of the south-west corner of the signal tower at Rathlee Signal Station.

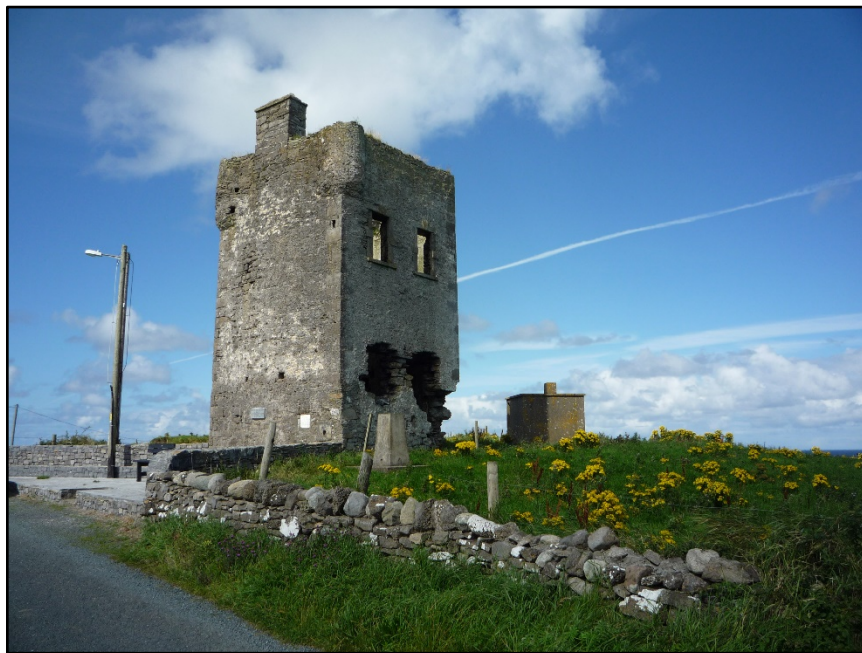
Figure C.19. View of the south-east corner of the signal tower at Rathlee Signal Station, with the trigonometry pillar in the foreground and L.O.P. 65 in the background, to the right of the signal tower.

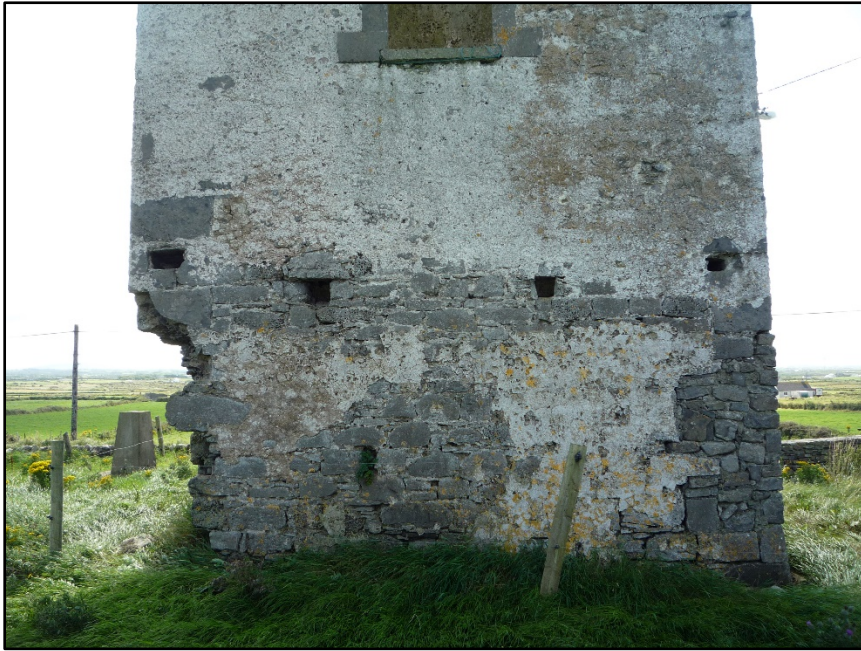
Figure C.20. The lower part of the external face of the north wall of the signal tower at Rathlee Signal Station. The bottom of the door can be seen, above the uneven row of four holes penetrating into or passing through the body of the wall. The damaged north-east corner can be seen at the left.

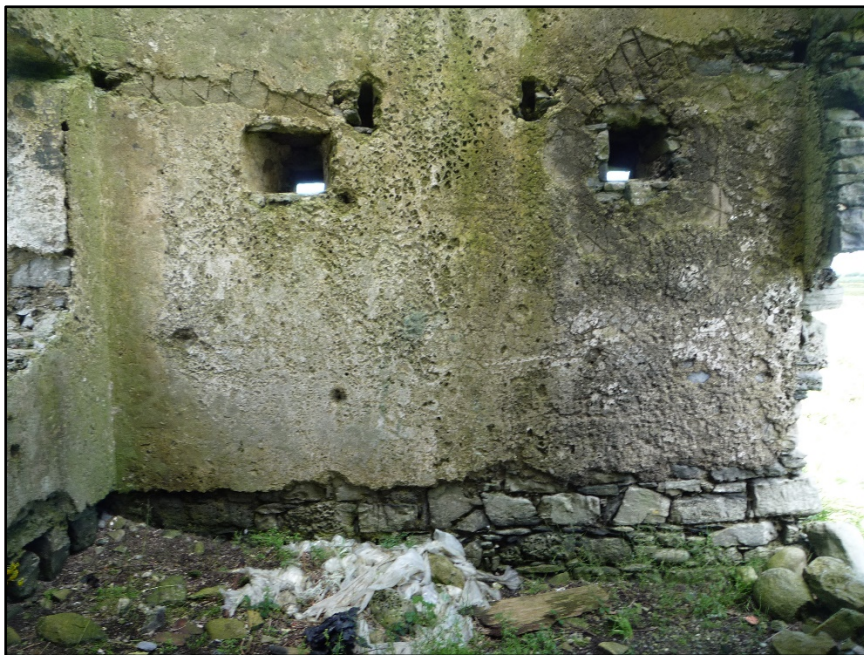
Figure C.21. The lower part of the internal face of the north wall of the signal tower at Rathlee Signal Tower. The gap in the render for the ground floor, the two square holes passing through the wall and the sloping gaps in the render connecting to the narrowly spaced joist holes that may have held the split mezzanine levels can be seen.

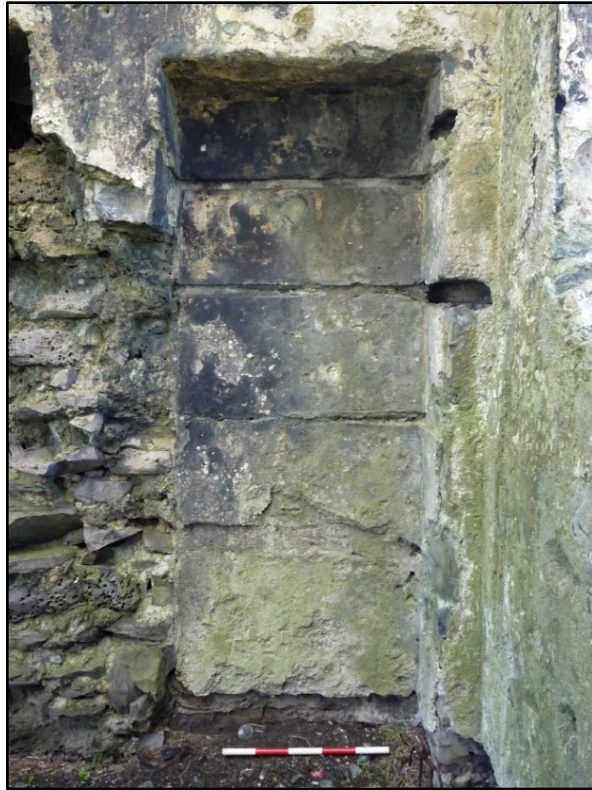
The rear wall at the south featured the standard pattern of central fireplaces with flanking alcoves on both the ground floor and the first floor. The ground floor alcoves retained thick layers of render. In the west alcove the impression of four thick shelves were visible in the render. In the east alcove the impression of two shelves were visible at the top of the alcove. A stone seat with a curved back protruding into the body of the wall occupied the lower part of the east alcove. There was no vertical drainage channel on or adjacent to the rear southern wall.

Figure C.22. The east alcove in the ground floor level of the internal south wall face showing the impression of four shelves in the render.

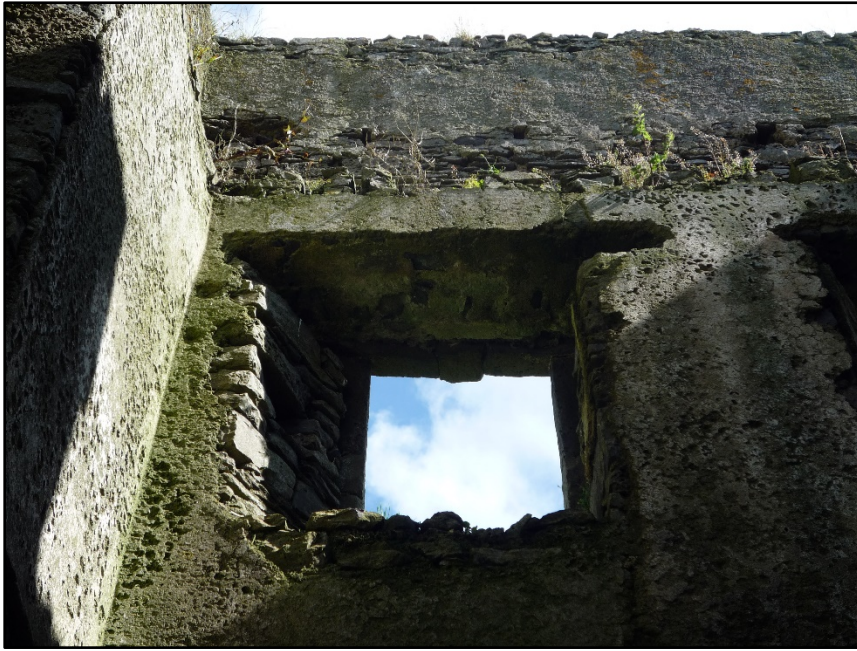
Figure C.24. Interior detail of the north first floor window on the east wall.

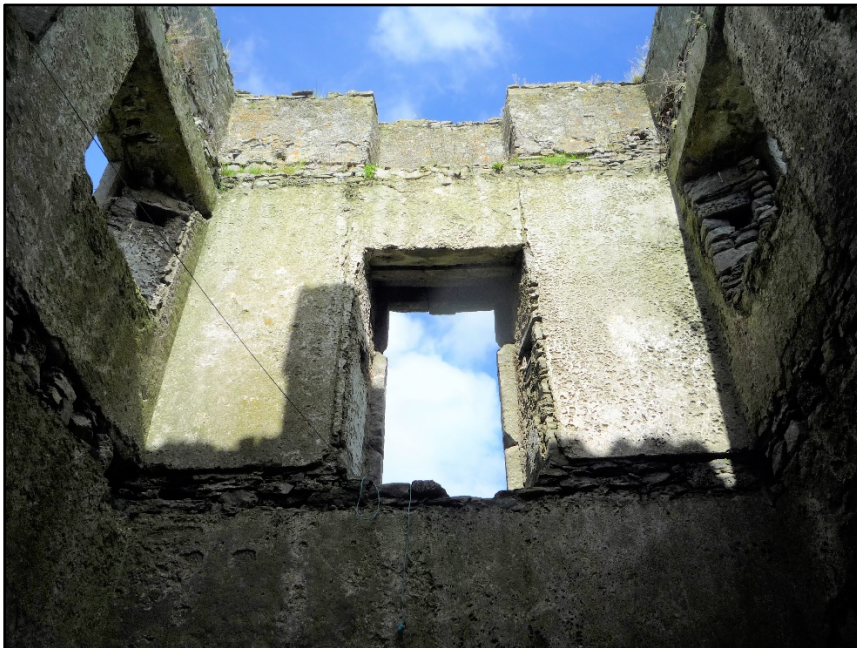
Figure C.25. Interior detail of the door on the north wall, showing the impression of the first floor and parapet level roof, above which is the entrance to the machicolation over the door.

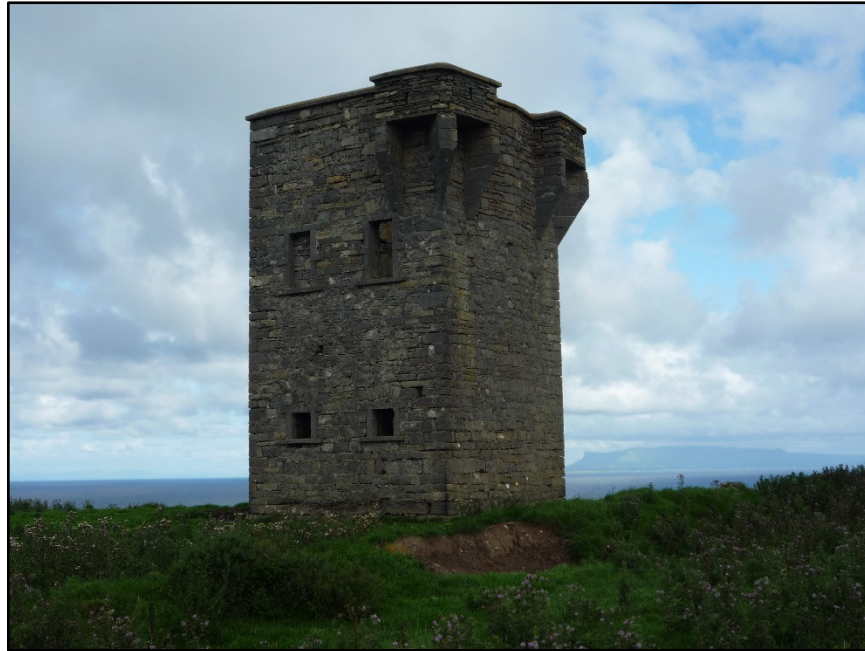
Figure C.37. The south-west corner of the signal tower at Carrowmably Signal Station.

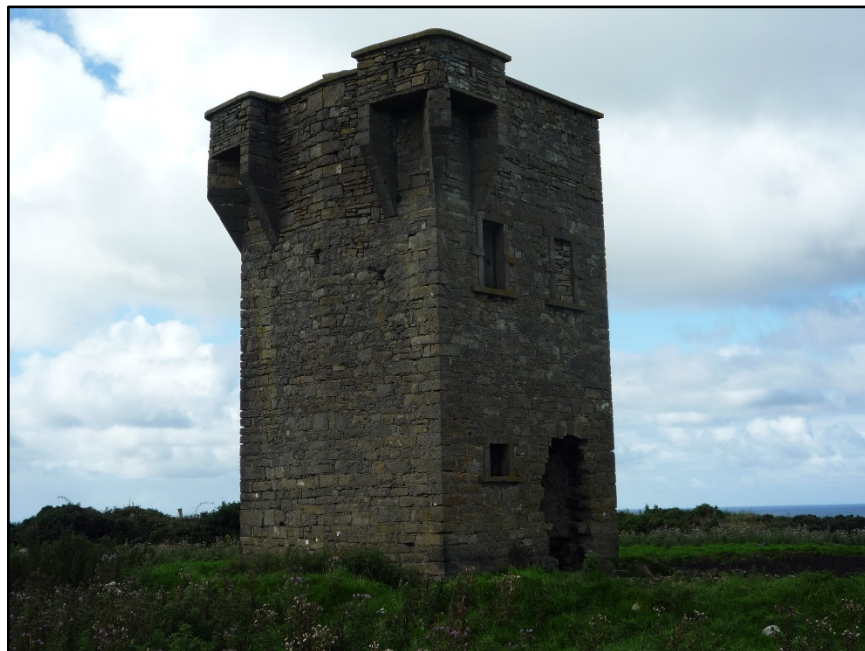
Figure C.38. The south-east corner of the signal tower at Carrowmably Signal Station.

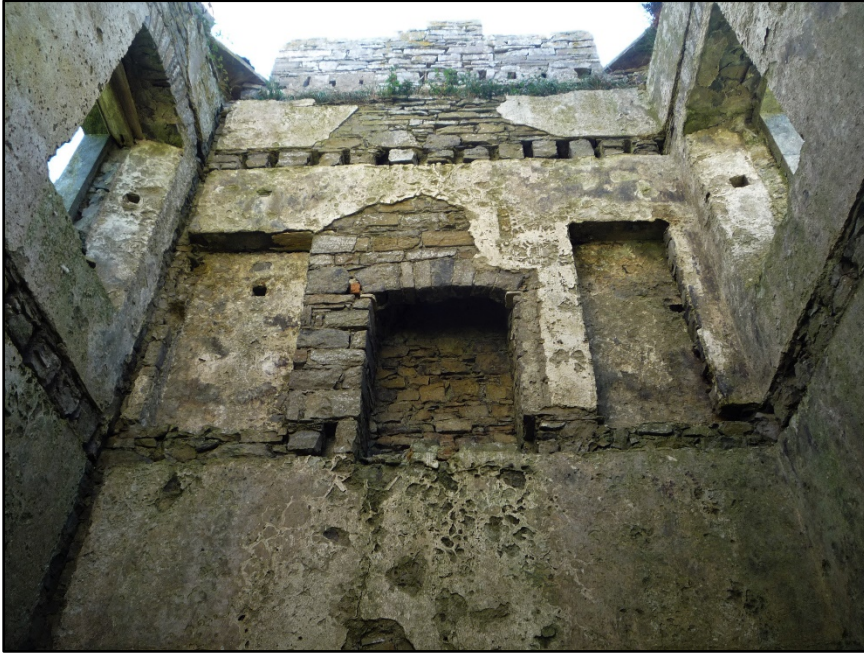
The south wall featured the usual pattern of central fireplaces with flanking alcoves. The semi-basement level was un-rendered. The chute which passed through the south wall opened up into the semi-basement level, below the position of the eastern ground floor alcove. The slot for the ground floor timbers divided the semi-basement from the ground floor. It was missing most of the stone blocks that would have separated individual joist holes. All but one of the dressed stone surrounds of the ground floor fireplace had been removed. The ground floor alcoves were rendered but there were no impressions of shelves. The tops of the alcoves were arched. Above the alcoves there were the joist holes of the split mezzanine level. The position of the first floor was marked by a gap in the render, and there were two joist holes at that height on either side of the base of the first floor fireplace. The first floor fireplace was small and lacked a dressed stone surround. The alcoves were rendered but lacked any impressions of shelves, and the tops were horizontal rather than arched. Above the alcoves the position of the attic was marked by a slot with joist holes. The attic level was rendered. At the top of the attic level the wall had an instep creating a well-defined ledge, above which was the parapet wall with a row of joist holes at the base, marking the position of the roof timbers. The internal face of the parapet wall did not feature a layer of render. A short portion of a centrally placed chimney stack was present at the top of the parapet wall.

Figure C.39. The upper portion of the internal wall face of the south wall of the signal tower at Carrowmably Signal Station. The first floor fireplace and flanking alcoves, the attic level slot, the instep at the parapet level, the roof level joist holes, the entrances to the bartizans and the drainage channel running down the southern edge of the east wall can be seen.

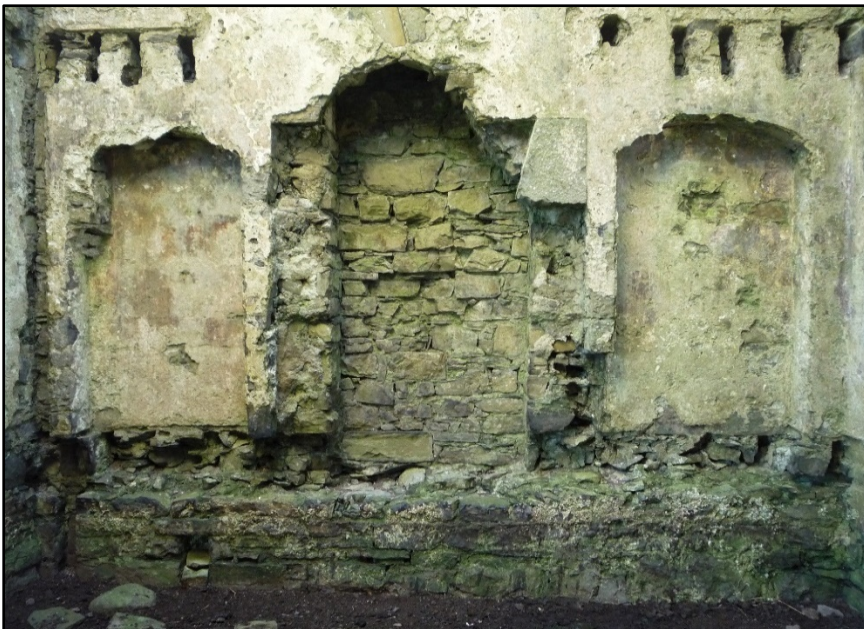
Figure C.40. The lower portion of the internal wall face of the south wall of the signal tower at Carrowmably Signal Station. The upper part of the semi-basement level, the chute into the semi-basement level, the ground floor slot, the ground floor central fireplace flanked by alcoves, and the joist holes for the split mezzanine level can be seen.

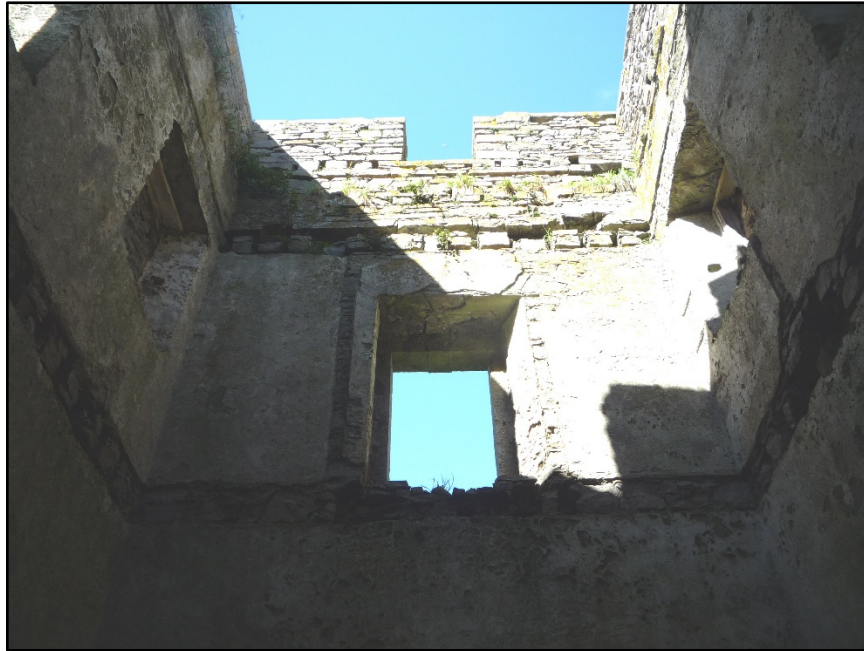
Figure C.41. The upper portion of the internal wall face of the north wall of the signal tower at Carrowmably Signal Station. The position of the first floor, the first floor door, the slot west of the door, the attic level slot, the instep at the parapet level, the parapet joists, and the entrance to the machicolation can all be seen.

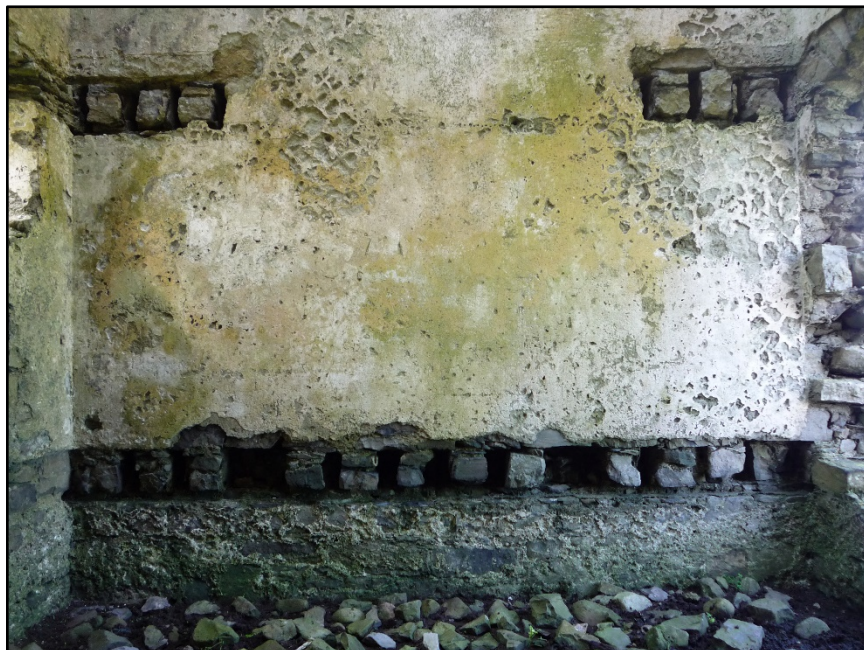
Figure C.42. The lower portion of the internal wall face of the north wall of the signal tower at Carrowmably Signal Station. The semi-basement level, the ground floor slot with joist holes, and the joist holes of the split mezzanine level can be seen.

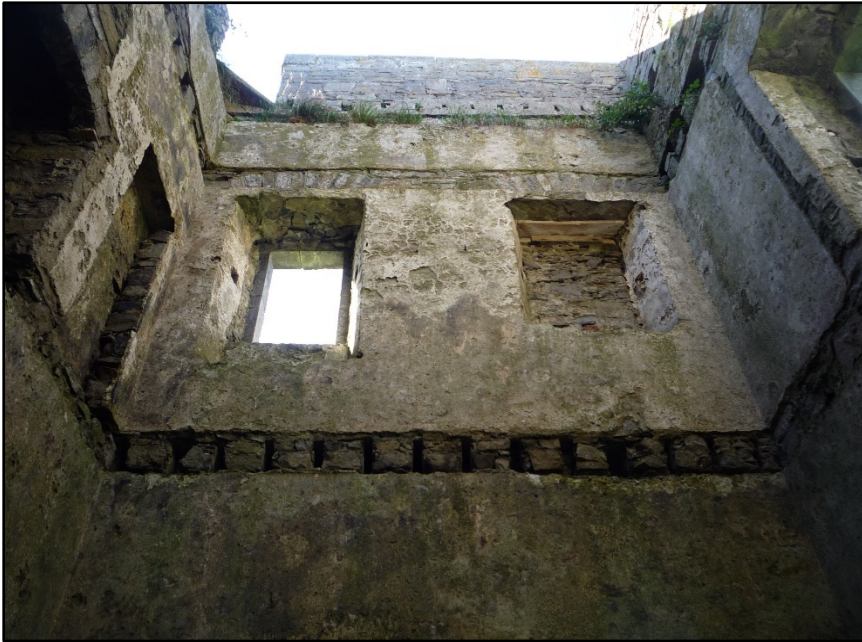
Figure C.43. The upper portion of the internal wall face of the south wall of the signal tower at Carrowmably Signal Station. The slot with joist holes for the first floor, the open south window with square bar hole, the north blocked window with square bar hole and timber frame parts, the attic level slot, the parapet wall, the parapet wall joist holes and the entrance to the south-west bartizan are visible.

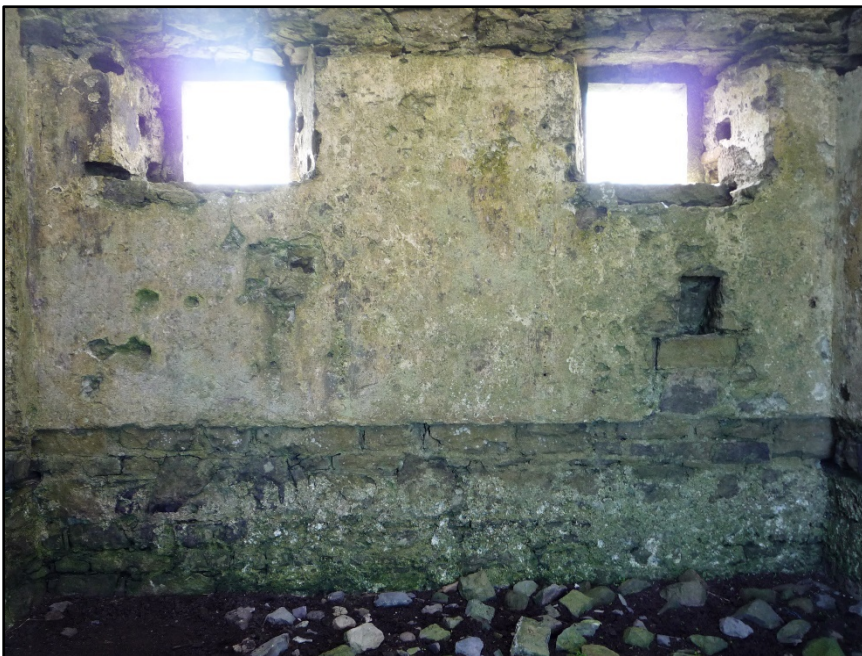
The west wall almost exactly mirrored the arrangement of the east wall but lacked the vertical channel in the render leading down from the north first floor window. On the ground floor wall, under the northern window, there was a rectangular hole that led into a square section channel that ran vertically down through the body of the wall. The probable drain was blocked at roughly the current ground level and it is not known if the feature exited internally or externally.

Figure C.44. The lower portion of the internal wall face of the south wall of the signal tower at Carrowmably Signal Station. The un-rendered semi basement level, the rectangular hole under the north window and the ground floor windows with square bar holes are visible.

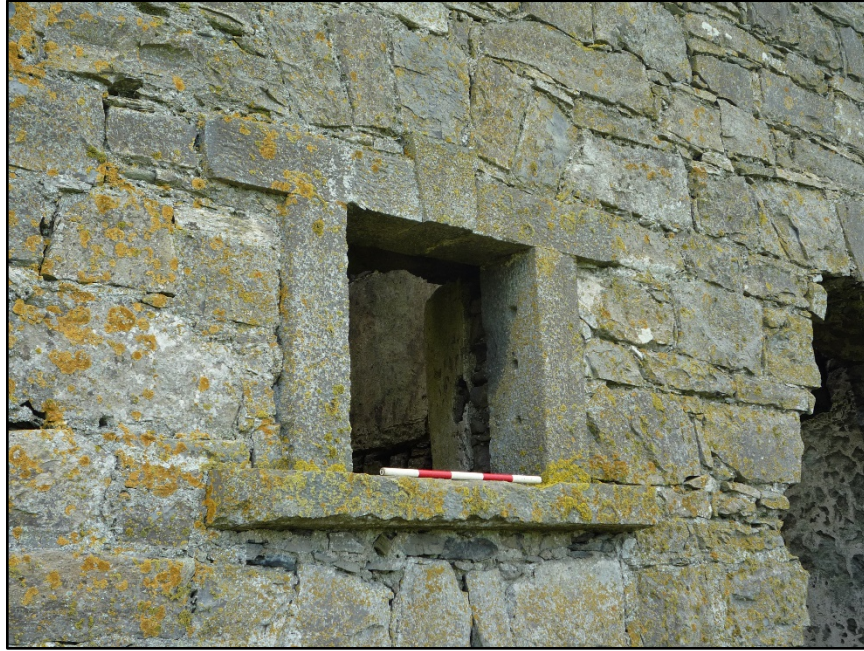
Figure C.45. Exterior detail of the south ground floor window on the east wall, showing the intact stone surround and the three small holes for window bars in the side stone.
