The construction, survival, and use of Signal Defensible Guard Houses on the Irish Coast

Volume II of II

Ph.D. Thesis (Archaeology)

IT Sligo

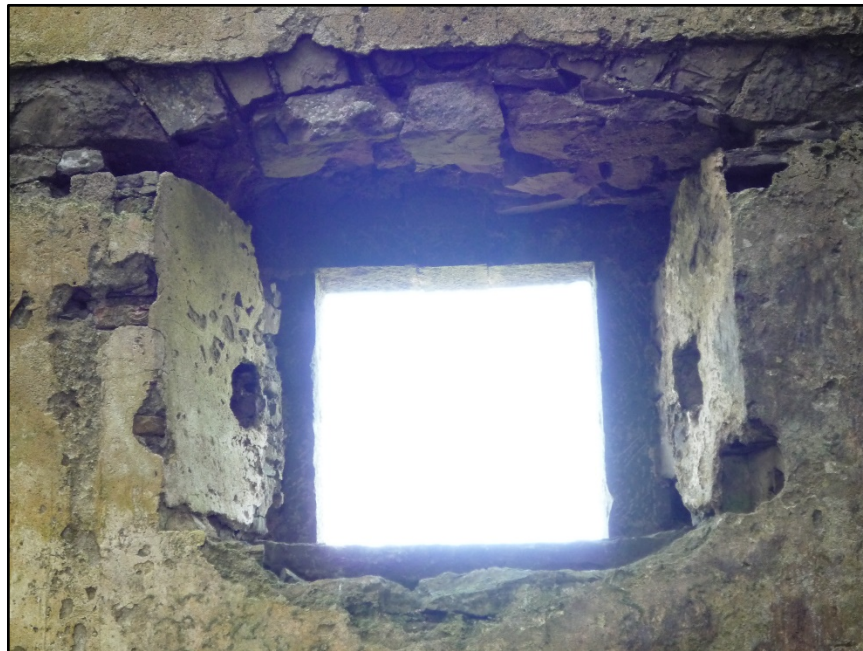
Figure C.46. Interior detail of the north ground floor window on the west wall, showing the large holes on the splayed sides of the window which may have held a wide horizontal timber.

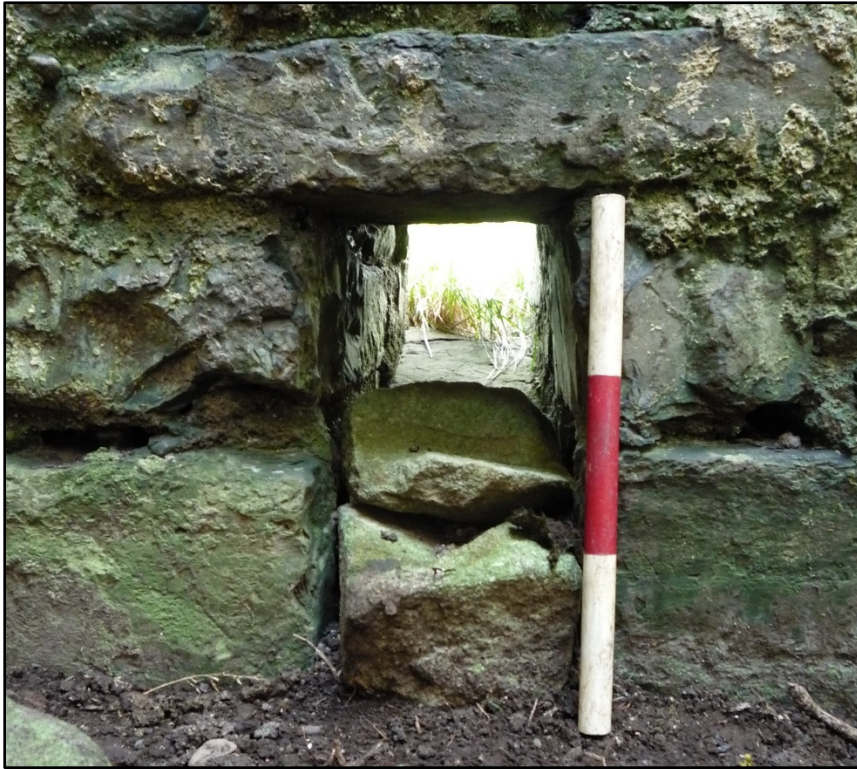
The south wall featured the usual pattern of central fireplaces with flanking alcoves. The semi-basement level was un-rendered. The chute which passed through the south wall opened up into the semi-basement level, below the position of the eastern ground floor alcove. The slot for the ground floor timbers divided the semi-basement from the ground floor. It was missing most of the stone blocks that would have separated individual joist holes. All but one of the dressed stone surrounds of the ground floor fireplace had been removed. The ground floor alcoves were rendered but there were no impressions of shelves. The tops of the alcoves were arched. Above the alcoves there were the joist holes of the split mezzanine level. The position of the first floor was marked by a gap in the render, and there were two joist holes at that height on either side of the base of the first floor fireplace. The first floor fireplace was small and lacked a dressed stone surround. The alcoves were rendered but lacked any impressions of shelves, and the tops were horizontal rather than arched. Above the alcoves the position of the attic was marked by a slot with joist holes. The attic level was rendered. At the top of the attic level the wall had an instep creating a well-defined ledge, above which was the parapet wall with a row of joist holes at the base, marking the position of the roof timbers. The internal face of the parapet wall did not feature a layer of render. A short portion of a centrally placed chimney stack was present at the top of the parapet wall.

Figure C.47. Detail of the chute passing through the south wall into the semi-basement level.

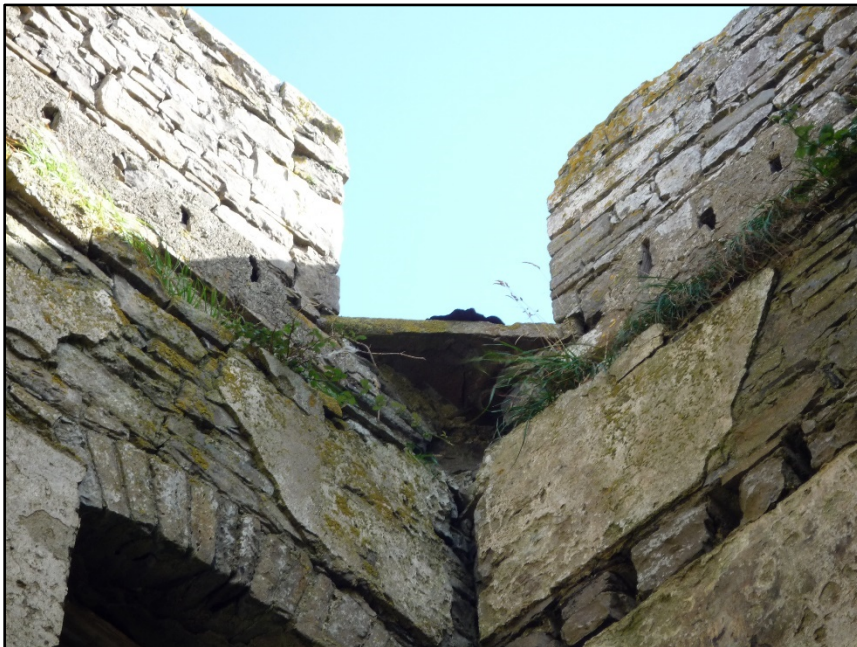
Figure C.48. Detail of the entrance to the south-west bartizan.

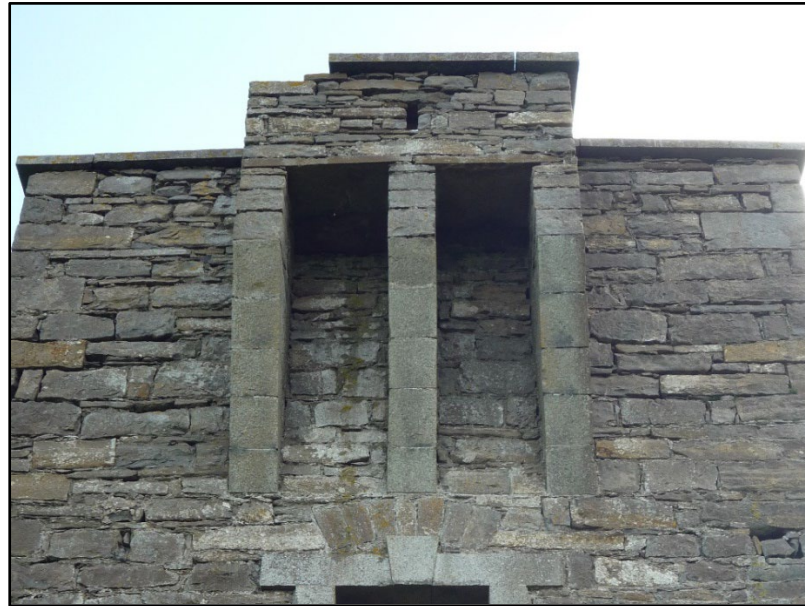
Figure C.49. Detail of the machicolation over the door on the south wall of the signal tower at Carrowmably. Note the gun-loop in the centre of the south wall of the machicolation.

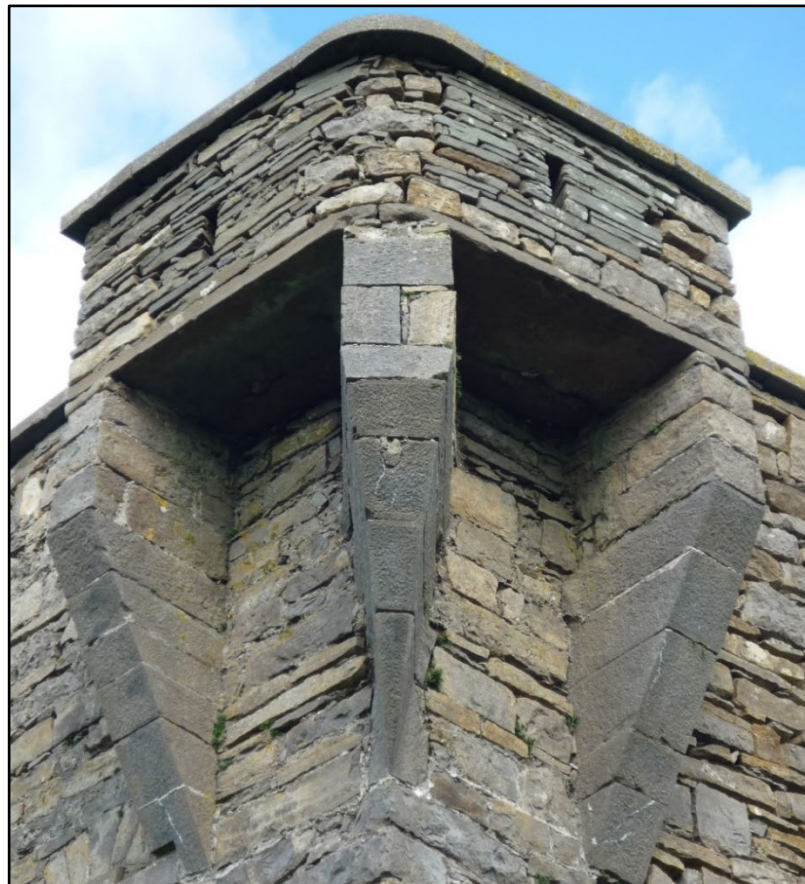
Figure C.50. Detail of the bartizan at the signal tower at Carrowmably Signal Station, showing the two outward facing gun-loops.

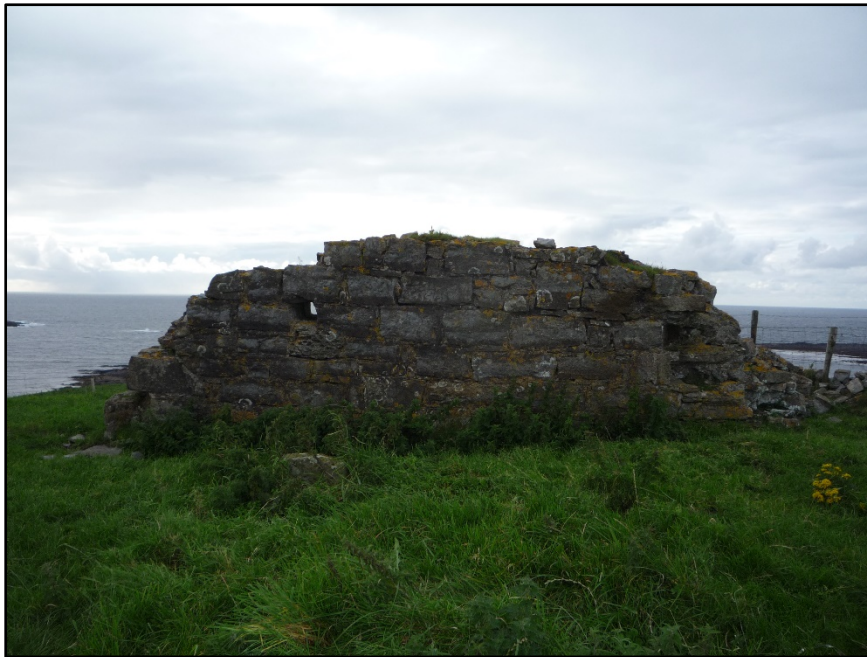
The signal station at Knocklane Hill consisted of the lower portions of the ground floor of an unenclosed signal tower. The entire first floor and roof level were missing. The walls defined a square building between 5.8 m (19') and 5.9 m (19'4") across, with walls facing north-east, south-east, south-west and north-west respectively. The internal space measured up to 4.35 m (14'3") across.

Figure C.62. External face of the south-east wall of the collapsed signal tower at Knocklane Hill Signal Station.

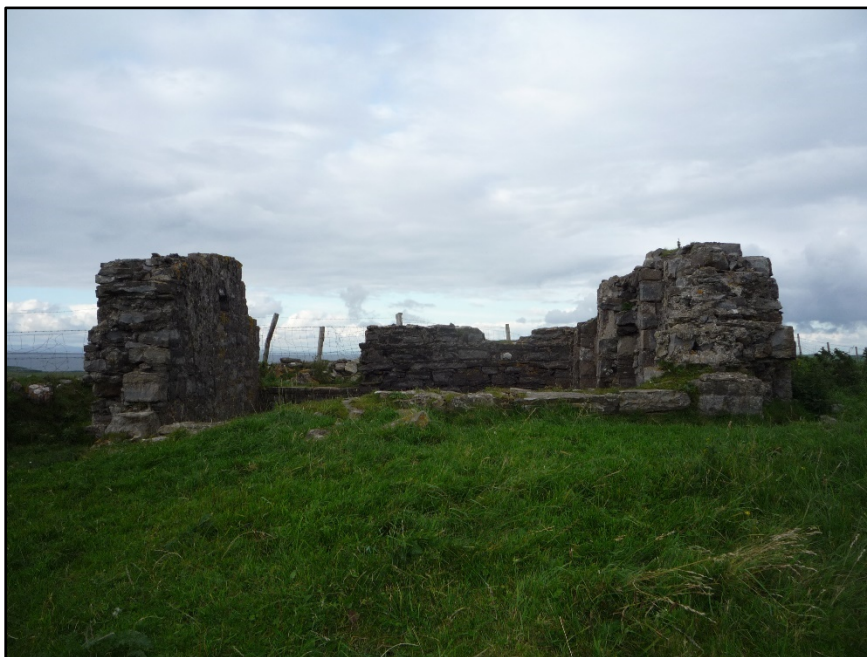
Figure C.63. External face of the south-west wall of the collapsed signal tower at Knocklane Hill Signal Station.

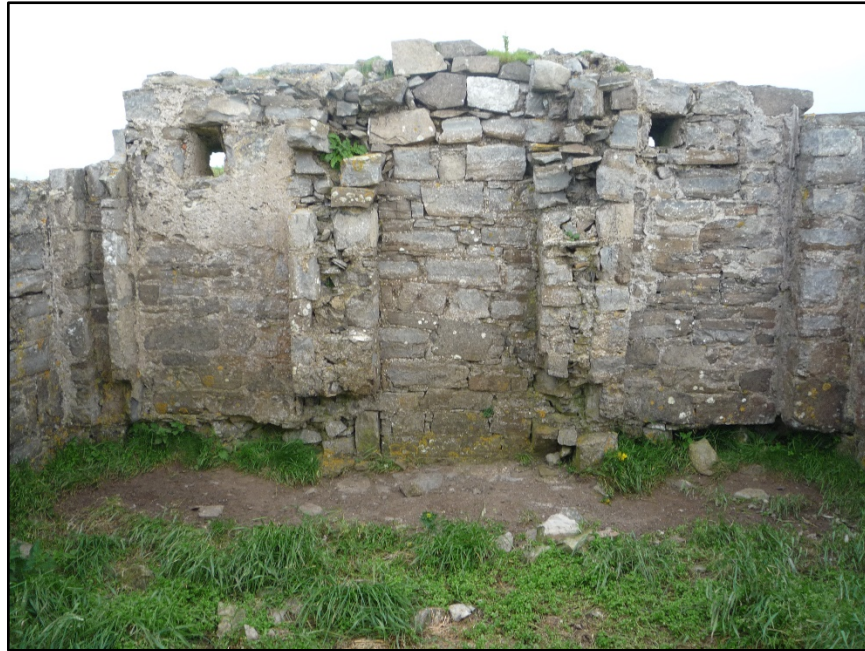
Figure C.64. Internal face of the south-east wall of the collapsed signal tower at Knocklane Hill Signal Station. The central fireplace, the flanking alcoves, the chutes passing through the wall at the top of the alcoves, and the vertical drainage channel at the north corner of the wall can be seen.

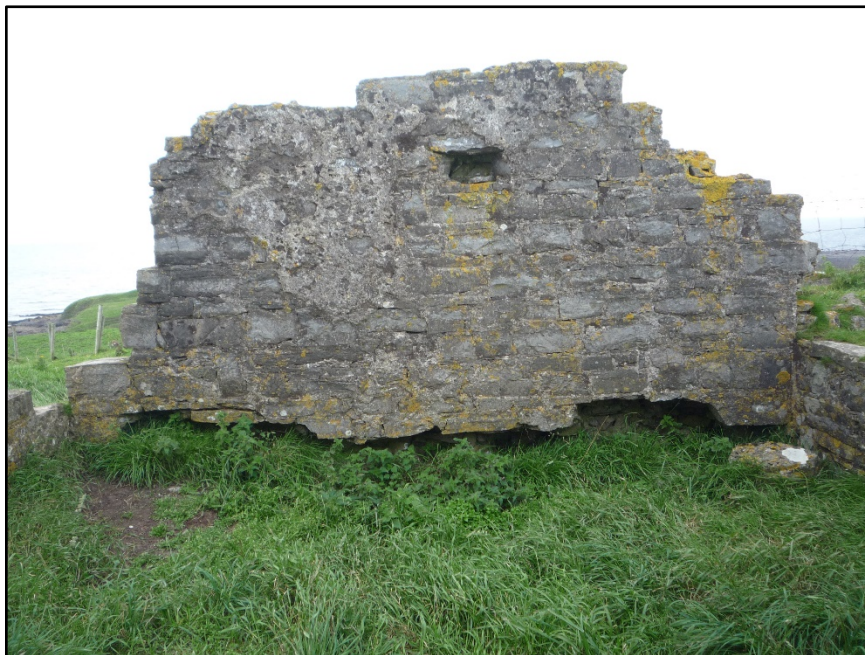
Figure C.65. Internal face of the north-west wall of the collapsed signal tower at Knocklane Hill Signal Station. The slot for the ground floor level can be seen at the bottom of the exposed section of wall.

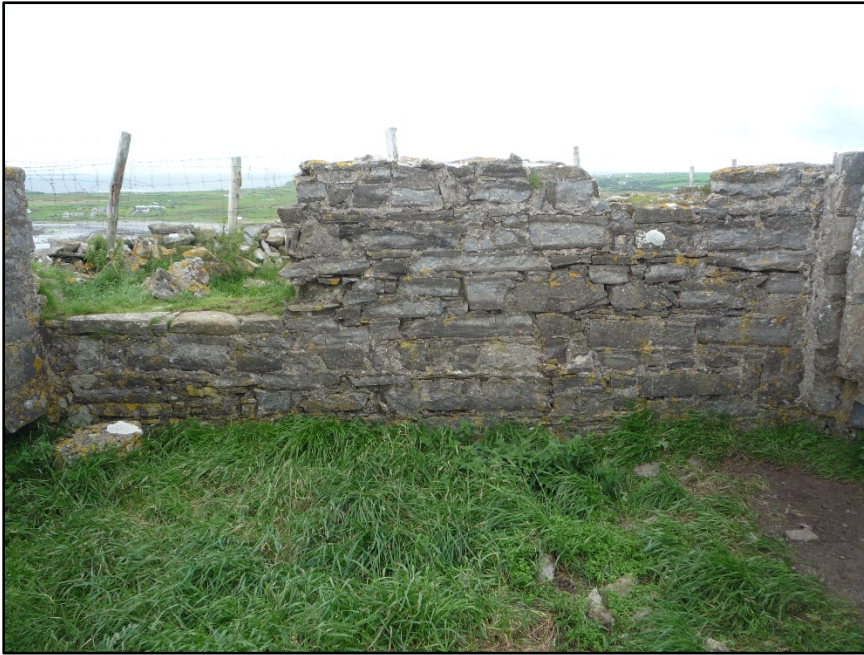
Figure C.66. Internal face of the north-east wall of the collapsed signal tower at Knocklane Hill Signal Station.

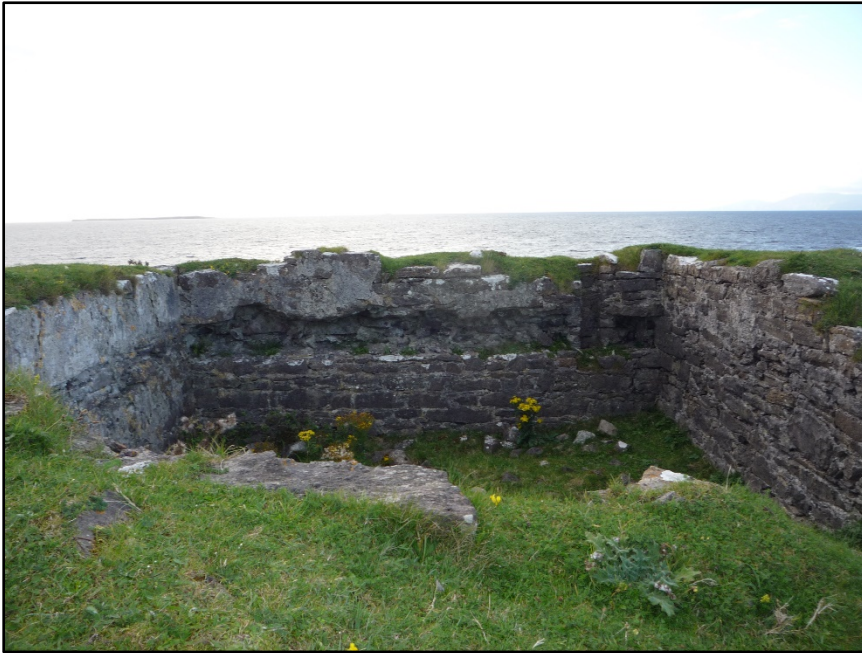
Figure C.75. The internal north-west wall face of the collapsed signal tower at Streedagh Signal Station.

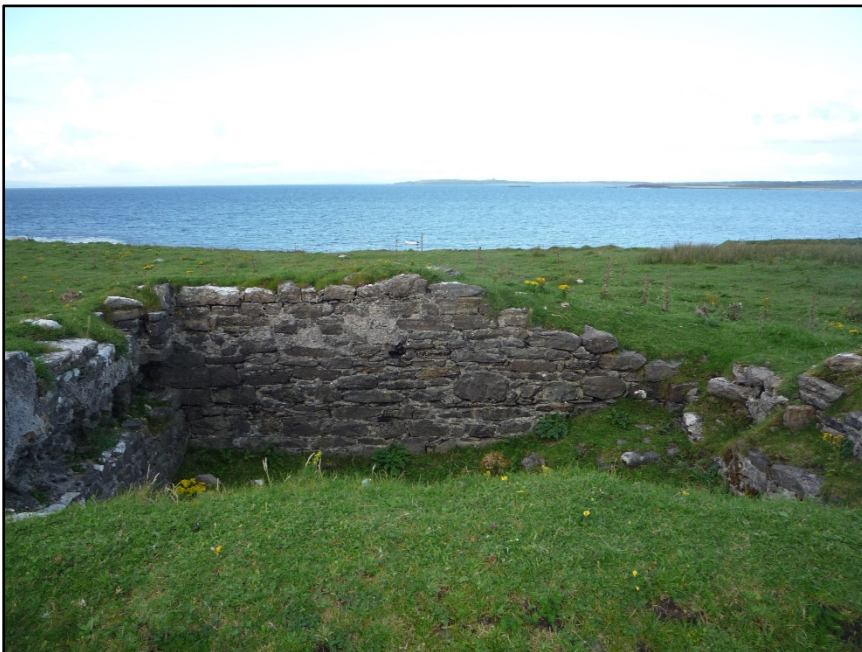
Figure C.76. The internal north-east wall face of the collapsed signal tower at Streedagh Signal Station.

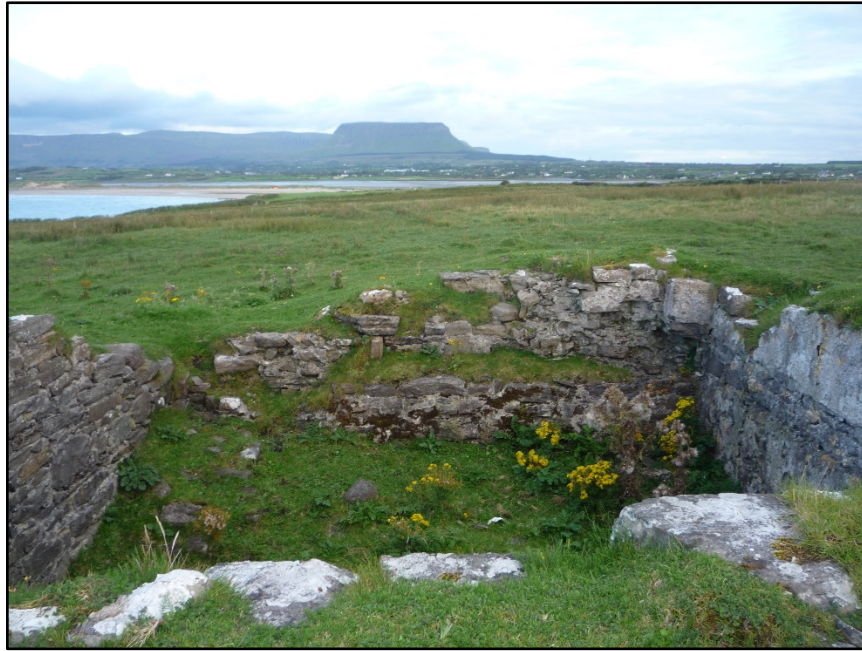
Figure C.77. The internal south-east wall face of the collapsed signal tower at Streedagh Signal Station.

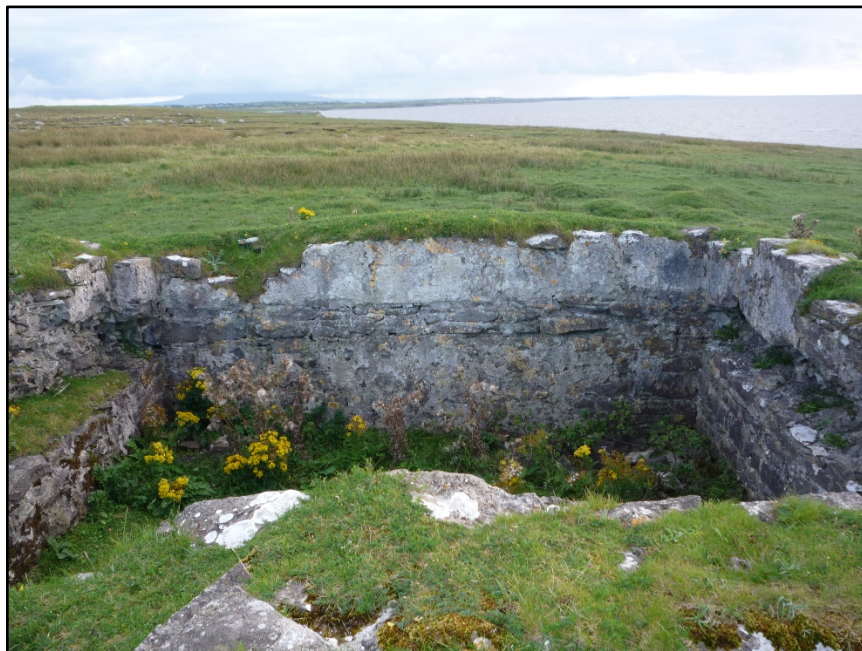
Figure C.78. The internal south-west wall face of the collapsed signal tower at Streedagh Signal Station.

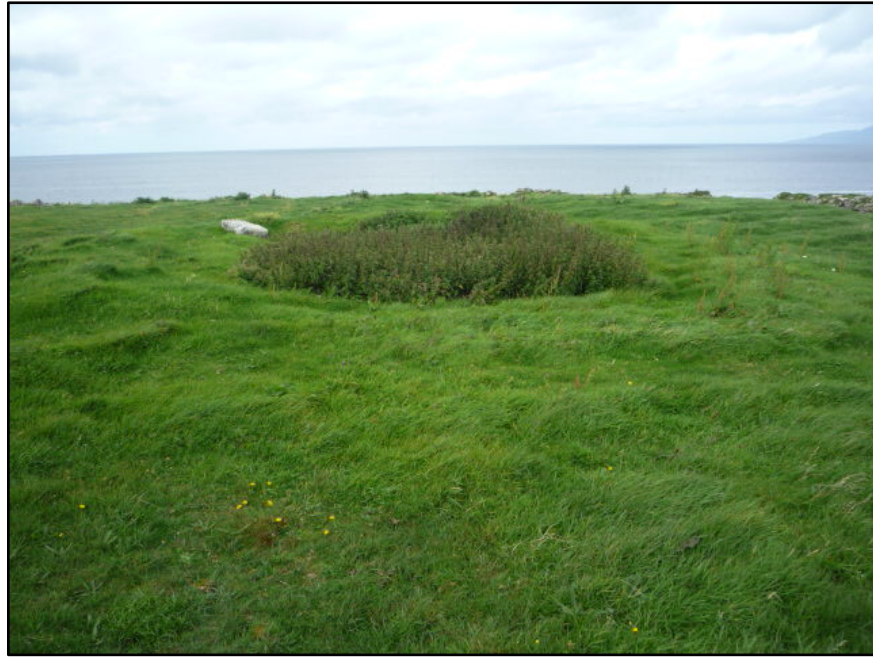
Figure C.83. Looking north-west at the probable location of the signal tower at Killcologue Point. The tower location was marked by a shallow nettle filled hollow surrounded by a low bank.

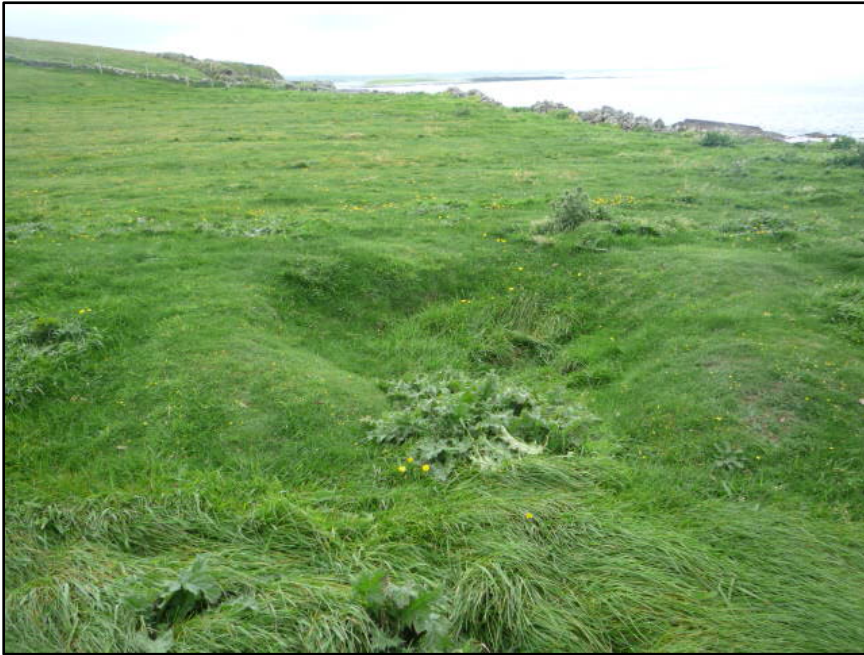
Figure C.85. The remains of the possible lime kiln to the north-west of the location of the signal tower at Killcologue Signal Station, looking south-west.

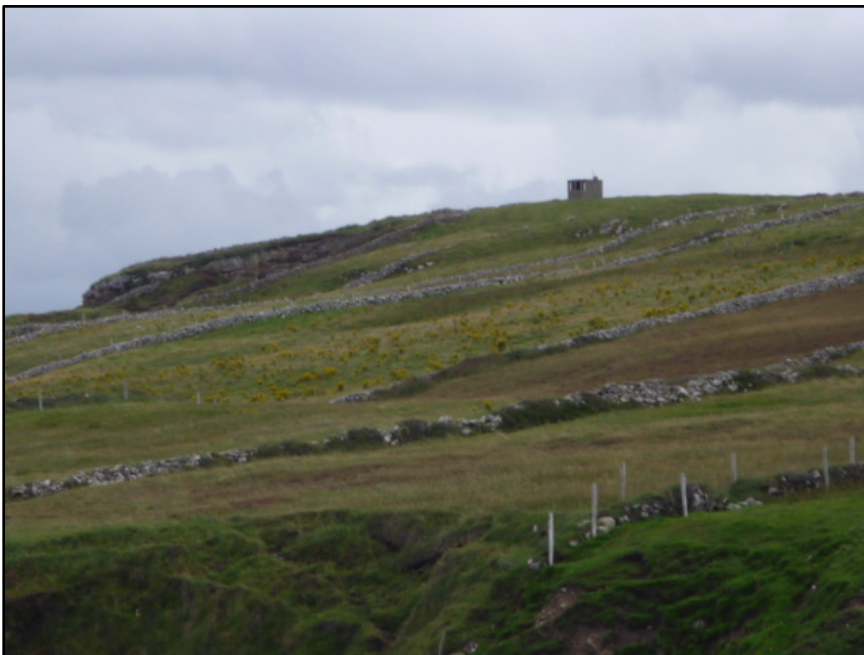
Figure C.86. The Look Out Post (L.O.P. 69) to the north-east of Killcologue Signal Station.

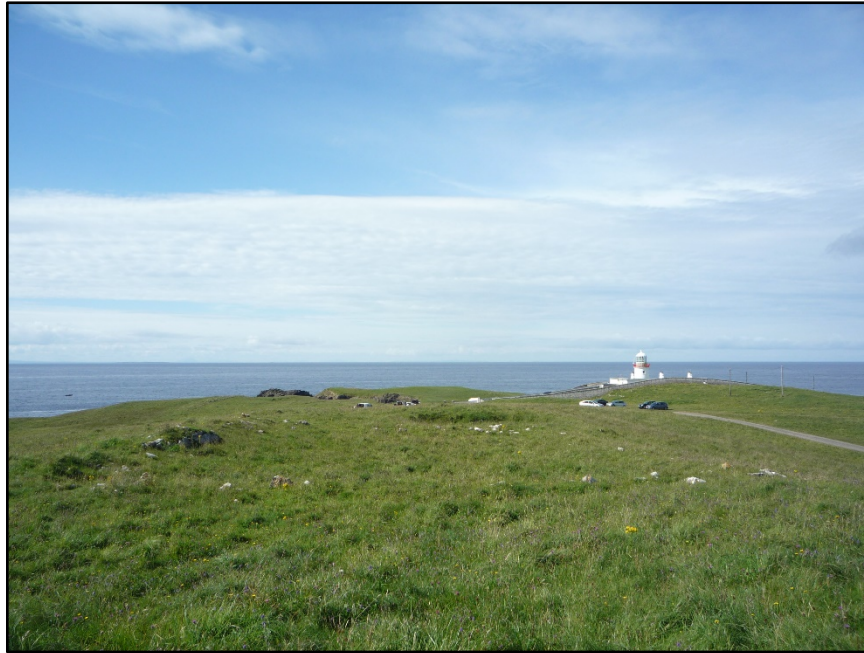
Figure D.6. The overgrown enclosure at St John's Point Signal Station, looking south-west, with the lighthouse complex visible in the background.

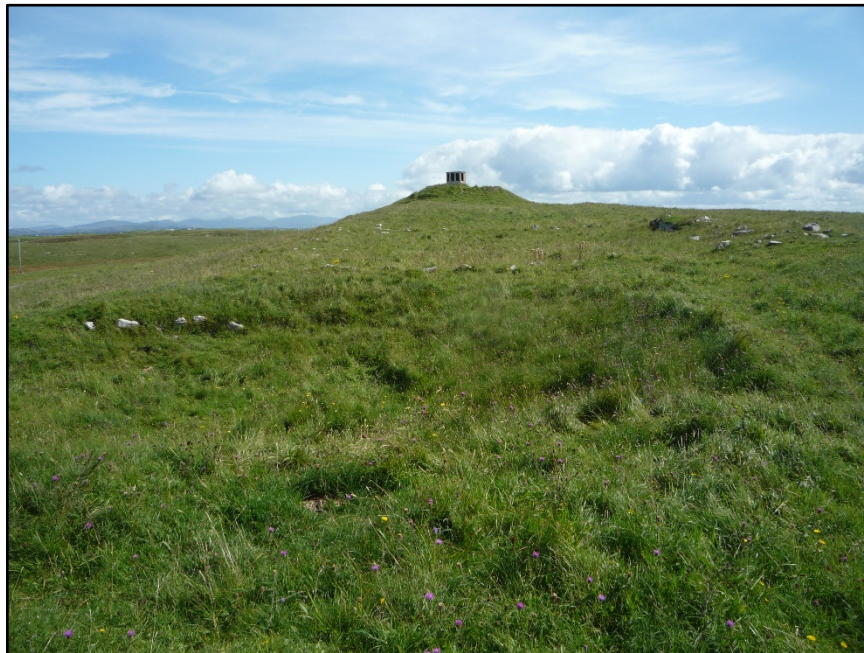
Figure D.7. The hollow feature which could mark the former location of the signal tower at John's Signal Station, looking north-east, with the possible cairn topped by L.O.P. 70 in the background.

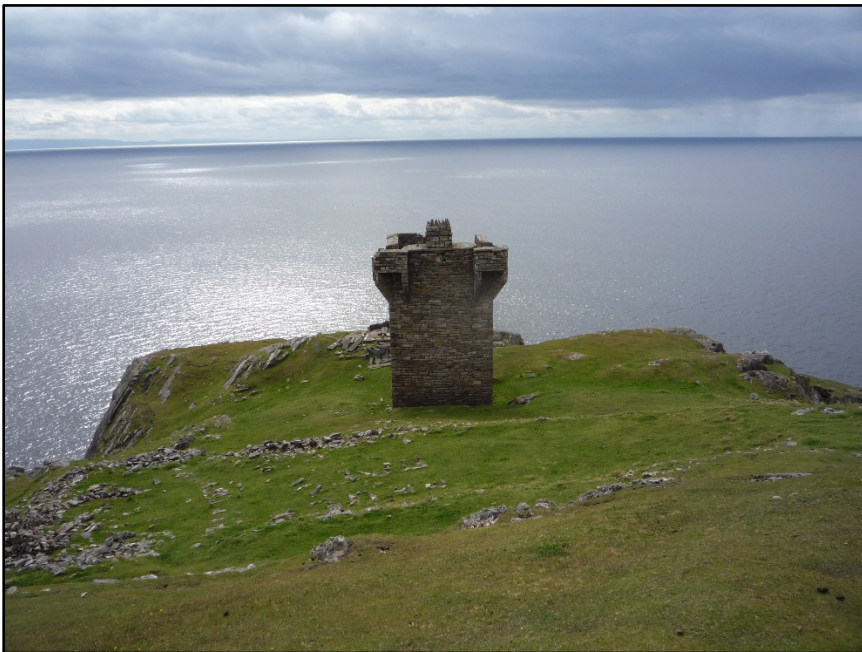
Figure D.12. The north-east wall of the signal tower at Carrigan Head Signal Station, with the low overgrown banks enclosure visible in front of the signal tower.

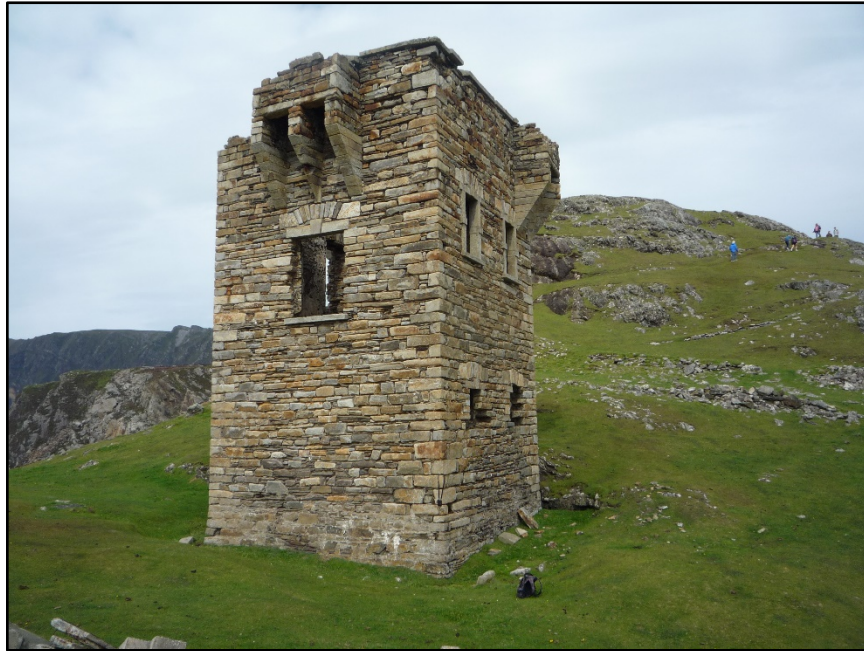
Figure D.13. The south corner of the signal tower at Carrigan head Signal Station.

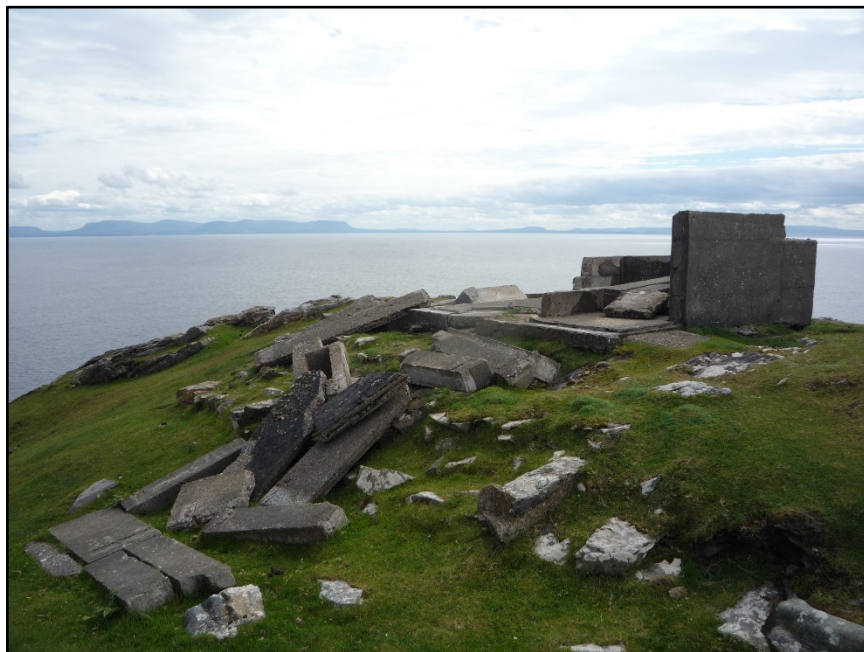
Figure D.14. The badly collapsed remains of L.O.P. 71, located to the south of the signal tower at Carrigan Head Signal Station.

To the south-west of the signal tower there was a World War 2 era Look Out Post (L.O.P. 71) that was in a ruinous state. It consisted of an incomplete set of low concrete walls and a concrete slab foundation, surrounded and overlain by a spread of concrete wall fragments. Given the location of L.O.P.71 it is possible that the small walls observed within the enclosure are the remains of an 'Eire sign'.

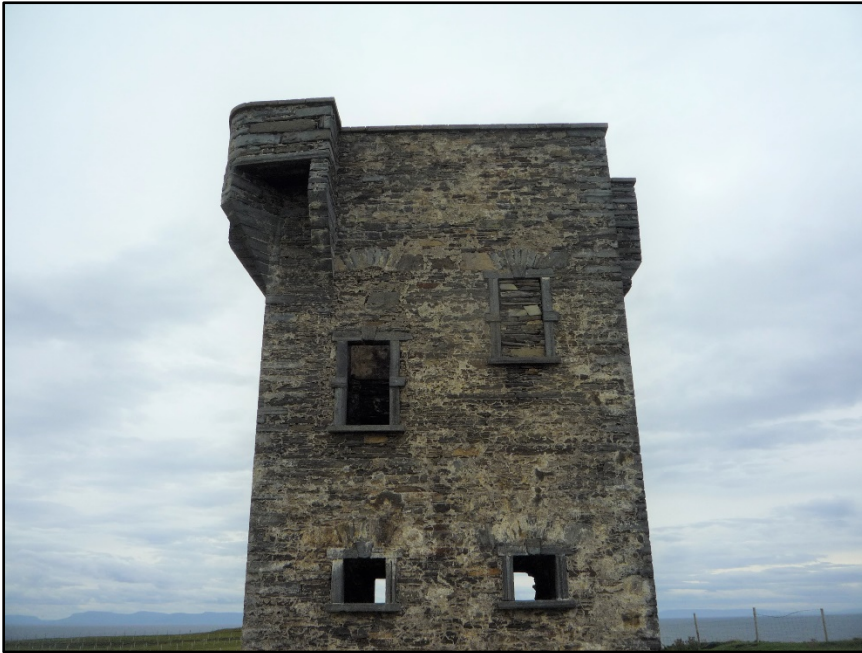
Figure D.25. The upper portion of the north-west external wall of the signal tower at Carrigan Head Signal Station, showing the repositioned north window, the infilled south window, the north bartizan and the ground floor windows.

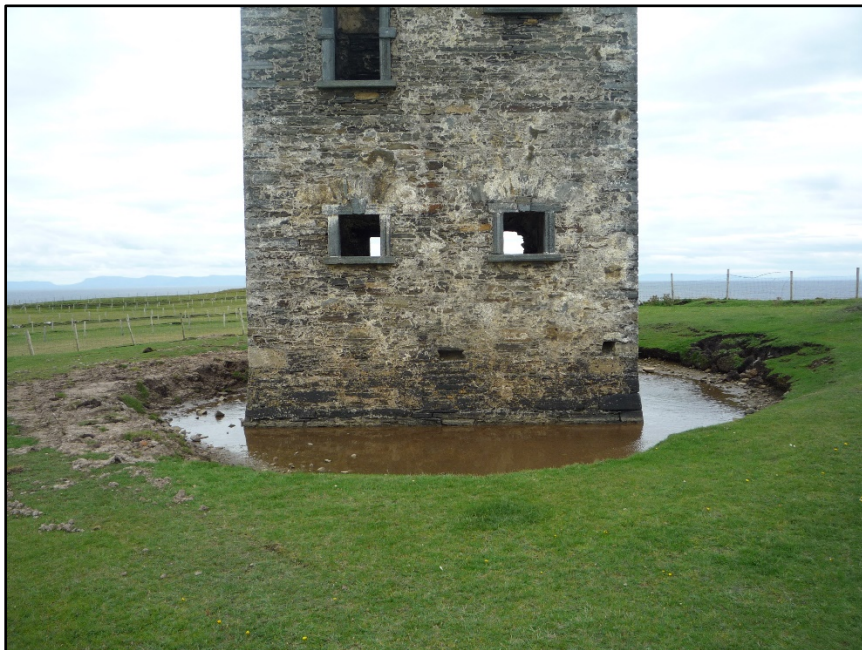
Figure D.26. The lower portion of the north-west external wall of the signal tower at Carrigan Head Signal Station, showing the water filled hollow around the signal tower.

At the time of the survey the tower was located in a shallow water filled hollow which appeared to be the result of recent drainage work in the area. Unfortunately, because the interior was filled with water, it couldn't be properly assessed. From what could be observed of the north-east wall of the interior, it contained the expected arrangement of alcoves and fireplaces on the east wall. There were no indications of the slots or joist holes for a split mezzanine level, but given the amount of alterations, these could have been removed. A small alcove was built into the attic level of the north-east wall, a feature not observed at other signal towers in the main study area. A square section vertical drainage channel ran down the north edge of the north-west wall. The alterations to the first floor windows on the northern wall were clearly visible from inside the building. A set of flat square stone slabs projected into the interior of the tower, from the top of the instep at the base of the parapet wall. These are difficult to explain but may relate to lowering of the roof level at the same time the height of the first floor windows were lowered. The alcove in the attic level wall may have been added during the same period of modification.

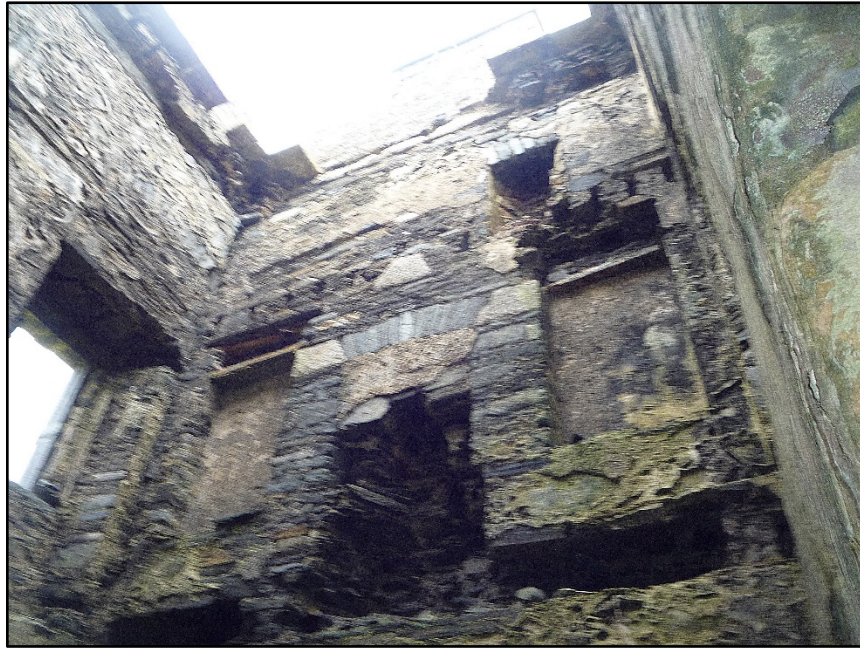
Figure D.27. The upper portion of the north-east internal wall face of the signal tower at Carrigan Head Signal Station. The position of the first floor, the first floor fireplace with flanking alcoves, the joist holes of the attic level and the unusual alcove in the attic level are visible. Note the flat stones projecting inwards from the base of the parapet level.

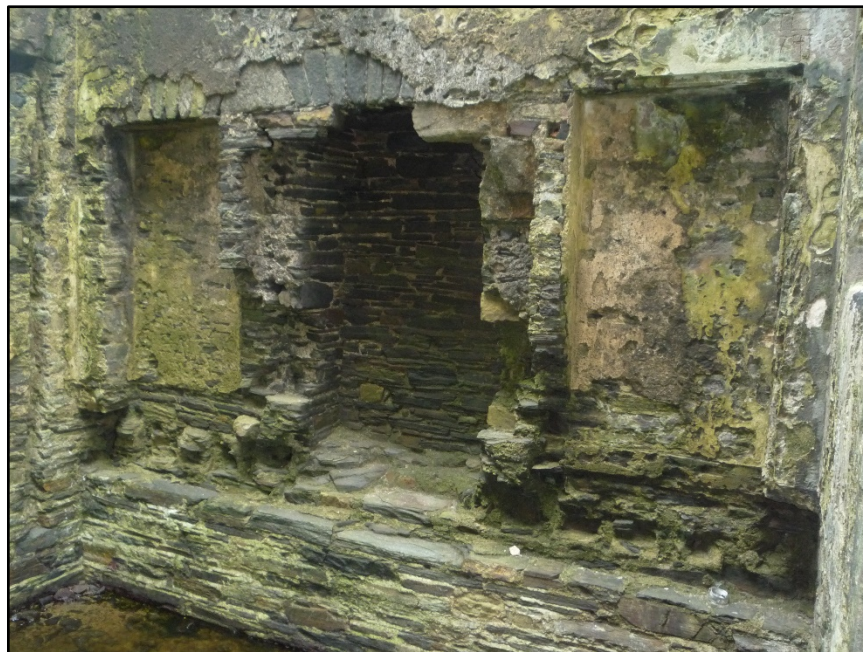
Figure D.28. The lower portion of the north-east internal wall face of the signal tower at Carrigan Head Signal Station. The upper part of the semi-basement level, the ground floor slot, the central fireplace and the flanking alcoves are visible.

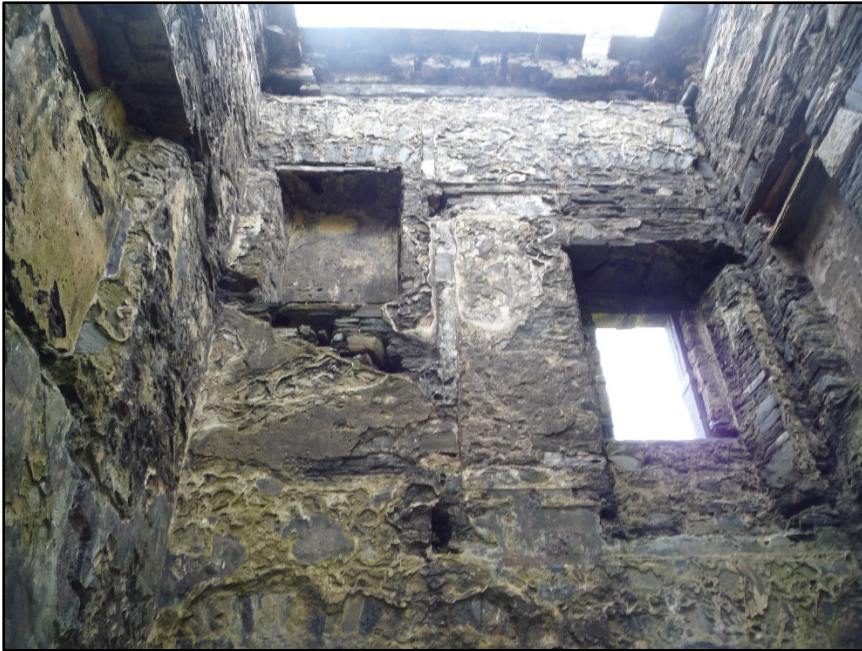
Figure D.29. The upper portion of the internal face of the north-west wall of the signal tower at Carrigan head Signal Station, showing the heavily modified first floor windows.

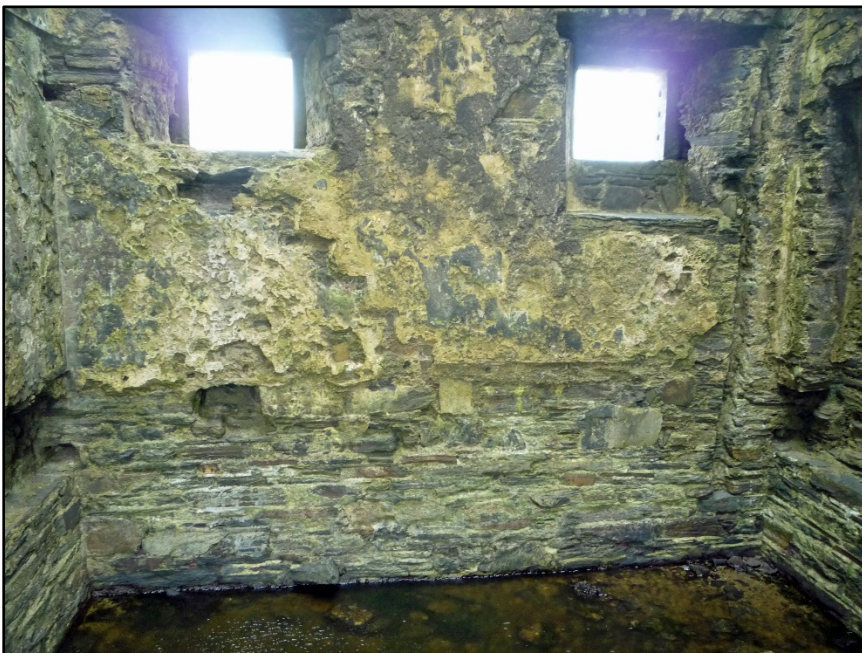
Figure D.30. The lower portion of the internal face of the north-west wall of the signal tower at Carrigan Head Signal Station. The row of three holes in the side stone of the south window which would have held horizontal bars protecting the window are visible towards the top right of the image.

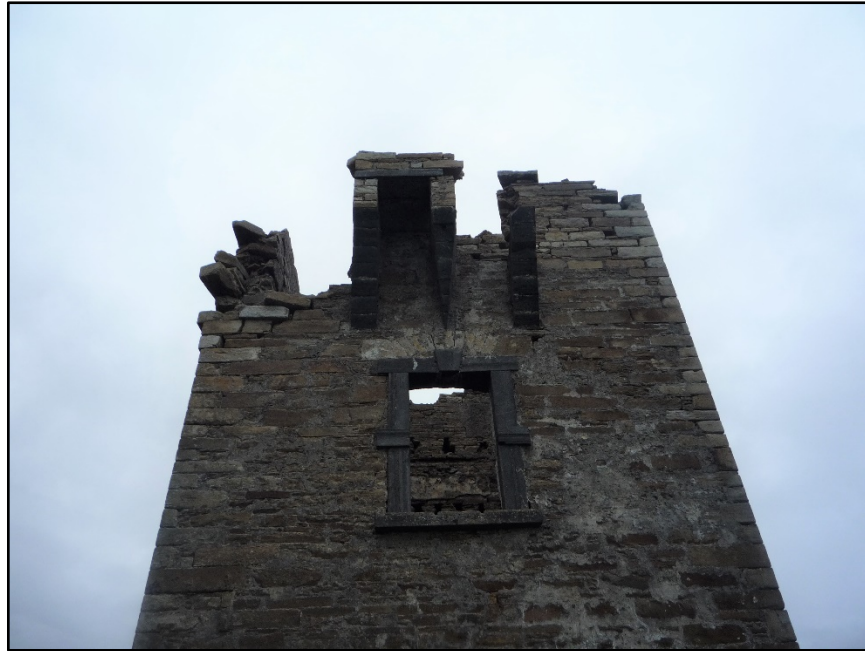
Figure D.41. The upper portion of the external face of the north-west wall of the signal tower at Glen Head Signal Station, showing the first floor doorway with its intact stone surround and the partially collapsed machicolation.

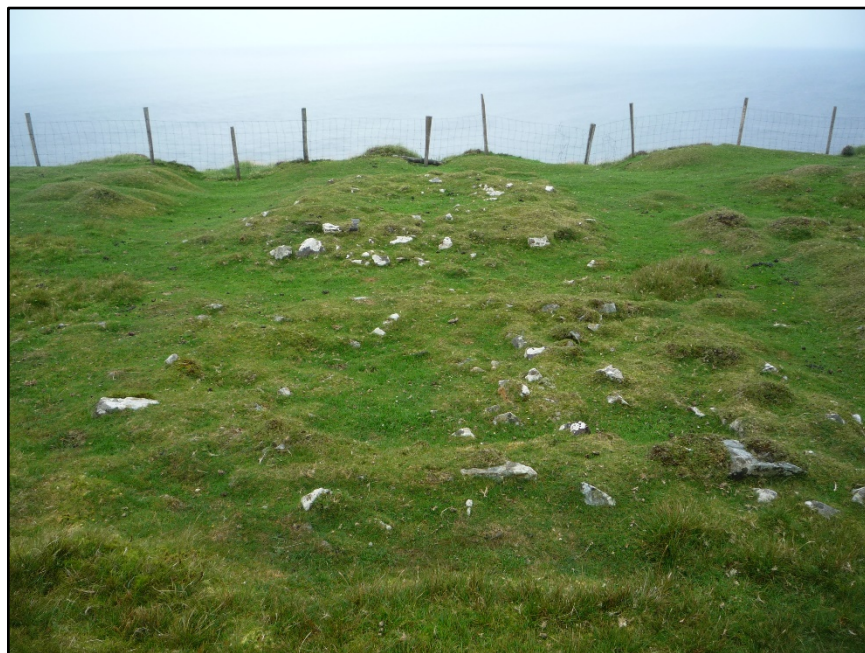
Figure D.42. The hut foundations to the north of the signal tower at Glen head Signal Station, looking north-west.

The foundations of two small buildings were located close to the cliff edge to the north of the signal tower. They were tentatively listed as secondary buildings in the main text (Section 4.7) because there was nothing to indicate that they were contemporary with the signal station. However, the buildings have some similarity to some of the buildings believed to be contemporary elements of the enclosed signal stations, and this possibility is explored in Section 5.3.3. The north-western foundation measures 4.85 m by 4.1 m (15' 11" by 13' 6") and the south-eastern foundation, located 1.2 m (3' 11") away, measured 3.2 m by 4.1 m (10' 6" by 13' 6"). A small stone structure to the immediate north-east of the south-western building could possibly be the remains of a mast mount. The feature consisted of a small ring of stone set within an earthen mound. It had an internal diameter of 1.2 m (3' 11").

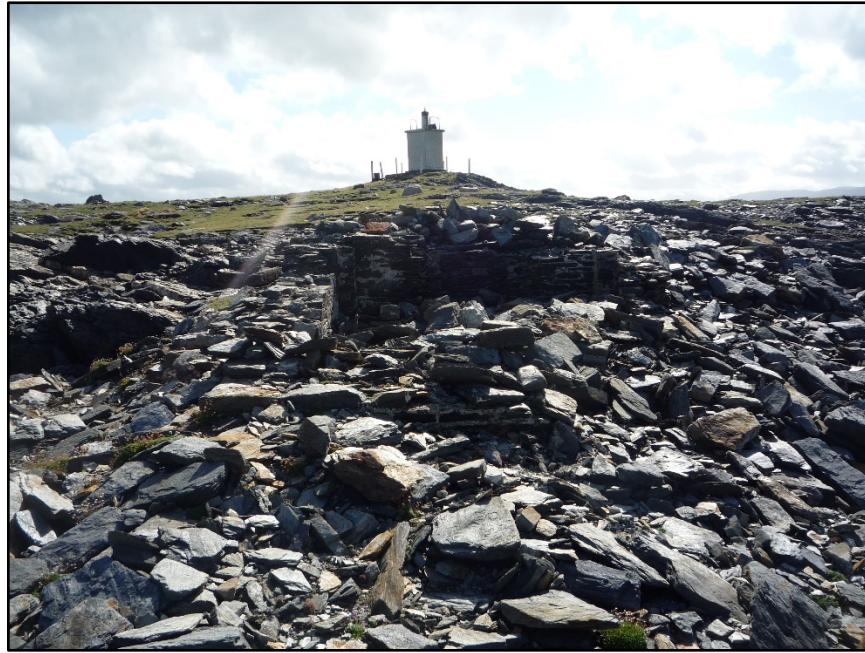
Figure D.50. The collapsed signal tower at Dawros Head Signal Tower, looking south-east, with the automated weather station in the background.

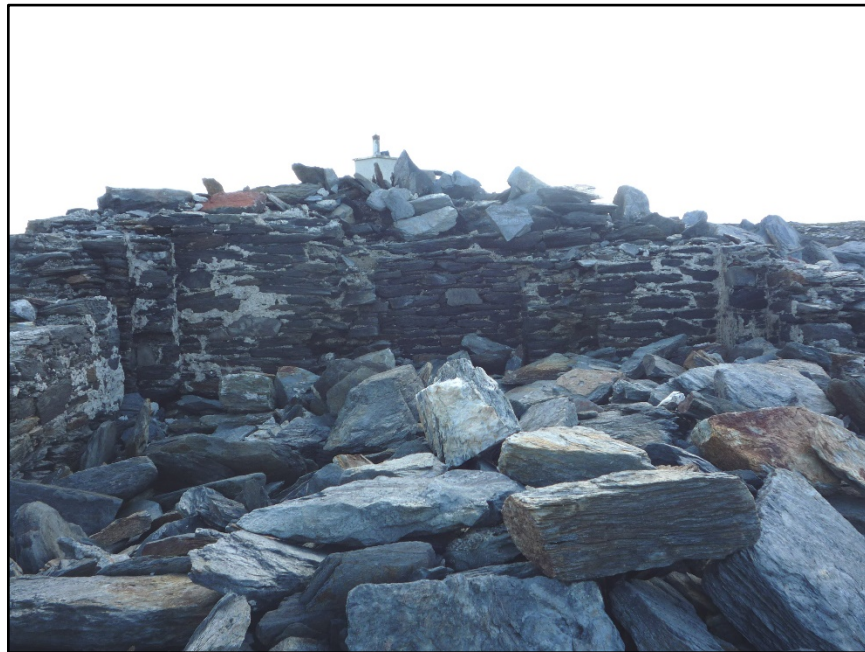
Figure D.51. The internal face of the south-east wall of the collapsed signal tower at Dawros Head Signal Station, with the lower portions of the ground floor central fireplace and flanking alcoves visible.

The south-eastern internal wall face featured the lower parts of two alcoves flanking the base of a central fireplace. The bottom part of a square section vertical drainage channel was located at the south-east of the north-east internal wall face. The presence of these features allowed the original orientation of the tower to be calculated; the first floor door would have been on the north-west wall facing the sea, the north-east and south-west walls would have featured the windows, and the rear wall would have been at the south-east. The walls of the signal tower were constructed from a dark-grey coarse-grained stone, possibly schist.

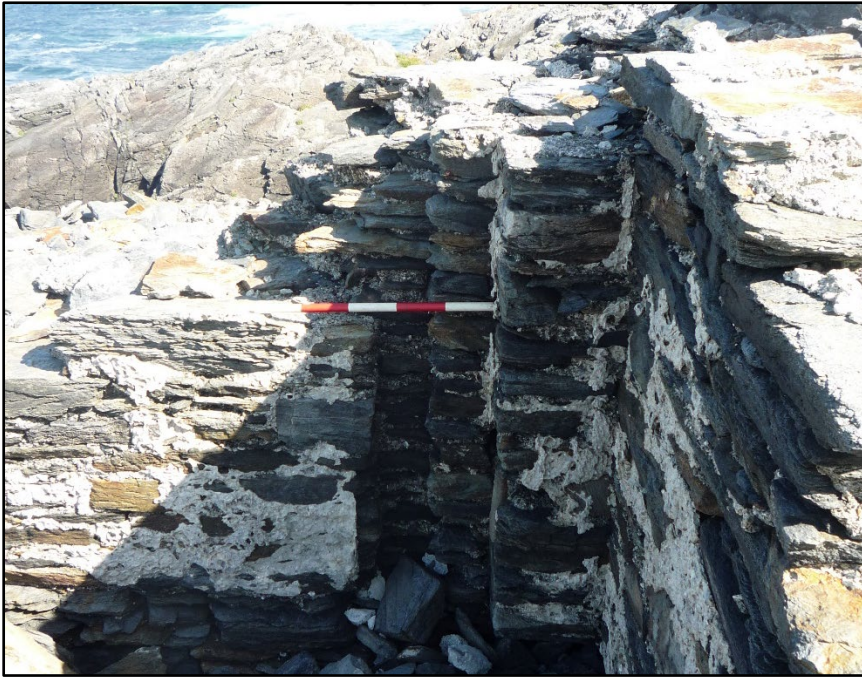
Figure D.52. Detail of the surviving portion of the vertical drainage channel at the south-east of the north-east internal wall face of the collapsed signal tower at Dawros Head Signal Station.

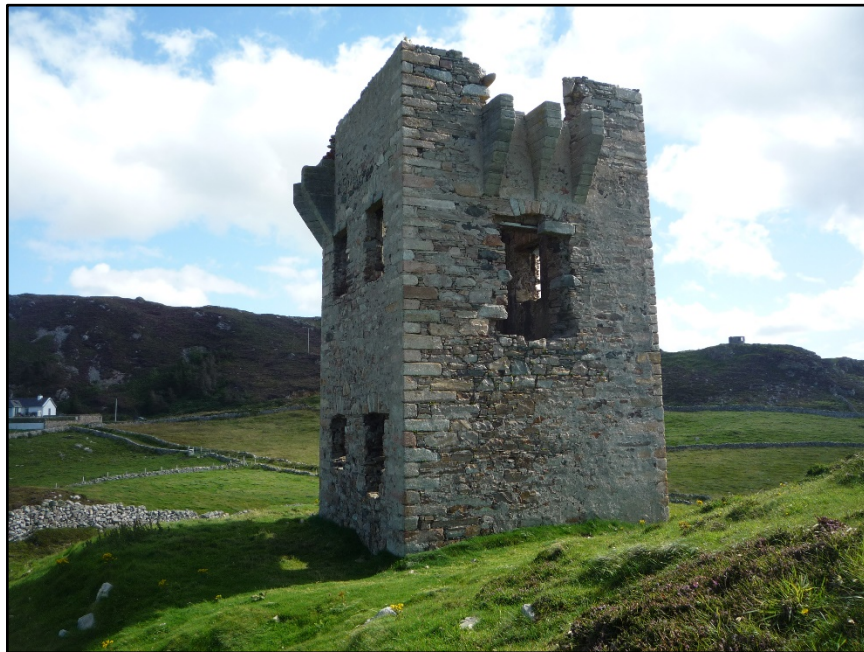
Figure D.58. The north corner of the signal tower at Crohy Head Signal Station. L.O.P. 74 can be seen on the hill top in the background, to the right of the signal tower.
