The construction, survival, and use of Signal Defensible Guard Houses on the Irish Coast

Volume II of II

Ph.D. Thesis (Archaeology)

IT Sligo

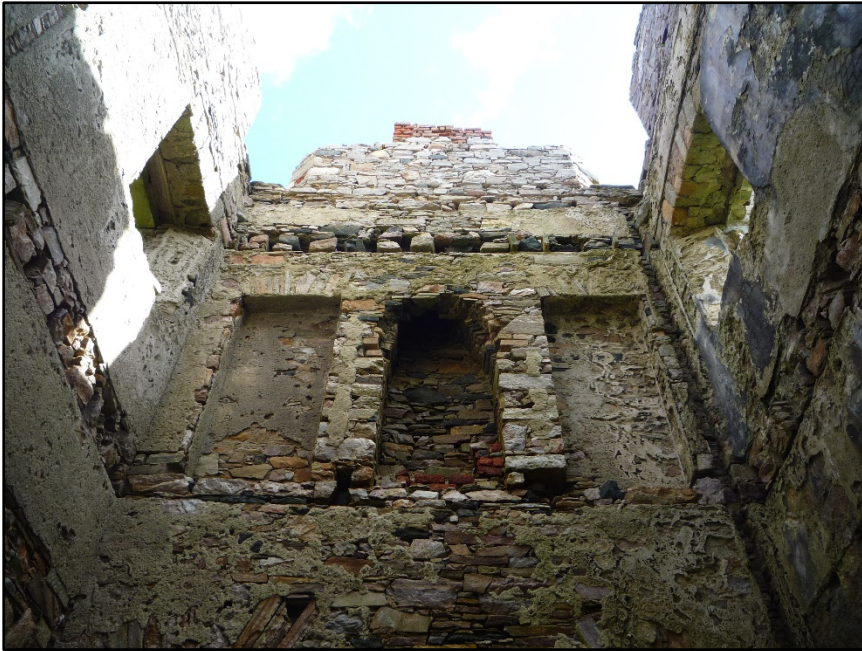
Figure D.59. The upper portion of the internal face of the south-east wall of the signal tower at Crohy Head Signal Station.

An unusual feature of the building was the presence of fragments of wood within the some of the joist holes and above some of the windows, clearly the ends of joists. These may indicate that the site was maintained for a longer period than normal, or that at some point it was subject to renovation. The use of red brick in the upper portion of the chimney may also support this notion.

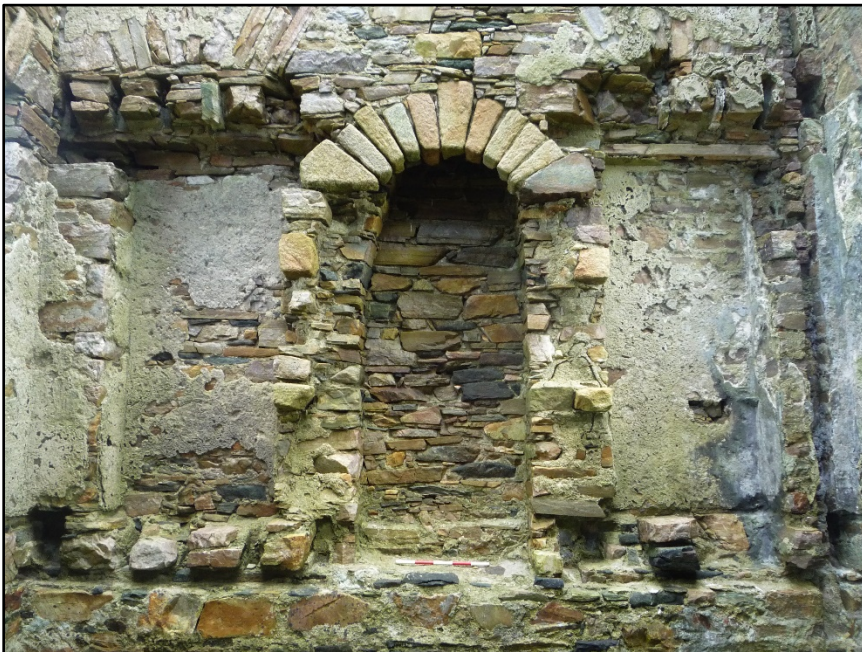
Figure D.60. The lower portion of the internal face of the south-east wall of the signal tower at Crohy Head Signal Station, showing the slot with joists holes for the ground floor, the ground floor central fireplace and the flanking alcoves, and the joist holes of the split mezzanine level.

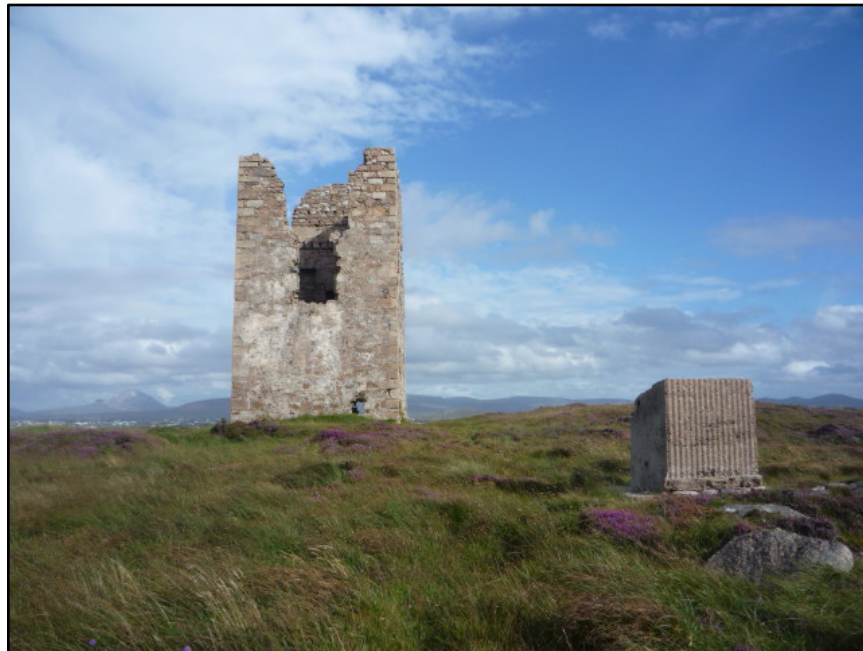
The most visible element at the Mullaghderg Hill Signal Station was the well-preserved signal tower that survived to its full height, but which was missing the machicolation over the first floor door and the bartizans on the rear corners. The tower was positioned with its walls facing north north-east, east south-east, south south-west, and west north-west respectively. The north-west and south-east walls featured extensive areas of external render, and the north-west and south-east walls featured occasional patches of render with fragments of weather-proof slates still adhered to the walls.

Figure D.72. View of the north-west wall of the signal tower at Mullaghderg Hill Signal Station, with the concrete pillar in the foreground.

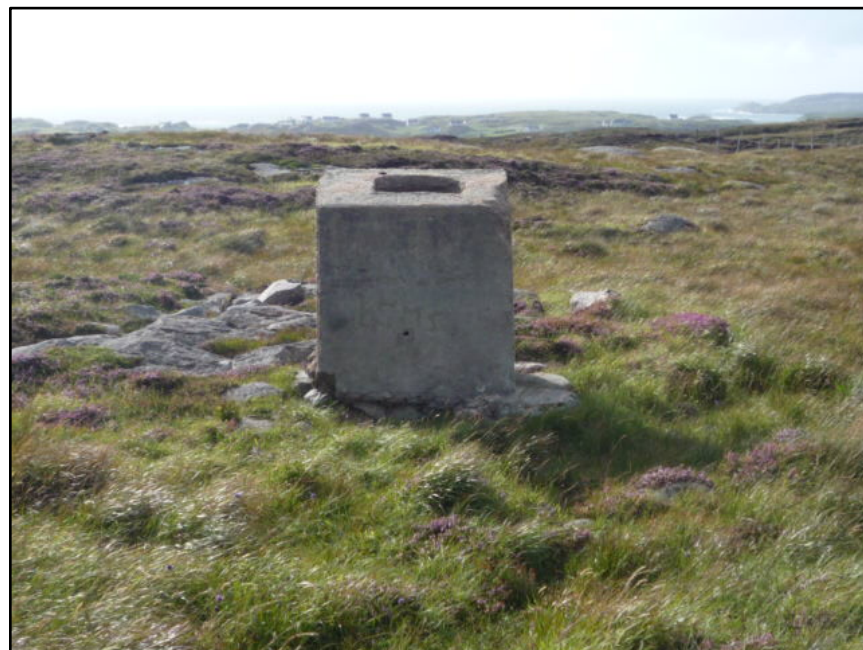
The signal station does not seem to have been associated with an enclosure. The site was re-used sometime after the 1st edition Ordnance Survey map was surveyed between 1834-1836, as a Coast Guard Station. During that period a rectangular enclosure was present to the immediate west of the signal tower, which is depicted on the 3rd edition Ordnance Survey map, surveyed 1900-1905 (the 2nd edition Ordnance Survey map was not available online). Although no traces of this later enclosure were identified during the field survey, a small poured concrete structure, possibly a mast-mount) to the west of the signal tower appears to be a remnant from this secondary period of use at the site.

Figure D.73. Detail of the concrete structure adjacent to the signal tower at Mullaghderg Hill Signal Station, looking west.

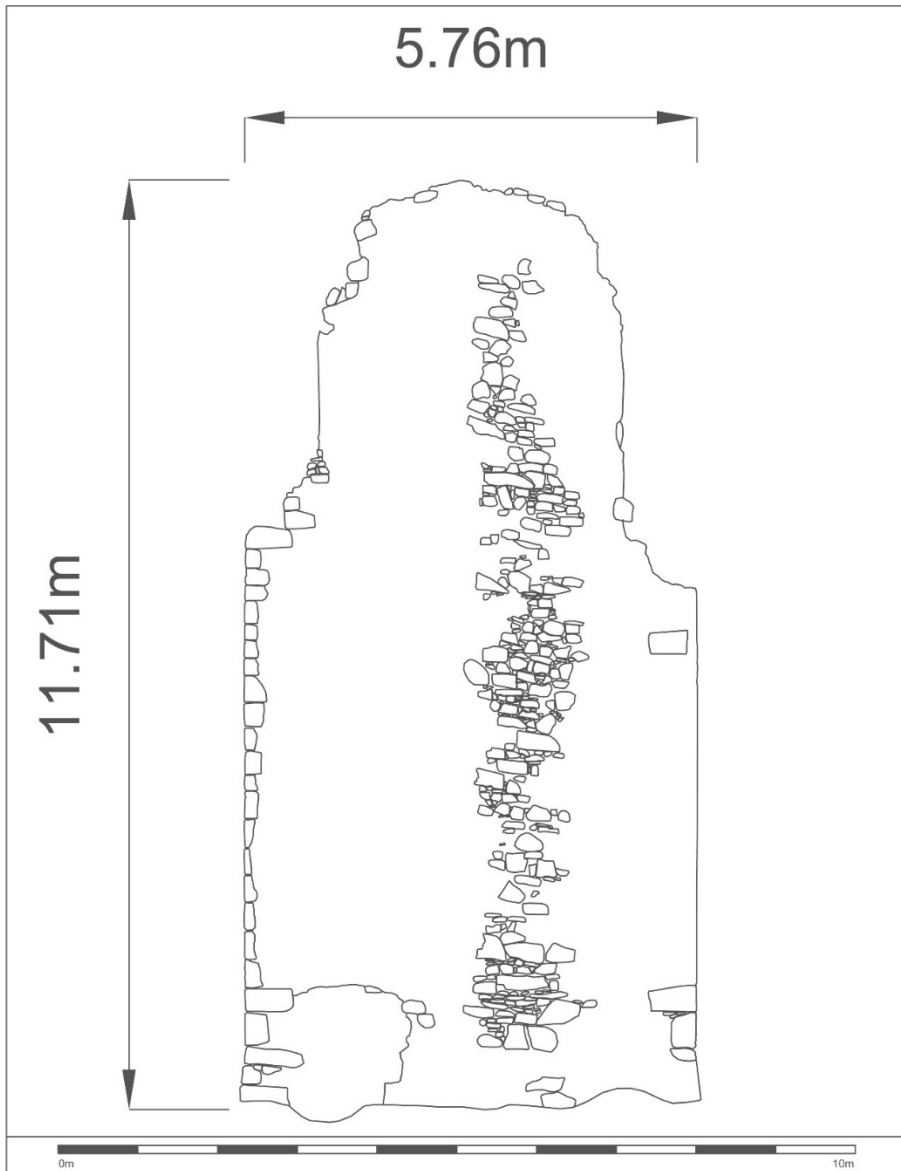
ran down the north-east corner of the south-east wall. There was clear evidence of a split-level mezzanine floor between the ground floor and the first floor. It was visible as rows of joist holes above the alcoves on the south-east wall, as rows of joist holes below the first floor slot with joist holes on the west north-west wall, and as slots in the render on the north north-eastern and east south-western walls, between the ground floor windows and the first floor slot with joist holes.

Figure D.76. External elevation of the south-east wall of the signal tower at Mullaghderg Hill Signal Tower.

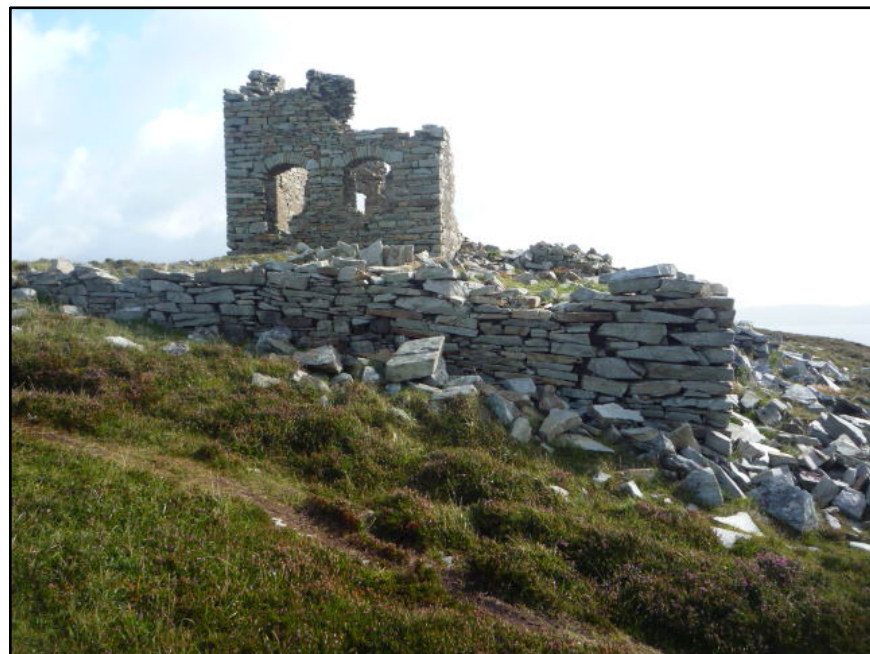
Figure D.90. The external face of the west wall of the signal tower at Horn Head Signal Station, with the south-west corner of the enclosure in the foreground.

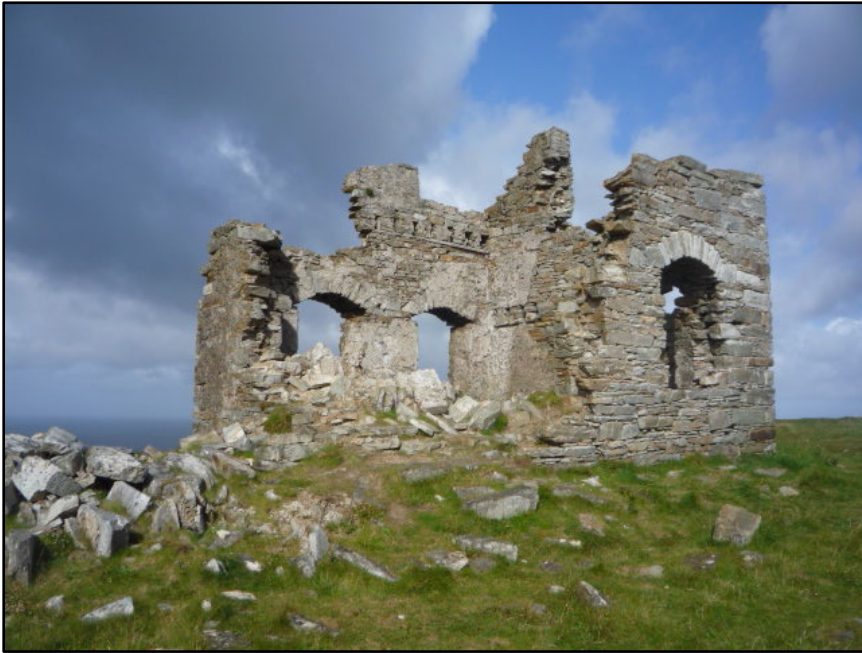
The main feature at Horn Head Signal Station was a largely collapsed signal tower. It was set in a sub-rectangular enclosure defined by a collapsed stone wall. The ruined signal tower was located close to the southern wall of the enclosure. Despite its condition, enough survived to orientate the tower. The walls faced north, east, south, and west. The first floor door was located on the northern wall where fragments of one side of the opening could still be seen. Two ground floor windows were visible on the west wall, and a single ground floor window was visible on the east wall. They were unusually large examples, featuring high arched tops. The lower parts of one first floor window was visible at the north of the western wall. A slot with joist holes that would have held the first floor was also visible on the west wall. On the northern wall the western joist holes for the split mezzanine level between the ground floor and the first floor were present. The area where the eastern set of joist holes for the mezzanine levels was marked by a hole in the wall, possibly suggesting the joist holes had introduced a weakness into the wall leading to its localised collapse. A small fragment of one of the ground floor alcoves that would have flanked the central fireplace was present on the small surviving part of the southern wall. The signal tower is surrounded by a large spread of rubble that extended to the west and the south, suggesting that the tower may have collapsed in a south-westerly direction. The walls of the signal tower were constructed from light-grey, coarse-grained stone, possibly quartzite.

Figure D.91. View of the largely demolished south-east corner of the signal tower at Horn Head Signal Station, looking north-west.

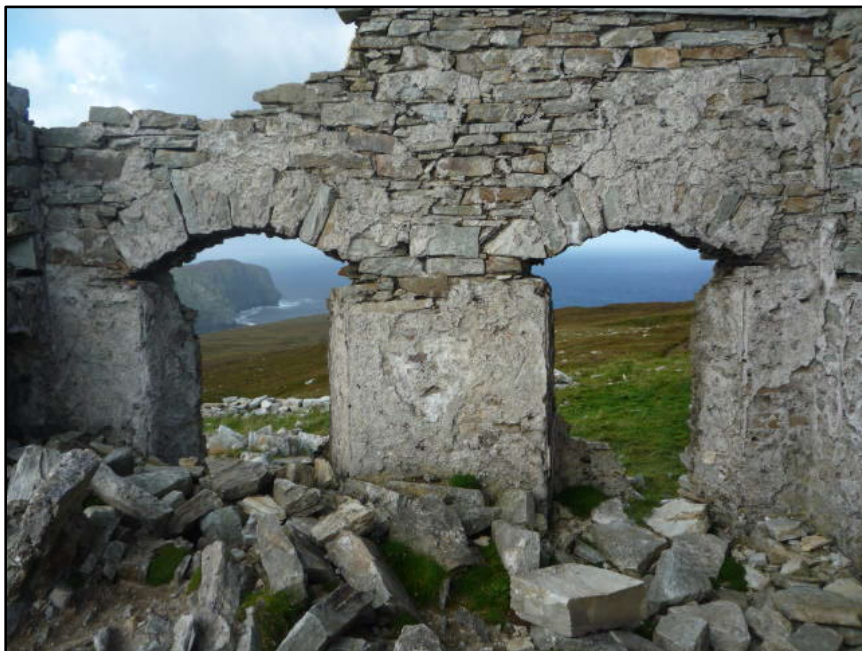
Figure D.92. The lower portion of the internal face of the west wall of the signal tower at Horn Head Signal Station, showing the ground floor windows with their unusual arched tops.

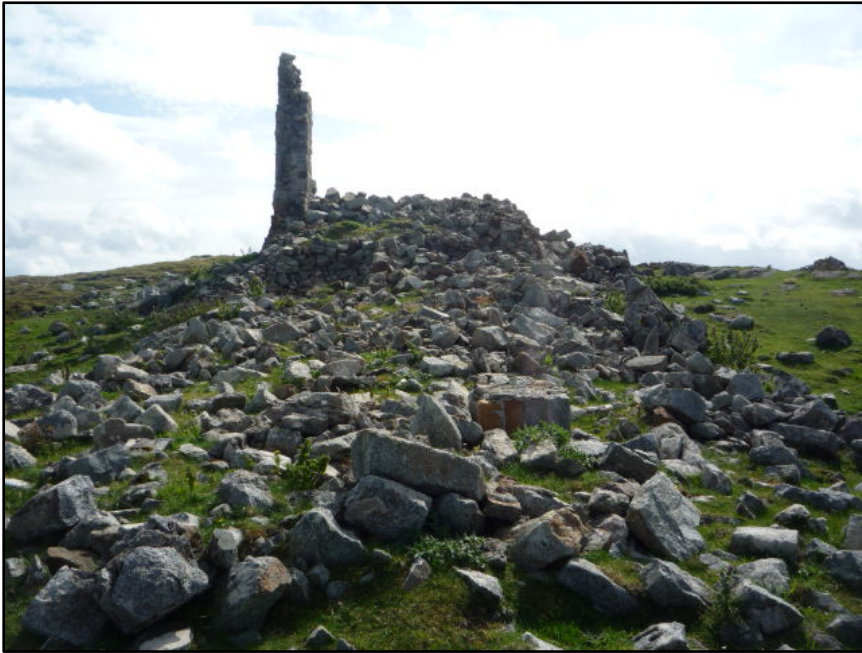
Figure D.99. The north side of the collapsed signal tower at Melmore Head Signal Station, looking south, with the extensive rubble spread in the foreground.

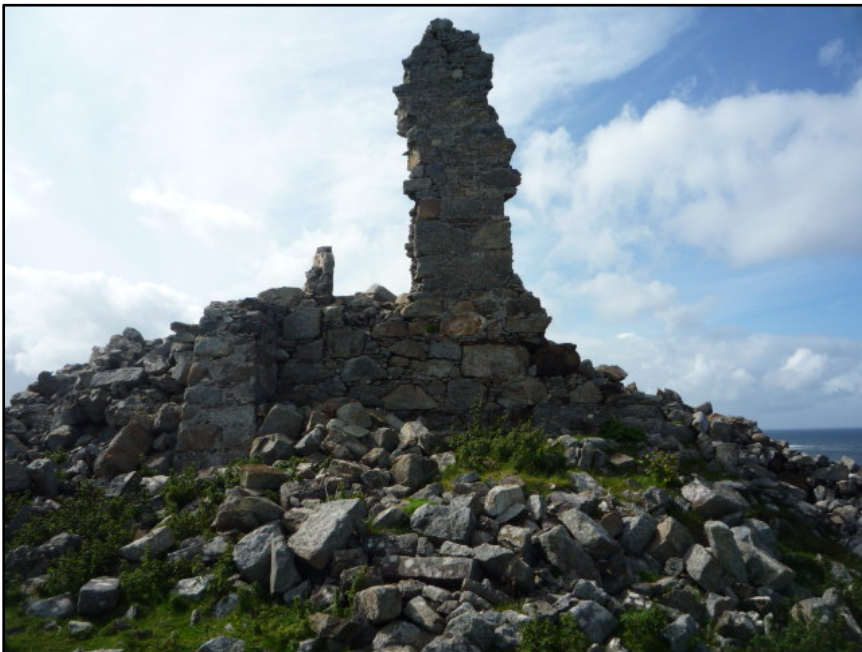
Figure D.100. The external face of the east wall of the collapsed signal tower at Melmore Head Signal Station, showing the surviving stonework that appeared to have been the pillar that separated the ground floor windows, and the external buttress at the south of the wall.

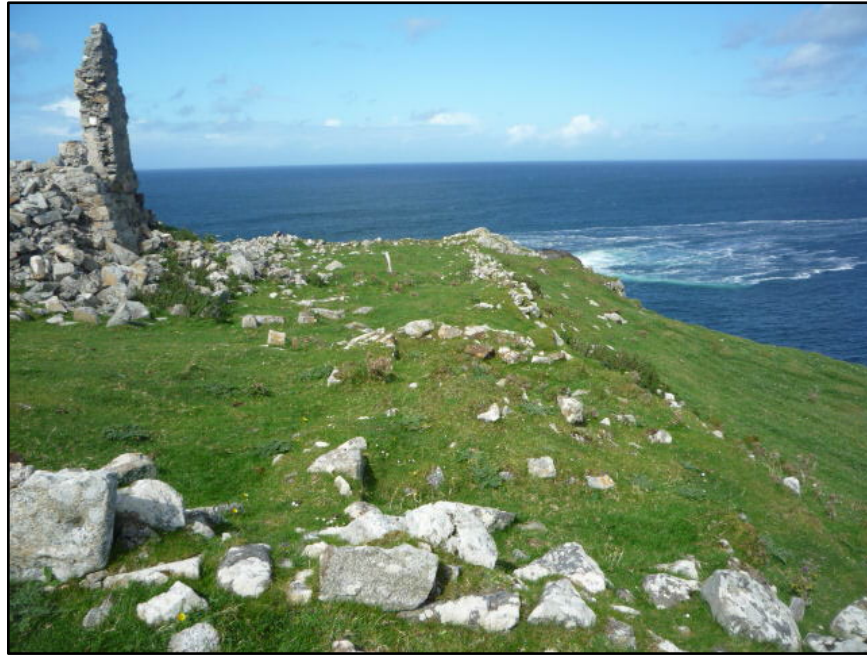
The low foundations of two small rectangular buildings were located within the enclosure, one against the south-east corner, the other against the south-west corner. The foundation in the south-east corner of the enclosure consisted of neat grassed over wall footings with frequent visible stonework. The building measured 7.95 m by 1.8 m (26' by 6') externally and 7 m by 1.45 m (23' by 4' 9") internally. The 1st edition Ordnance Survey map, surveyed 1834-1836, shows a long rectangular building in this

Figure D.101. The rectangular building in the south-east corner of the enclosure at Melmore Head Signal Station, looking north, with the eastern side of the signal tower in the background.

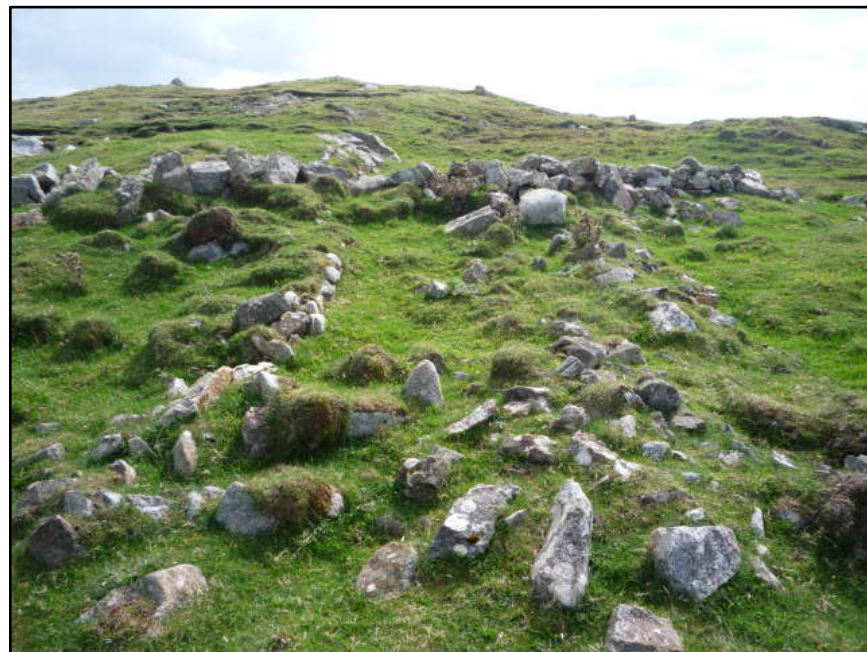
The building in the south-west corner of the enclosure consisted of a grassed over earthen bank with frequent protruding stones. It was not as well as constructed as the building at the south-east. It measured approximately 4 m by 2.15 m (13' by 7') externally and 3.35 m by 1.7 m (11' by 5' 6") internally. This building was not shown on the early Ordnance Survey maps and given its cruder appearance in comparison to the first foundation it was possibly a later addition to the site.

Figure D.102. The rectangular building in the south-west corner of the enclosure at Melmore Head Signal Station, looking south.

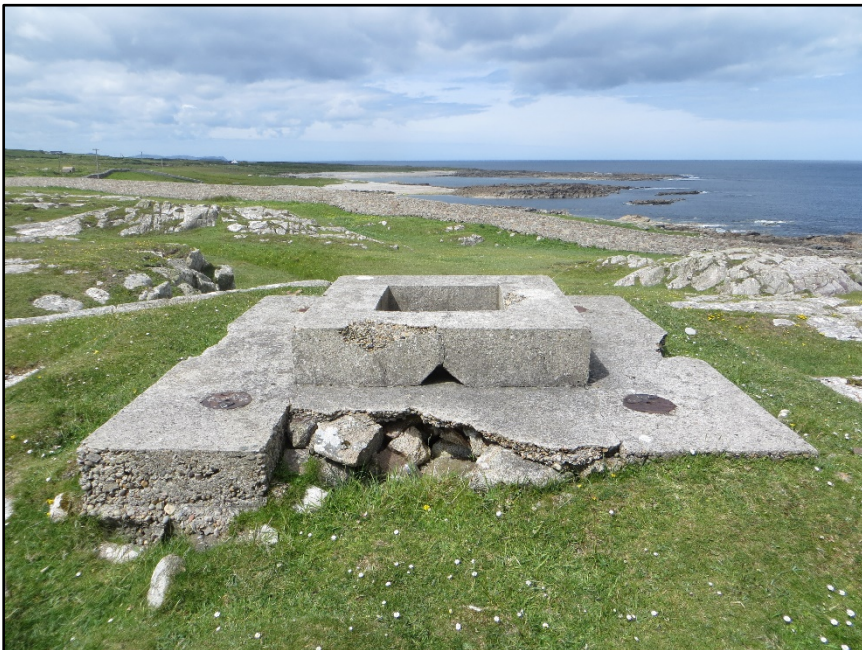
the examples at Fanad Head. A set of concrete foundations and metal anchor points west of the Fanad Head watch house also have parallels at Moyteogue. At Moyteogue the features supported a signal lamp for shore to ship communications and this explanation may also apply at Fanad Head. Another similarly designed watch house is located at Stroove, County Donegal, overlooking Inishowen Head (DG013-010----/Reg. No. 40901307). The NIAH states that the structure was built between 1890 and 1910 (NIAH 2019).

Figure D.108. One of several metal and concrete equipment mounts located in the vicinity of the early 20th Century watch house associated with Fanad Head Coast Guard Station.

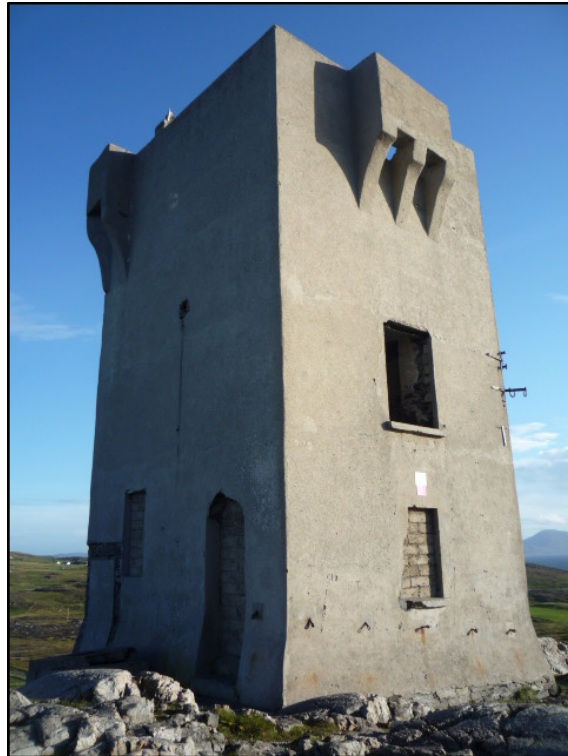
Figure D.119. The north corner of the modified signal tower at Malin Head Signal Station.

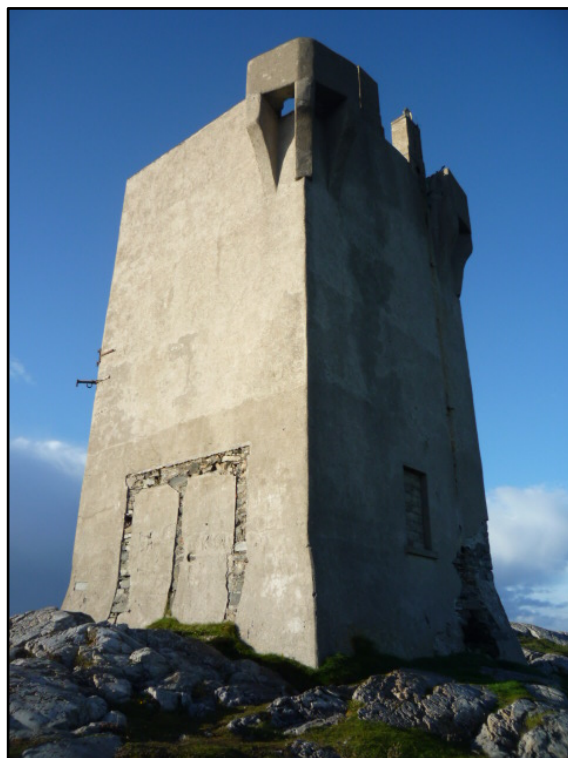
Figure D.120. The south corner of the modified signal tower at Malin Head Signal Station.

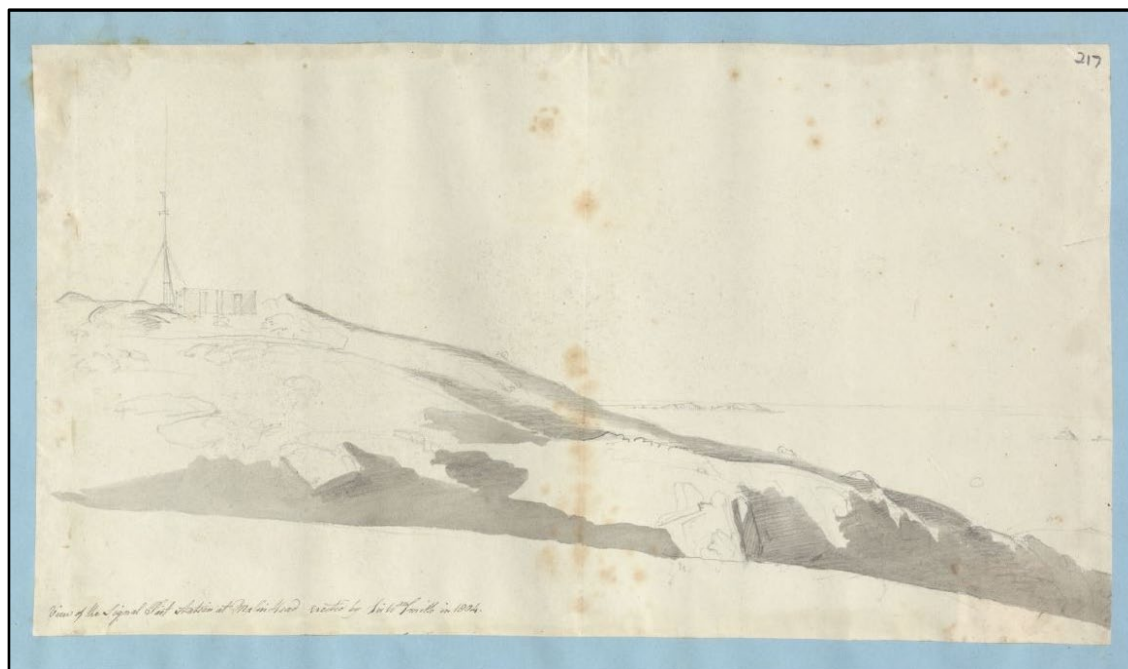
D.133. View of the Signal Port Station at Malin Head erected by Sir Wm Smith in 1804. (TCD MS 942/2: 217).

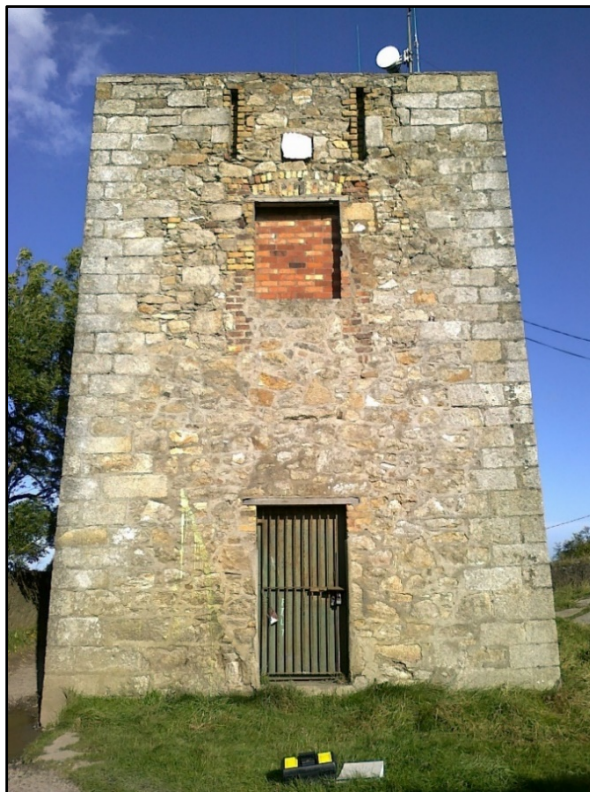
Figure E.4. The south-west wall of the signal tower at Dalkey Signal Station, County Dublin, looking north-east. (Photograph courtesy of Gary Dempsey).

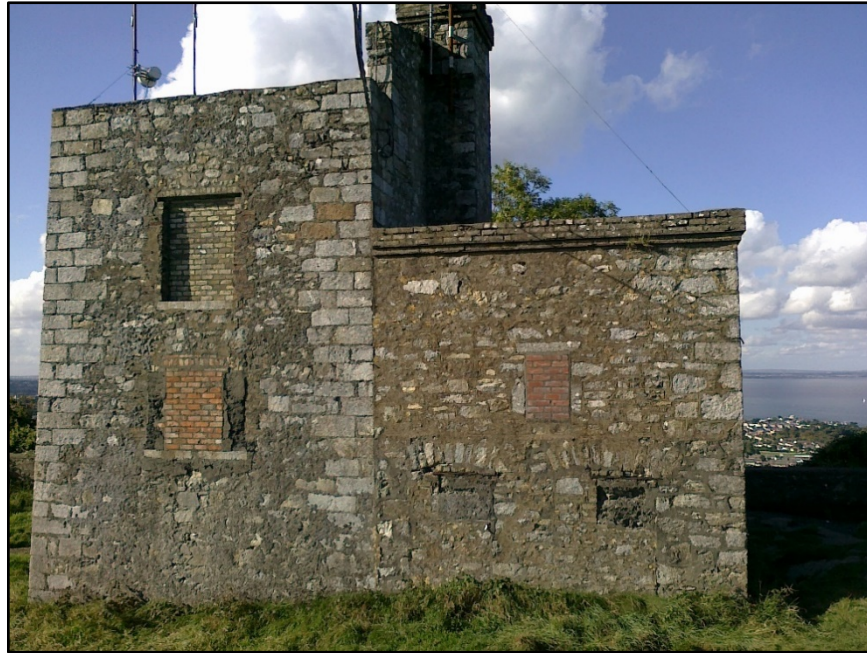
Figure E.5. The south-east wall of the signal tower at Dalkey Signal Station, County Dublin, showing the addition, looking north-west. (Photograph courtesy of Gary Dempsey).

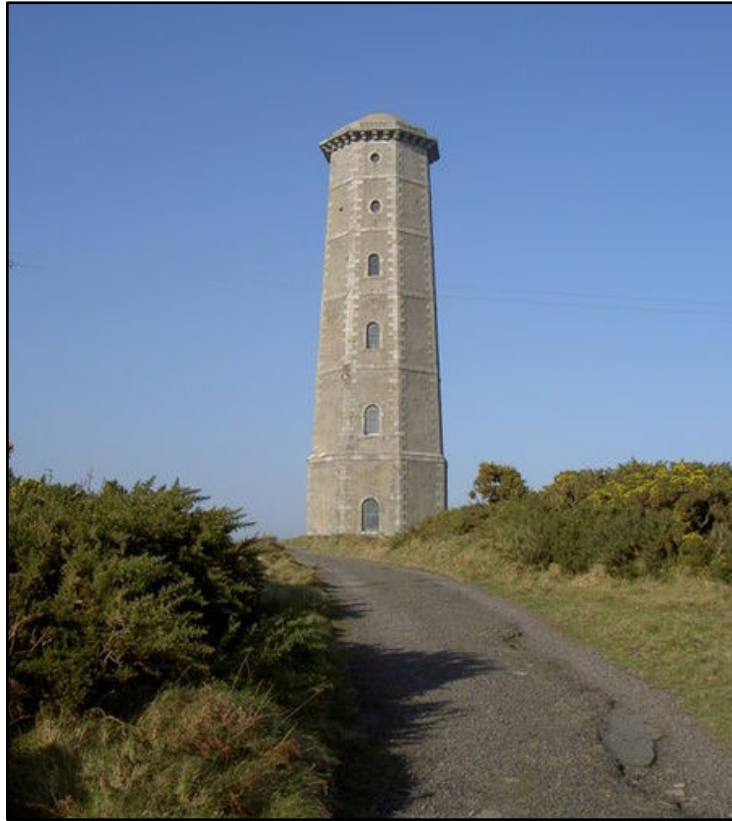
**Figure E.6. The earlier octagonal lighthouse at Wicklow Head, County Wicklow.
(Photograph by David Quinn used under Creative Commons License 2.0).**

The original six-stage lighthouse is 30 m (95') tall and has a distinctive octagonal plan (Figure E.6). It was designed by John Trail whilst serving as architect to the Commissioners of Revenue (Rynne 2006, 406). It is thought that the signal mast was the only addition made to the site when the signal station was established, and that the signal crew were housed within existing buildings (Kerrigan 1995, 161). The signal mast was erected by September 1805 (Kerrigan 1995, 276). It is not clear what was present at the site prior to the creation of a newer cylindrical lighthouse (Reg. No. 16403101) and its associated buildings in 1825, but no buildings are shown adjacent to the older lighthouse on the 1st edition Ordnance Survey map, surveyed 1838. The cylindrical lighthouse is located 100 m (328') to the east of the original lighthouse (Figure E.7).

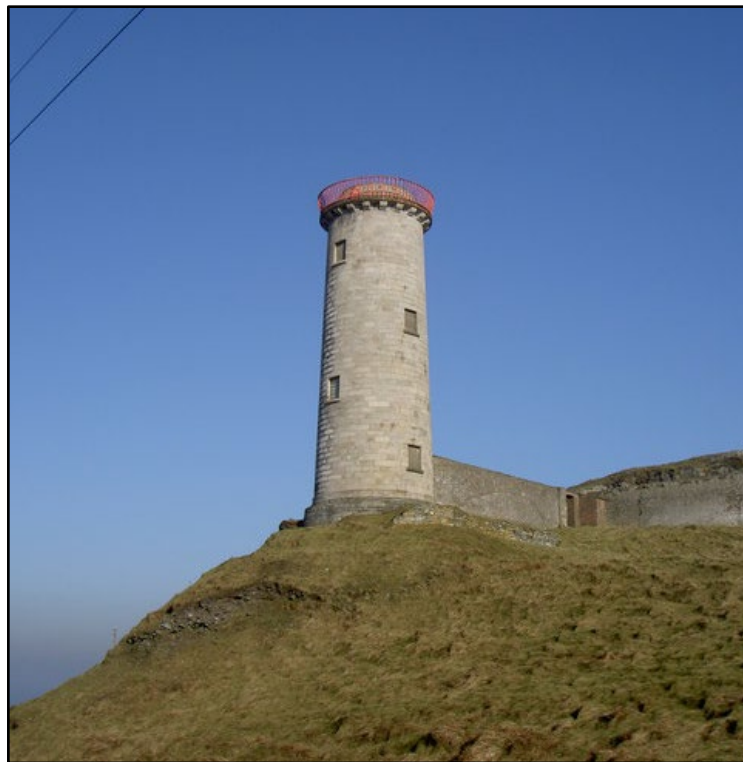
**Figure E.7. The later cylindrical lighthouse at Wicklow Head, County Wicklow.
(Photograph by David Quinn used under Creative Commons License 2.0).**

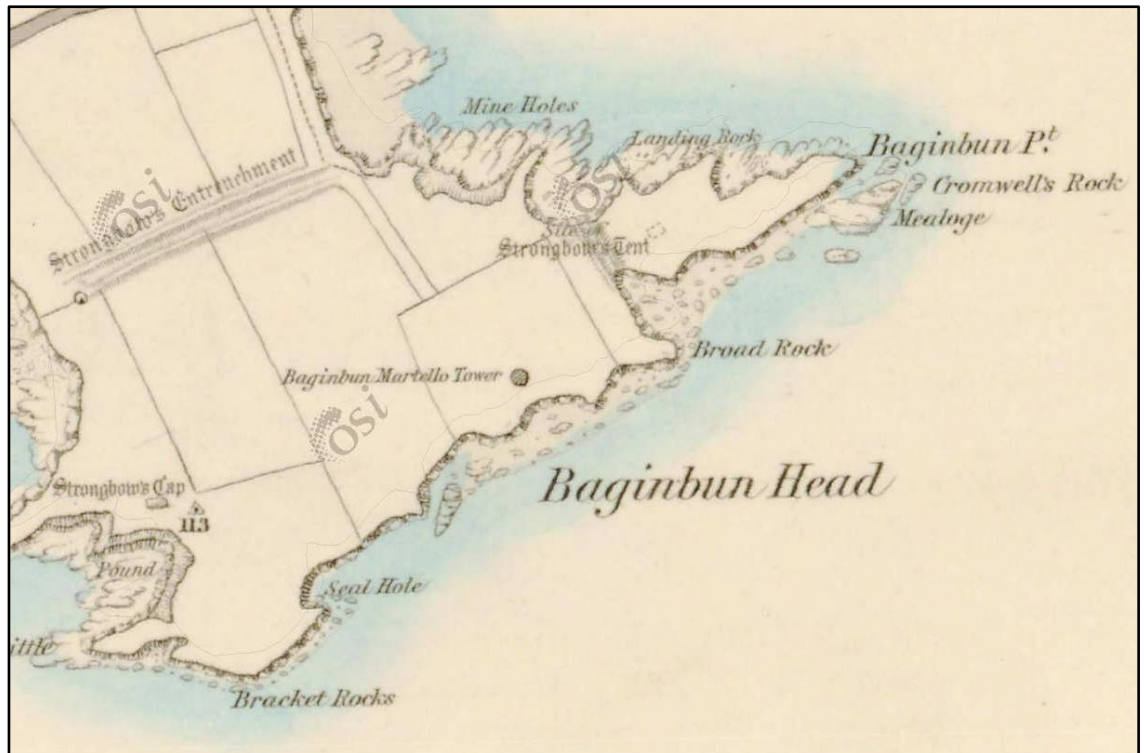
Figure E.9. 1st Edition Ordnance Survey map of Baginbun Martello Tower and Signal Station.

The signal station was located at Baginbun Martello Tower, which was under construction in 1805 (Kerrigan 1995, 276). The signal crew were housed within the tower complex and the signal mast, erected by 1805, was likely the only thing specifically constructed for the signal station (Kerrigan 1995, 161, 276). The NIAH entry (Reg. No. 15705009) describes the Martello Tower as a “freestanding single-bay two-stage Martello tower.” Two single storey, flat roof additions have been built against the exterior wall, one on the east side, the other on the west (Figure E.8). These additions are not shown on any of the first three Ordnance Survey maps, surveyed 1839-1840, 1902-1905 and 1921 respectively, and must have been constructed in the 20th century (Figure E.9). The tower was converted into a residence after it was sold to a private owner in 1947 (Clements 2013, 76). The 1st edition Ordnance Survey map indicates the local landscape consisted entirely of enclosed land.

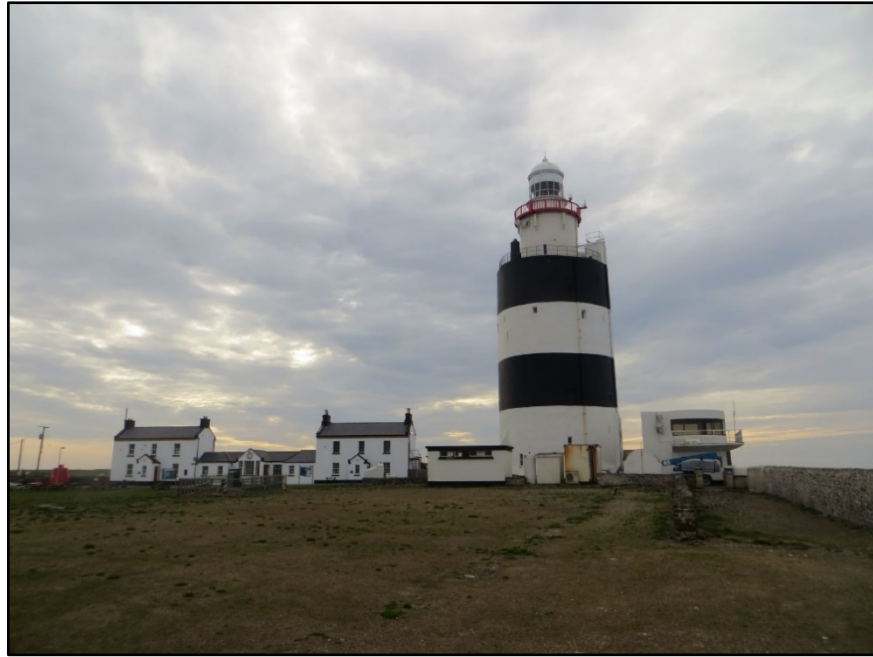
Figure E.10. Hook Head lighthouse, County Wexford, the location of Hook Head Signal Station, looking south-east.

The signal station was established at the existing lighthouse complex (Reg. No. 15705414) (Figure E.10). Other than a signal mast, erected by 1805, no new constructions were added to the site when the signal station was established (Kerrigan 1995, 276). The lighthouse is set towards the south-east corner of a large rectangular walled enclosure, surrounded by a restored cobbled yard, both of which are shown on the 1st edition Ordnance Survey map, surveyed 1839-1840. To the north of the lighthouse there are a pair of identical two storey lighthouse keeper's cottages (Reg. No. 15705415/15705416) constructed in the 1860s, which were subsequently connected by a range of single storey buildings (Colfer 2004, 290). Immediately south of the lighthouse there are some fragments of medieval buildings and a distinctive early 20th century two storey observation room, similar in form to the Look Out Post (L.O.P. 15) at Cross Faranogue, County Wexford. To the west was an arched roof magazine. The remains of a gun house that held a foghorn are located to the south-west of the enclosure, near to the low cliffs. The NIAH entry describes the lighthouse as a "freestanding single-bay four-stage lighthouse, extant 1245, on a circular plan originally single-bay three-stage. 'Restored', 1665-7. 'Repaired', 1792. 'Improved', 1864, producing present composition. Automated, 1996." The concrete slab foundation of a World War 2 era Look Out Post (L.O.P. 16) is located to the immediate south-west of the lighthouse. (Figure E.11). In 1999 a small archaeological excavation (License No. 99E0020) at the site revealed the remains of a 17th century or earlier enclosure around the lighthouse, but nothing that could be related to the signal station (Hayden 1999; Alan Hayden pers. comm.). The 1st edition Ordnance Survey map indicates the local landscape consisted entirely of enclosed land.

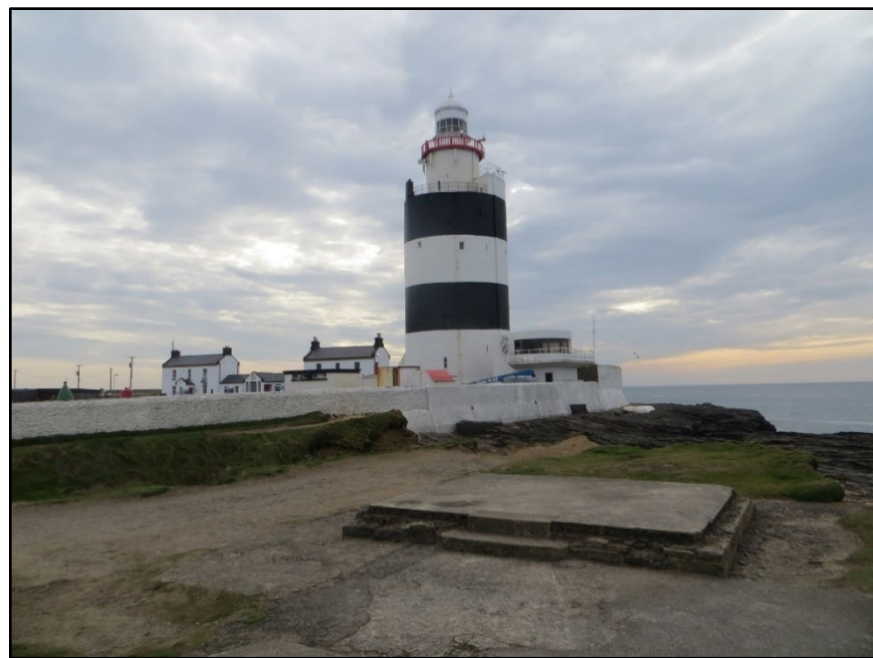
Figure E.11. The concrete slab foundation of Look Out Post 16, located to the south of the enclosure around the lighthouse, looking east.

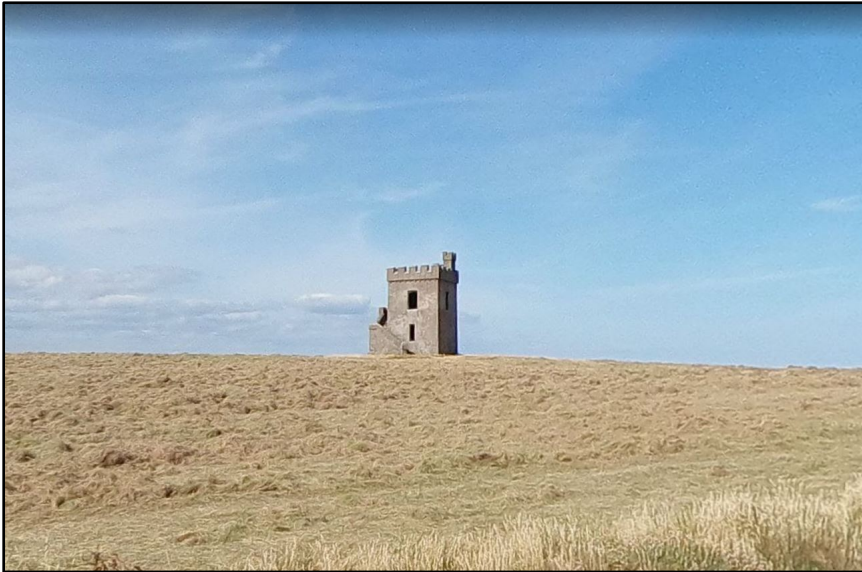
Figure F.2. The surviving signal tower at Ardmore Signal Station, County Waterford, looking north-east (Photograph courtesy of Google Earth).

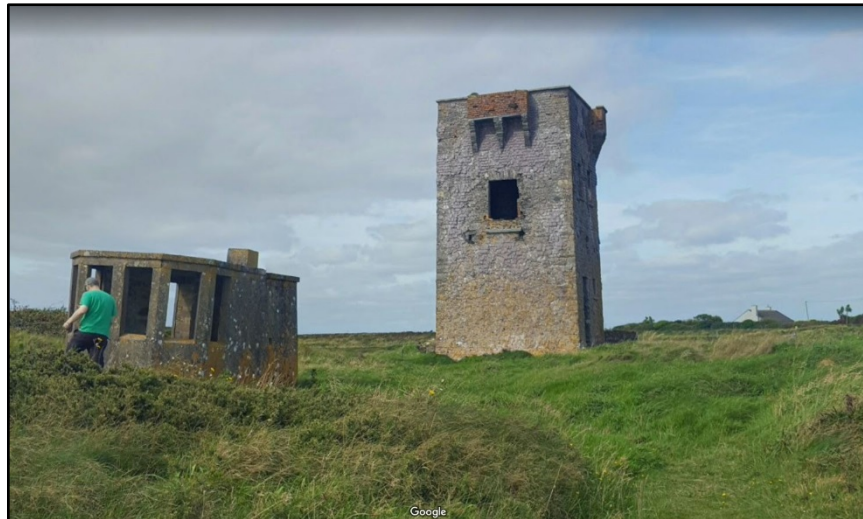
Figure F.3. The surviving signal tower at Knockadoon Signal Station, County Cork, looking north (Photograph courtesy of Google Earth).

The signal station is located on gently sloping ground on top of a small promontory to the south-west of Knockadoon head. The signal station features a well-preserved signal tower that survives to its full height (Figure F.3). Kerrigan established that a signal mast and the signal tower were completed in 1804 (Kerrigan 1995, 277). The tower conforms to the standard design used throughout the main study area. The signal tower is well-preserved and survives to its full height. The doorway is located on the first floor of the south-east wall and would have been accessed via a retractable ladder. The doorway is protected by a rectangular machicolation. The north-east and south-west walls each feature two ground-floor windows and two first-floor windows. A tall chimney extends up from the centre of the north-west wall. Bartizans are located on the north and west corners. Unusually the walls of the machicolation over the door and the bartizans over the corners are constructed of red brick, which may relate to a period of repair, but this may be an original feature. Unique amongst the signal towers that have not been heavily modified, this signal tower has a roof. It seems unlikely that this is an original roof, which would be over two hundred years old. The roof was built with joists fitting into the original joist holes at the top of the structure.

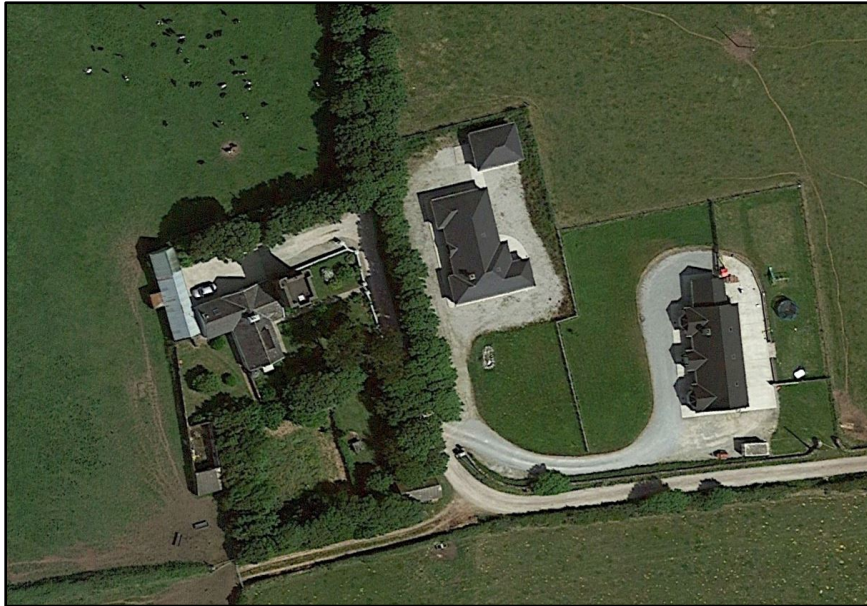
Figure F.5. Aerial view of Ballynacotter signal tower with the large residence attached to its western side. (Photo courtesy of Google Earth).

A modern bungalow has been constructed adjacent to and abutting the signal tower, obscuring the ground floor windows on the south-west wall. The ground floor windows on the north-east wall now feature PVC frames. The first floor windows on the north-east and south-west walls, and the first floor door on the south-east wall have been blocked.

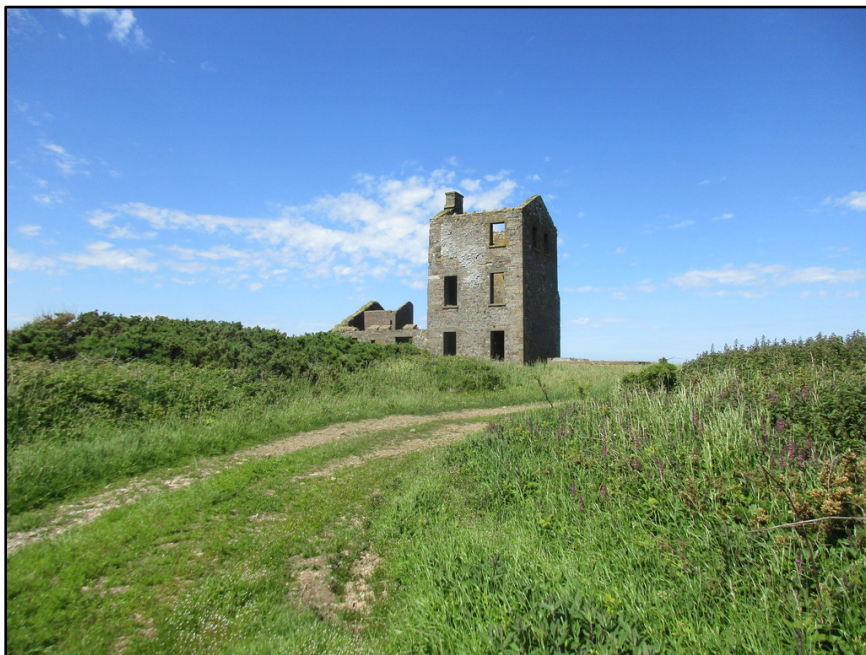
Figure F.9. Robert's Head Signal Station, County Cork. (Photograph by Johnathan Thacker used under Creative Commons License 2.0).

The extant building was not of the standard design found in the main study area. It is a tall three storey structure with gabled walls at the north-west and south-east. A small two storey addition abuts the north-east side of the building, a much larger single storey addition abuts the north-west wall, and there is a free-standing, flat roofed rectangular water cistern to the south-east. The south-west wall of the signal tower features six large windows, two on each floor. The south-east wall features two large windows on the second floor. The north-east wall features a single door on the ground floor and a single window on the second floor. The two storey addition has a large window on the first floor and the addition covers up a large first floor window or door on the main wall. The north-west wall features a large window on the second floor and a tall chimney protrudes from the peak of the gable (Figure F.9).

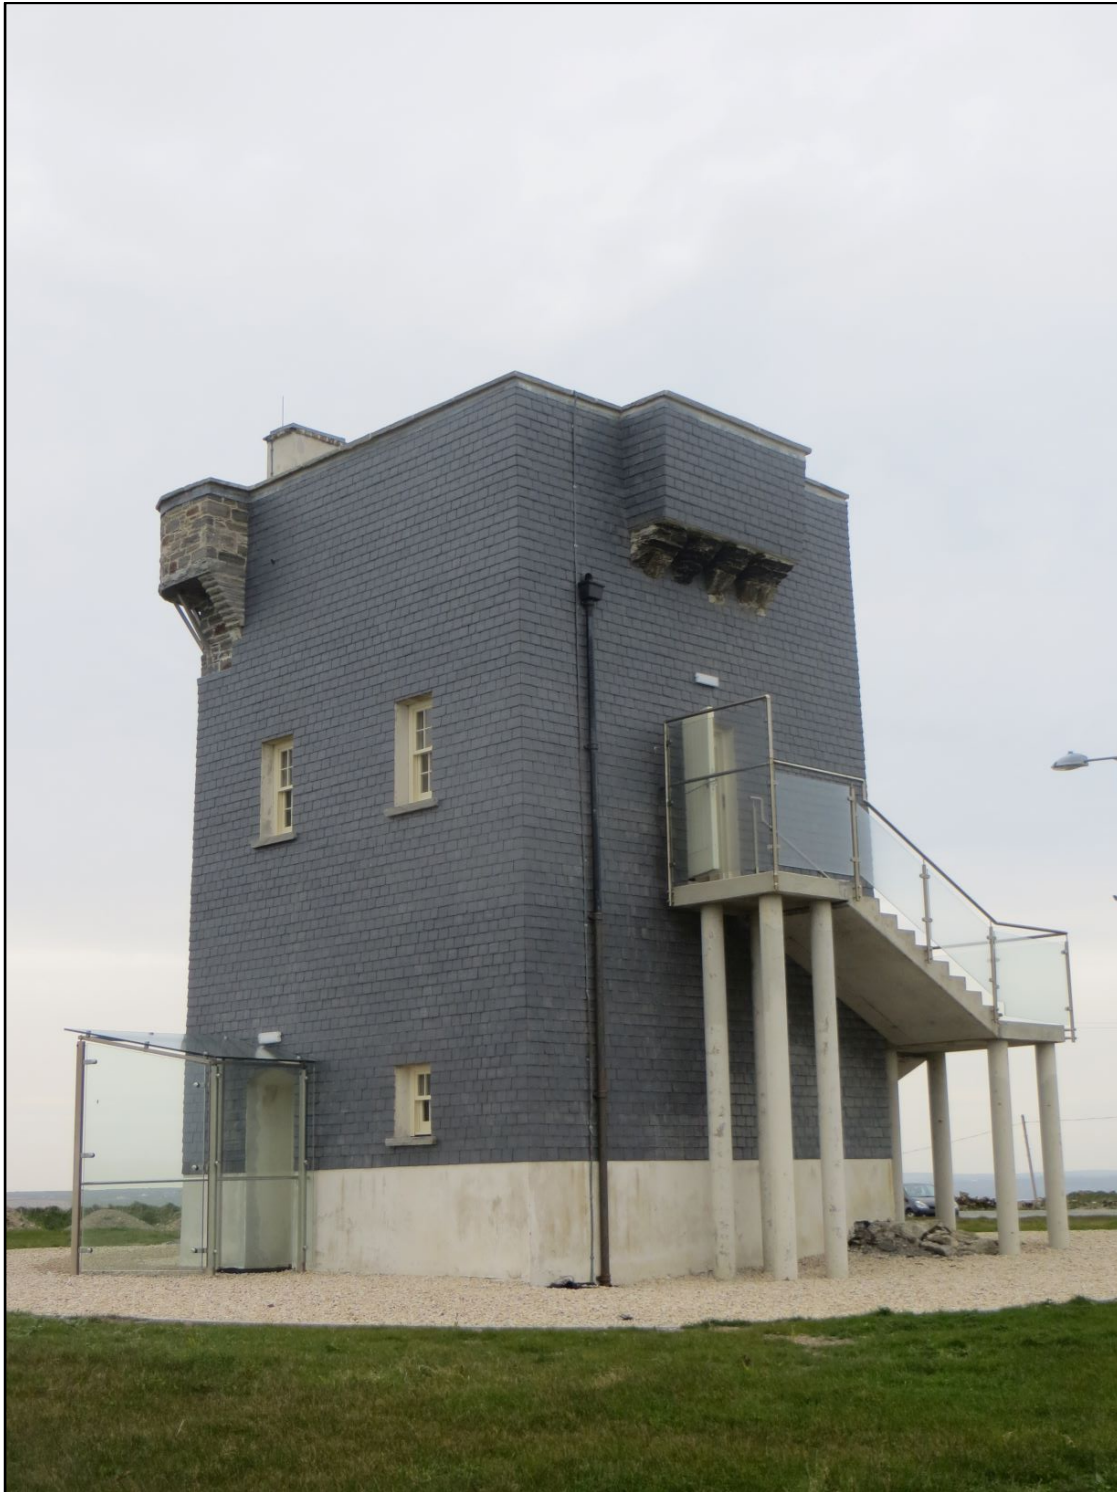
Figure F.10. The south-east and south-west walls of the restored signal tower at the Old Head of Kinsale Signal Station, County Cork, looking north.

The signal tower follows the standard design found across the main study area. The signal tower is positioned with its walls facing north-east, south-east, south-west, and north-west. The south-east wall features a first floor door that would have been accessed via a retractable ladder. The doorway is protected by a rectangular machicolation supported by three corbels. The north-east and south-west walls each feature two ground-floor windows and two first-floor windows. The north-west wall bows out slightly across its whole width, to create additional space in which to house the chimney flue. Bartizans are located on the north and west corners, each supported by three corbels.
