The construction, survival, and use of Signal Defensible Guard Houses on the Irish Coast

Volume II of II

Ph.D. Thesis (Archaeology)

IT Sligo

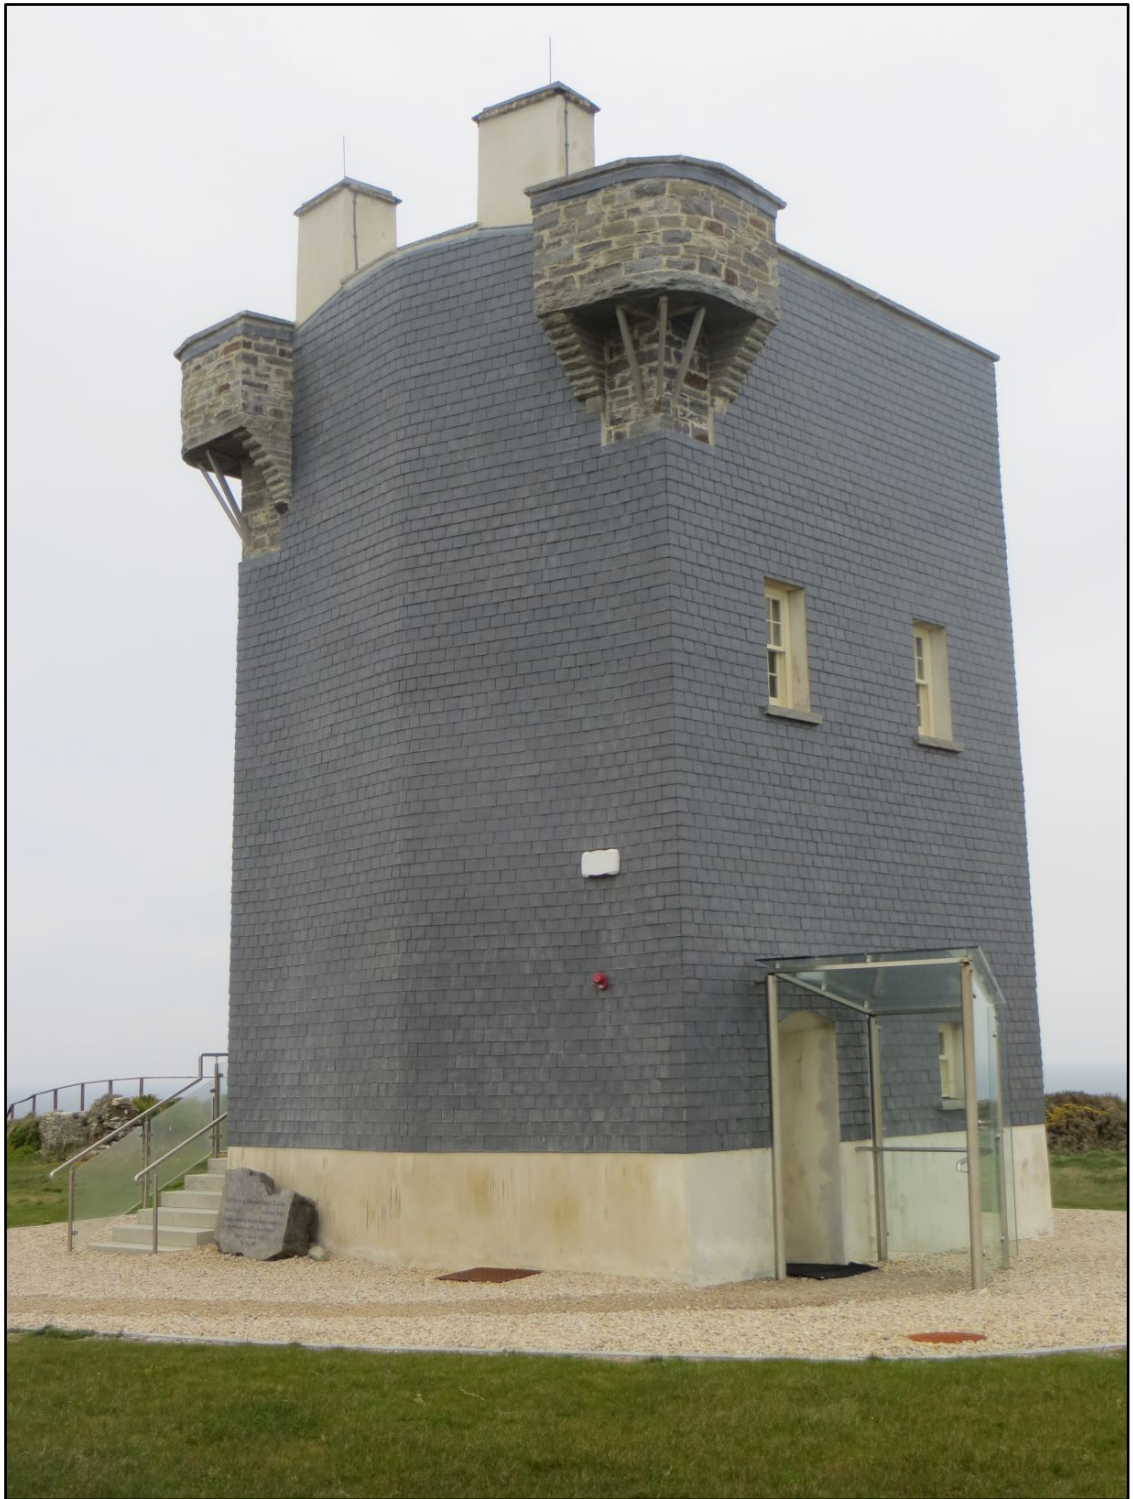
Figure F.11. The north-east and north-west walls of the restored signal tower at the Old Head of Kinsale Signal Station, County Cork, looking south.

The signal tower follows the standard design found across the main study area. The signal tower is positioned with its walls facing north-east, south-east, south-west, and north-west. The south-east wall features a first floor door that would have been accessed via a retractable ladder. The doorway is protected by a rectangular machicolation supported by three corbels. The north-east and south-west walls each feature two ground-floor windows and two first-floor windows. The north-west wall bows out slightly across its whole width, to create additional space in which to house the chimney flue. Bartizans are located on the north and west corners, each supported by three corbels.

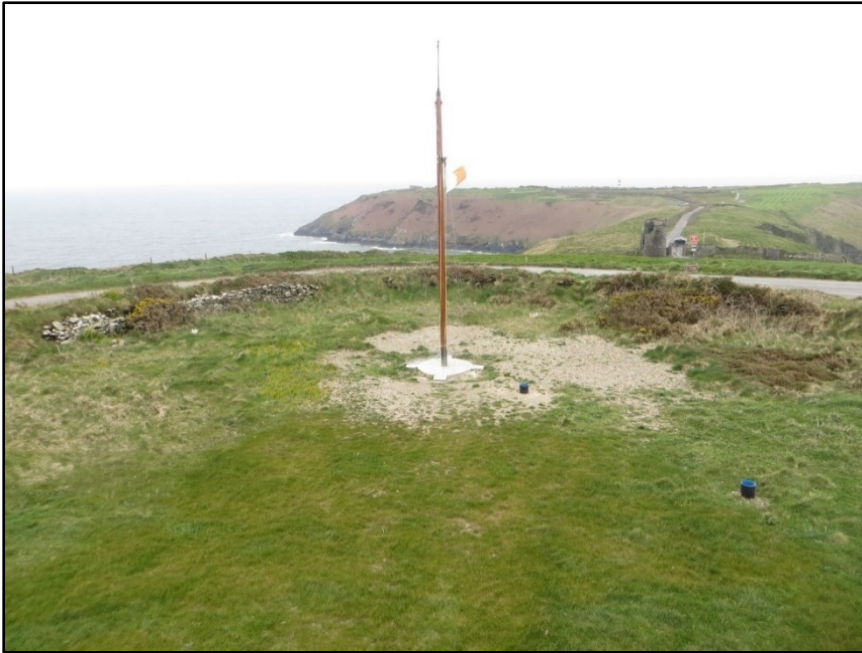
Figure F.12. The scale replica of the signal mast at the Old Head of Kinsale Signal Station, County Cork, looking south-east, with the curved section of the enclosure wall in the background. This photo was taken in 2015, prior to the creation of the remembrance garden.

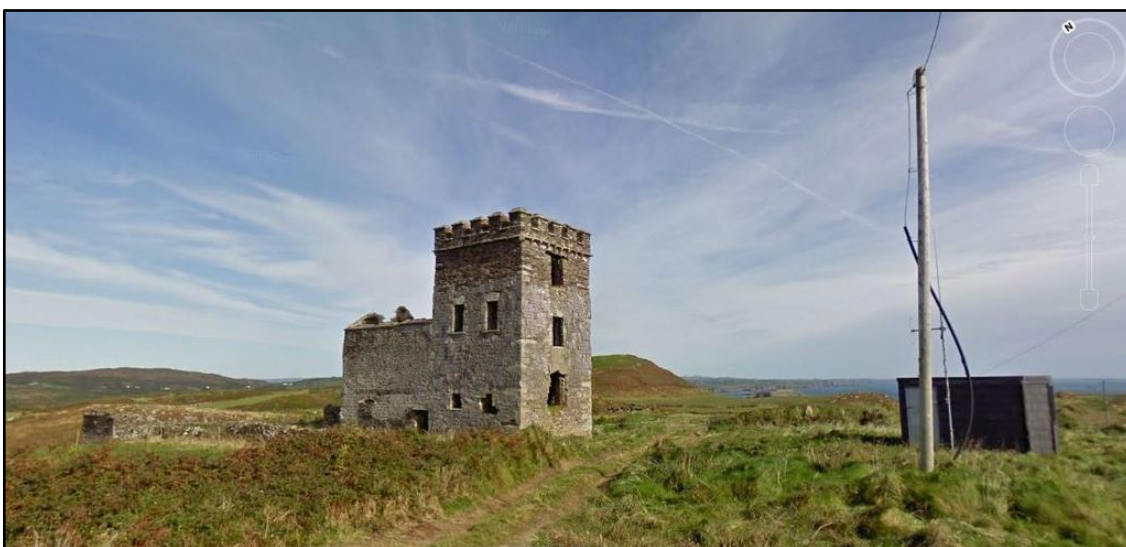
Figure F.14. Toe Head Signal Station, County Cork, looking north-east. (Photo courtesy of Google Earth).

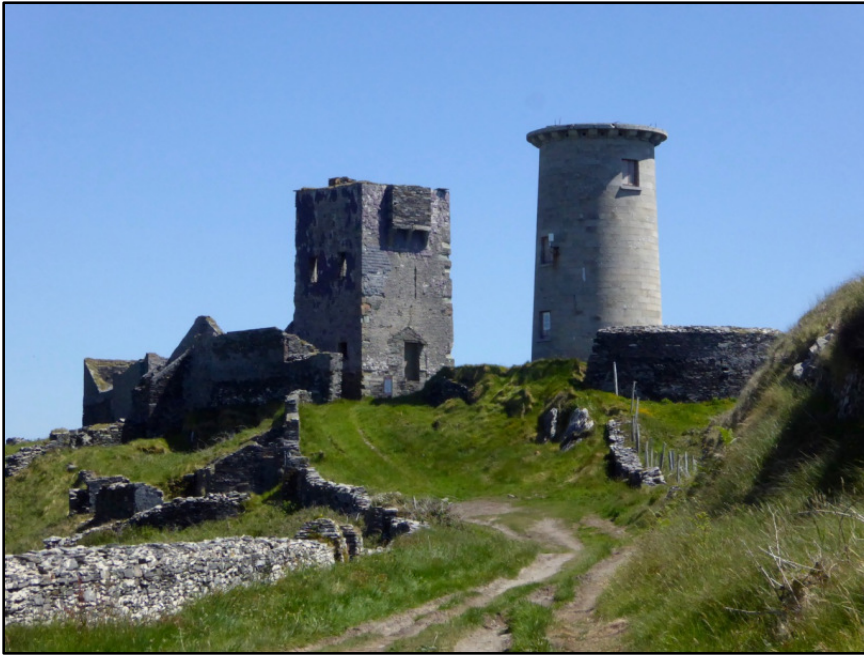
Figure F.15. Cape Clear Signal Station, County Cork, showing the later lighthouse in the foreground. (Photograph courtesy of Finola Finlay and Robert Harris, Roaring Water Journal).

A well-preserved early 19th century lighthouse (CO153-022001-/Reg. No. 20915308) was set in the centre of the curved end of the enclosure. The lighthouse has a short cylindrical form. The NIAH states that the lighthouse was constructed in 1818 and decommissioned in 1854 (Reg. No. 20915308).

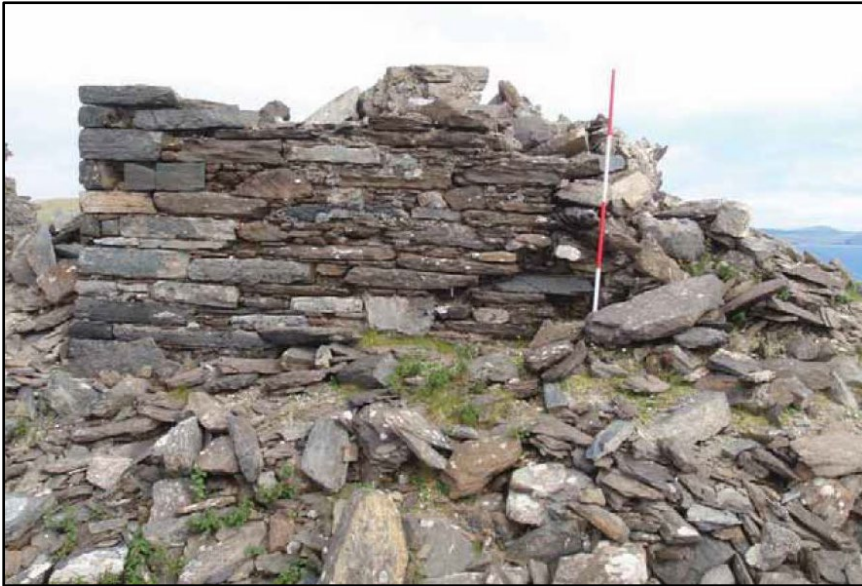
Figure F.19. The western wall of the collapsed signal tower at Bere Island Signal Station, County Cork. (Image taken from Shiels & Maloney 2015, with permission).

The enclosed signal station was located at the north-east edge of the large summit of the large hill at the west end of Bere Island. The signal station is set on undulating ground with moderate slopes to the north-west, north-east, and south-east. The level ridge that forms the top of the hill runs away to the south-west. Kerrigan established that the signal mast had been erected and the signal tower completed by 1805 (Kerrigan 1995, 278). The enclosed signal station was an important element of the heavily militarised landscape of Bere Island. It consists of the low ruins of a signal tower, of uncertain design, surrounded by a large spread of rubble (Figures F.19 & F.20). The ruins of a slightly better-preserved building are located to the north of the signal tower.

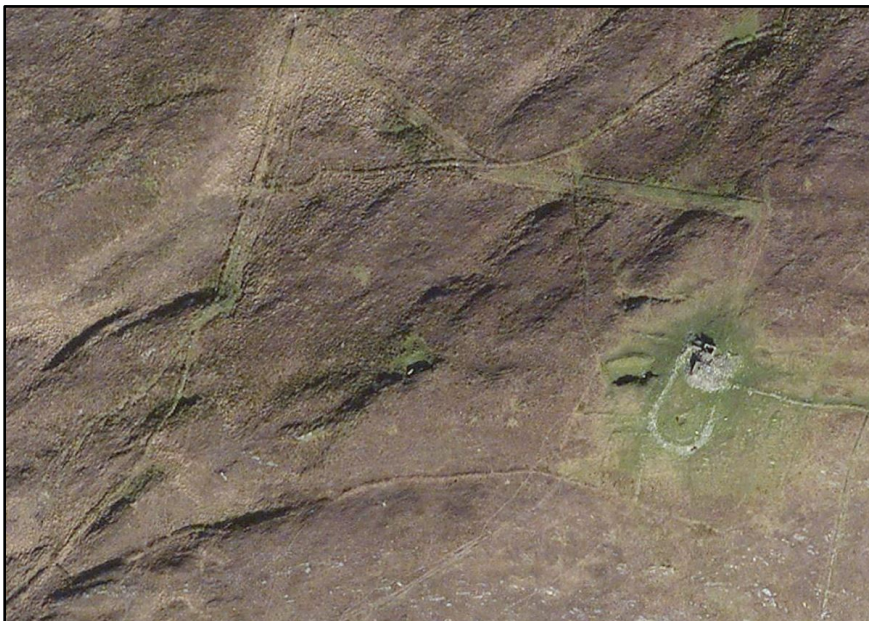
Figure F.20. Aerial photograph of Bere Island Signal Station, showing the curve ended enclosure to the south-west. The position of the signal mast mount can be seen in the centre of the rounded end of the enclosure (Photo courtesy of Google Earth).

The site was surveyed in 2012 which led to the identification of a quarry to the immediate west and a sunken feature in the centre of the rounded part of the enclosure which was identified as the base for the signal mast (Shiels & Maloney 2015, 49-50). It is believed that the signal tower was badly damaged by a lightning strike in 1959 and subsequently collapsed during a storm in 1964 (Shiels & Maloney 2015, 47).

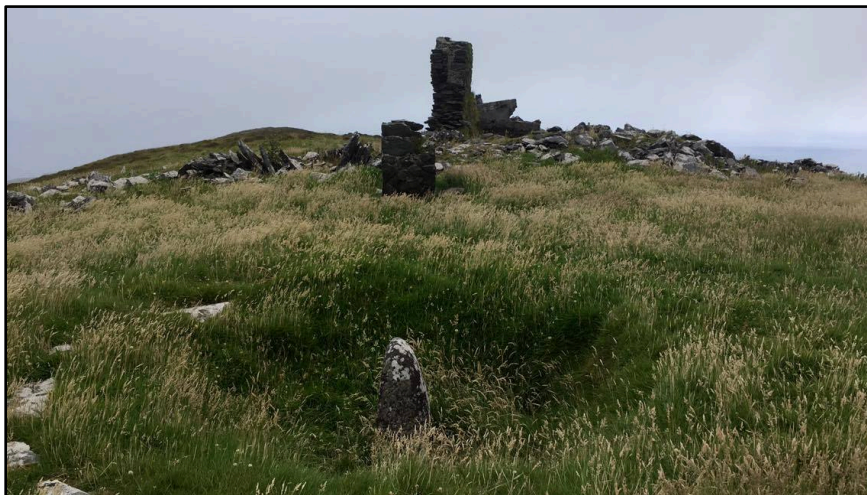
Figure F.23. Great Blasket Signal Station, County Kerry, showing the ruined signal tower with the signal mast support in the foreground. (Photograph courtesy of Dr James Bonsall).

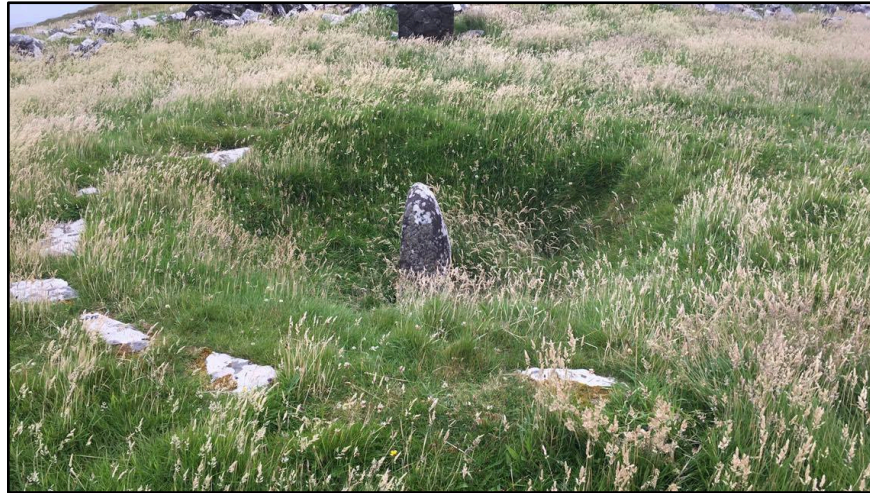
Figure F.24. Detail of the signal mast mount at Great Blasket Signal Station, County Kerry. (Photograph courtesy of Dr James Bonsall).

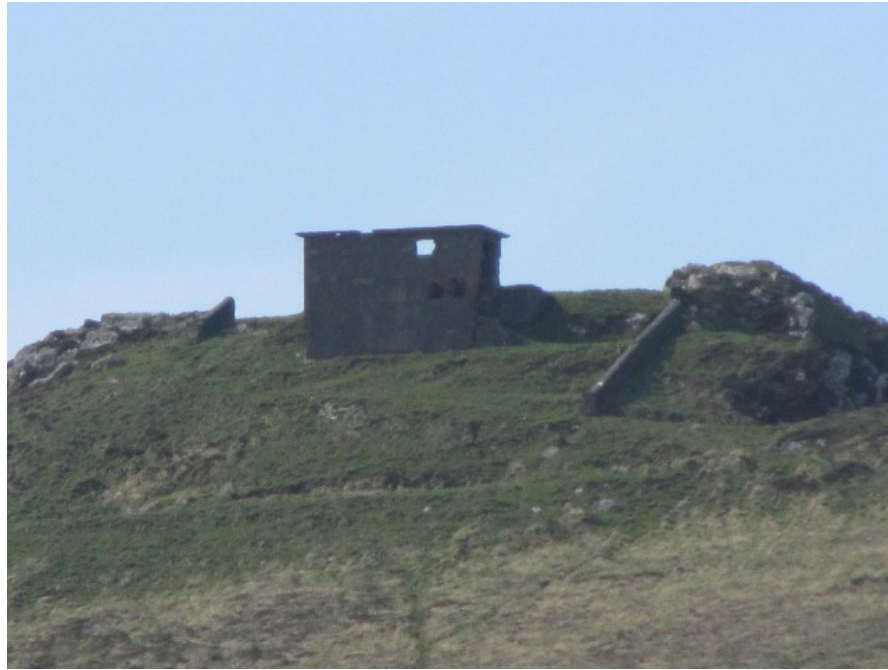
Figure F.25. Sybil Head Signal Station, County Kerry, looking north-west. The unusual two storey building and the enclosure wall can be seen. (Photograph courtesy of Isabelle Bennett).

The building may have been formed from connecting the two adjacent buildings shown on the later Ordnance Survey maps, in which case the north-east end of the building would have incorporated some of the mass of the original signal tower, the south-west end of the building would have incorporated some of the mass of the secondary building, and the central part of the building would represent new connecting elements.

A second possibility is that the original buildings have been demolished and entirely replaced by the building now on the site. Reviewing the building, there are no details which clearly indicate the incorporation of parts of a standard design signal tower. Clements identified the site as one of the locations used by the Royal Navy as a Naval War Signal Station during World War 1, and the current condition of the site is thought to relate to that period of reuse (Clements 2013, 102).

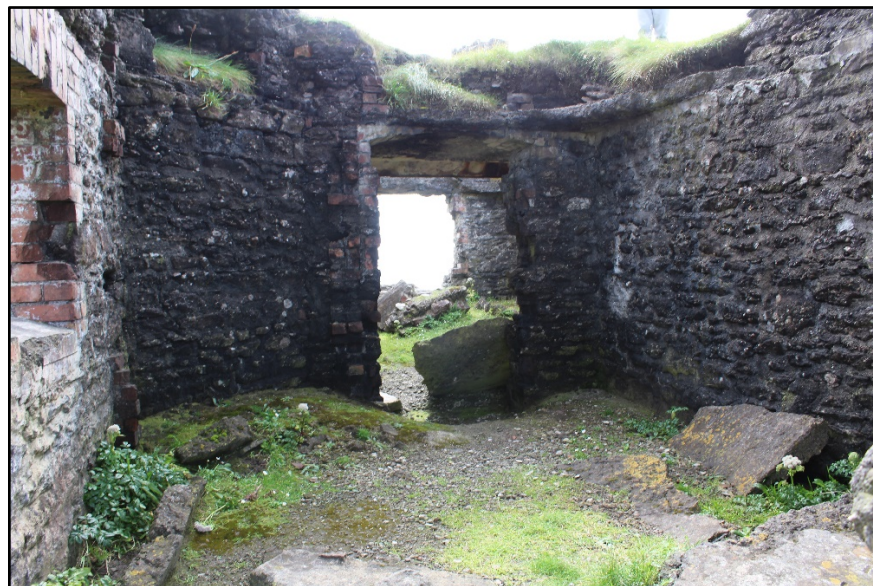
Figure F.26. Ground floor level cross wall, looking south-west. (Photograph courtesy of Dr James Bonsall).

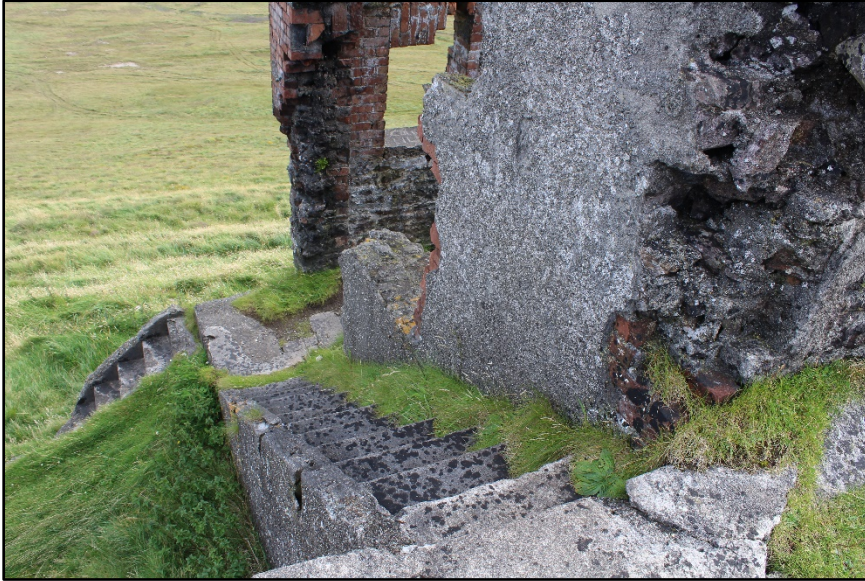
Figure F.27. Detail of steps running down north-east side of two storey building at Sybil Head Signal Station, County Kerry, looking south-east. (Photograph courtesy of Dr James Bonsall).

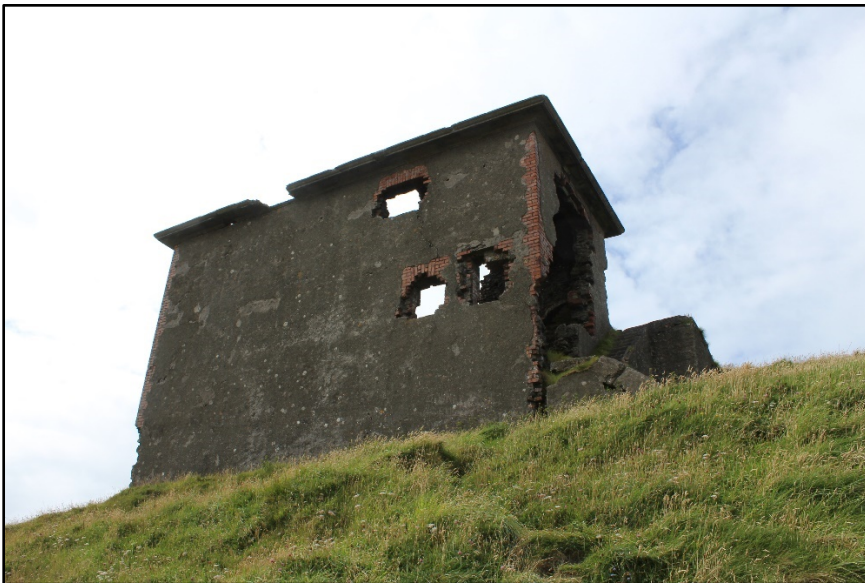
Figure F.28. View of the front, south-east, wall of the two storey building at Sybil Head Signal Station, County Kerry, looking north-west. (Photograph courtesy of Dr James Bonsall).

The front elevation at the south-east features three small brick lined window openings, with two windows high up on the ground floor level and one high up on the first floor level (Figure F.28). The rest of the wall is plain. The south-west side wall features two large window openings with traces of brick surrounds, one on each floor level (Figure F.29). The central part of the north-east side wall has largely collapsed, although traces of the edge of a large brick lined window are visible at the ground floor level (Figure F.30). The rear north-west elevation is largely collapsed, but a plain section survives at the north-east and traces of a small central projecting wing are visible extending from the centre of that side of the building (Figure F.31).

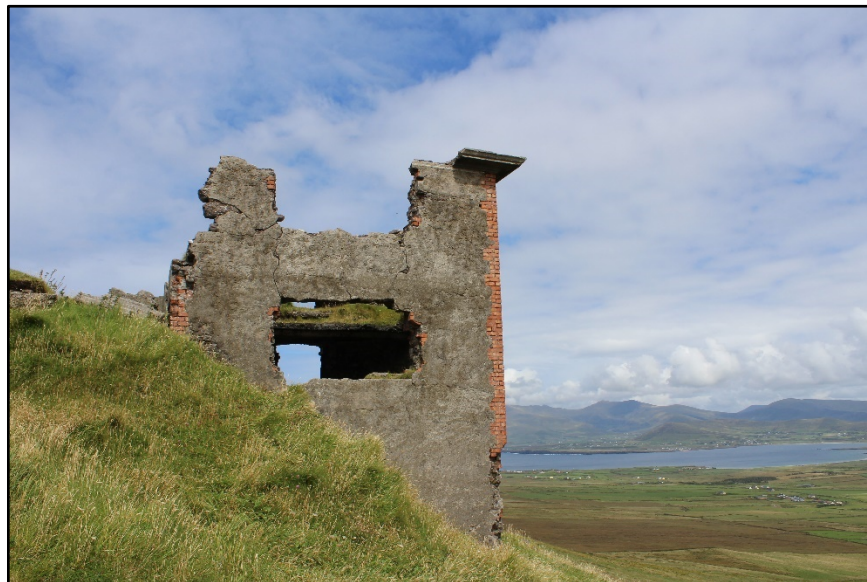
Figure F.29. View of the south-west side wall of the two storey building at Sybil Head Signal Station, County Kerry, looking north-east. (Photograph courtesy of Dr James Bonsall).

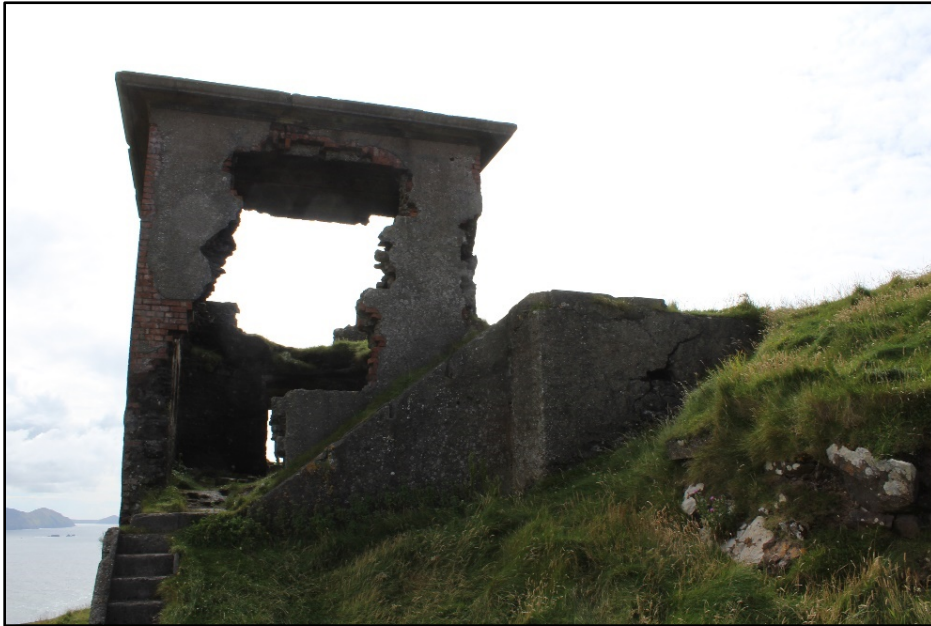
Figure F.30. View of the north-east side wall of the two storey building at Sybil Head Signal Station, County Kerry, looking south-west, with steps in the foreground. (Photograph courtesy of Dr James Bonsall).

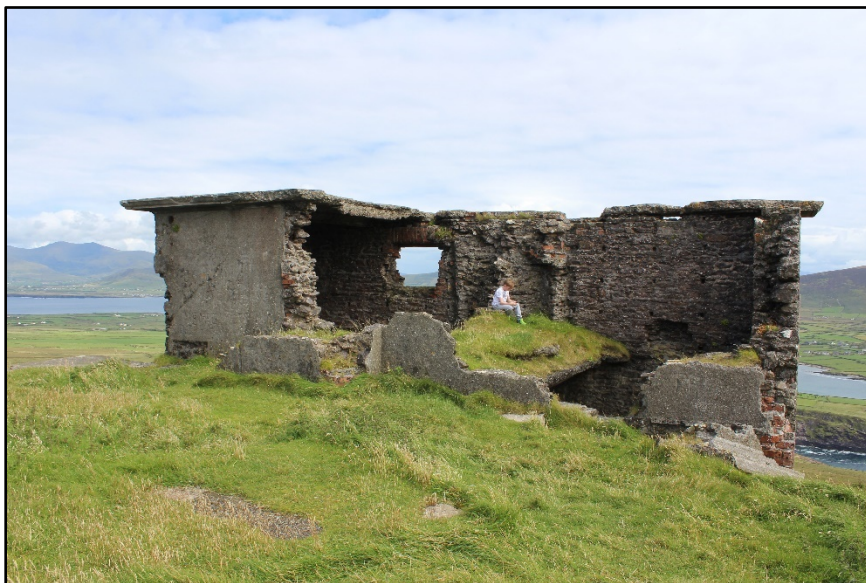
Figure F.31. View of the rear, north-west, wall of the two storey building at Sybil Head Signal Station, County Kerry, looking south-east. (Photograph courtesy of Dr James Bonsall).

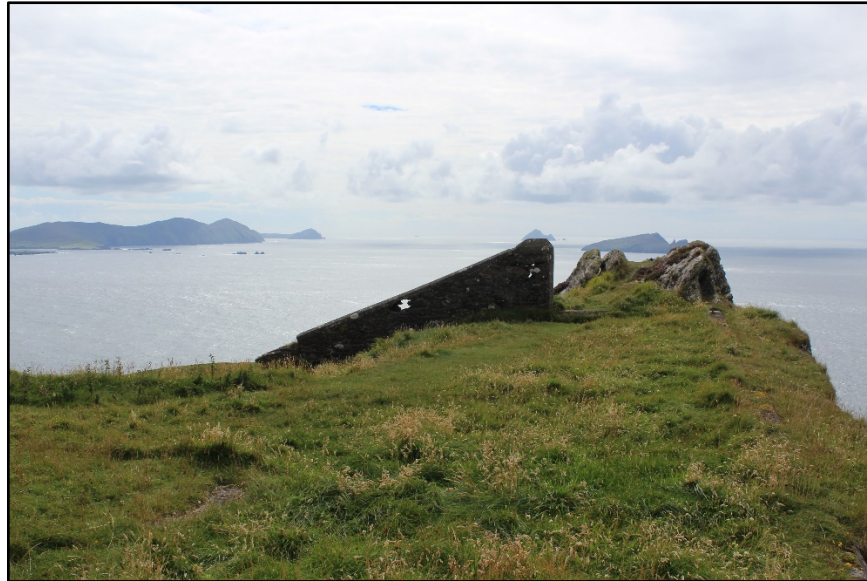
Figure F.32. Fragment of the enclosure wall at the north-west end of the south-west side of the enclosure. The base of the concrete foundation running along the cliff edge can be seen in the foreground. (Photograph courtesy of Dr James Bonsall).

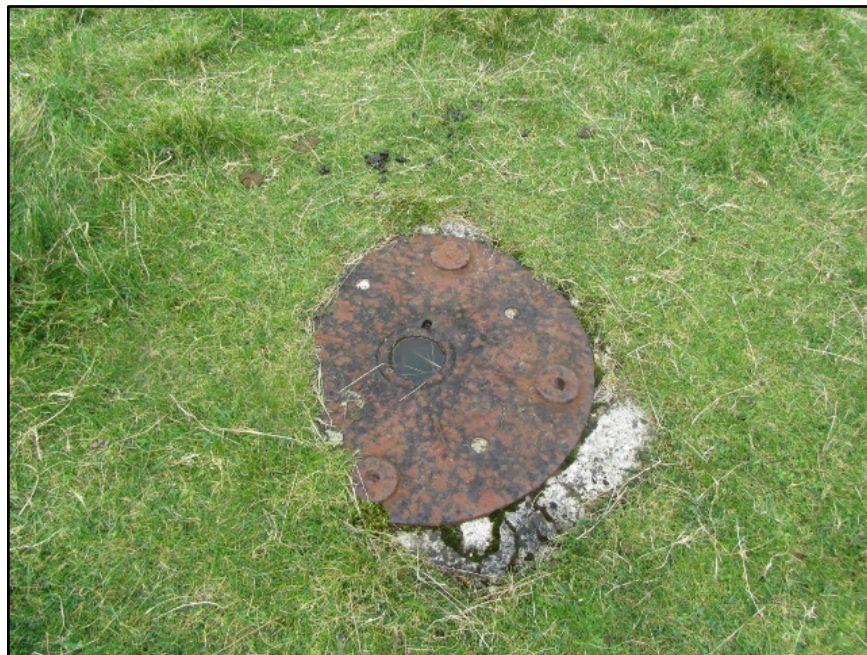
Figure F.33. Detail of metal mounting plate located to the north-west of the two storey building at Sybil Head Signal Station, County Kerry, looking north-east. (Photograph courtesy of Dr James Bonsall).

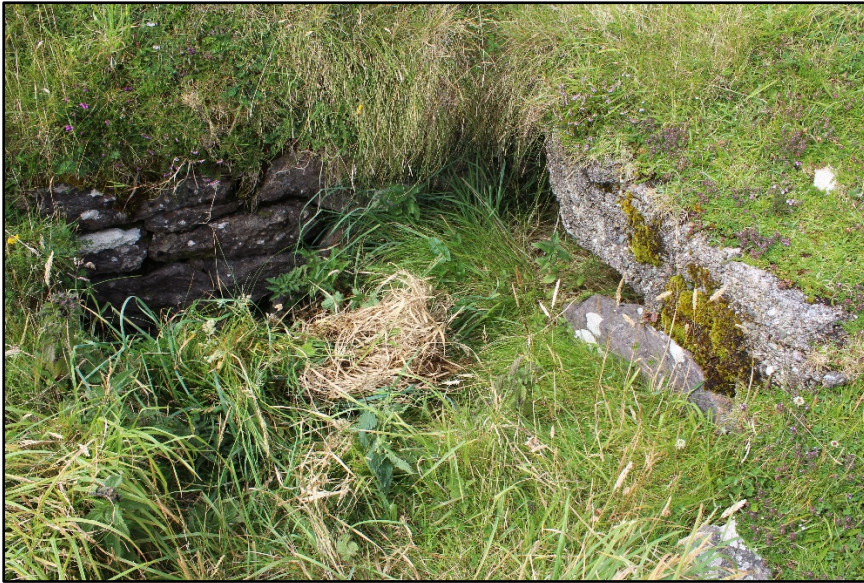
Figure F.34. detail of possible signal mast mount to the south-west of the two storey building at Sybil Head Signal Station, County Kerry, looking north-east. (Photograph courtesy of Dr James Bonsall).

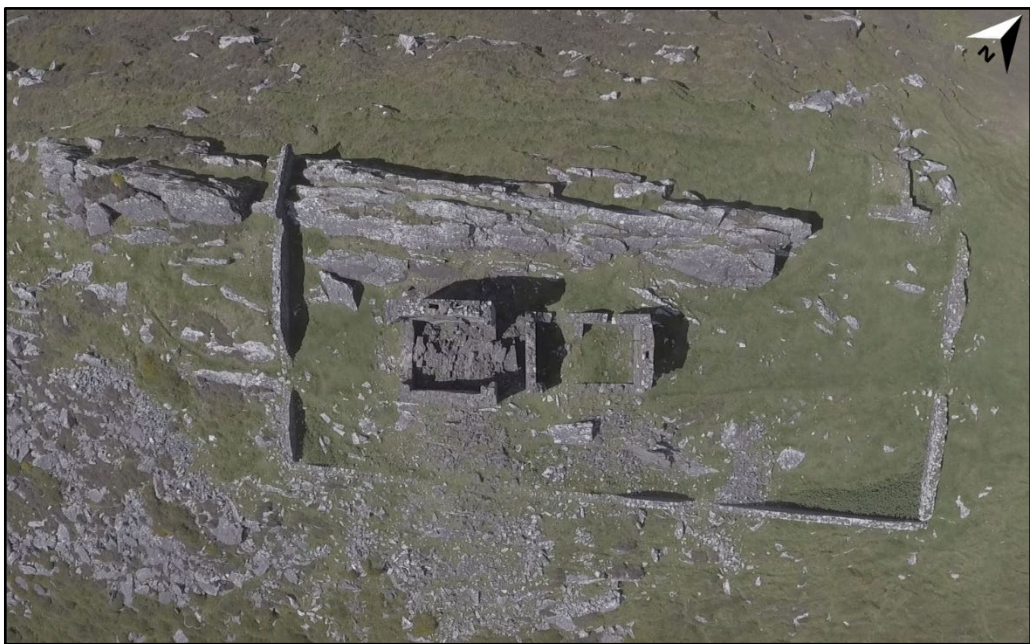
Figure F.36. Drone photograph of Ballydavid Head Signal Station showing the enclosure with traces of an entrance at the north-east and the small building at the north corner. The signal tower is towards the south-west end of the enclosure and the gabled building is located to the north-east of the tower. (Photograph courtesy of Dr James Bonsall).

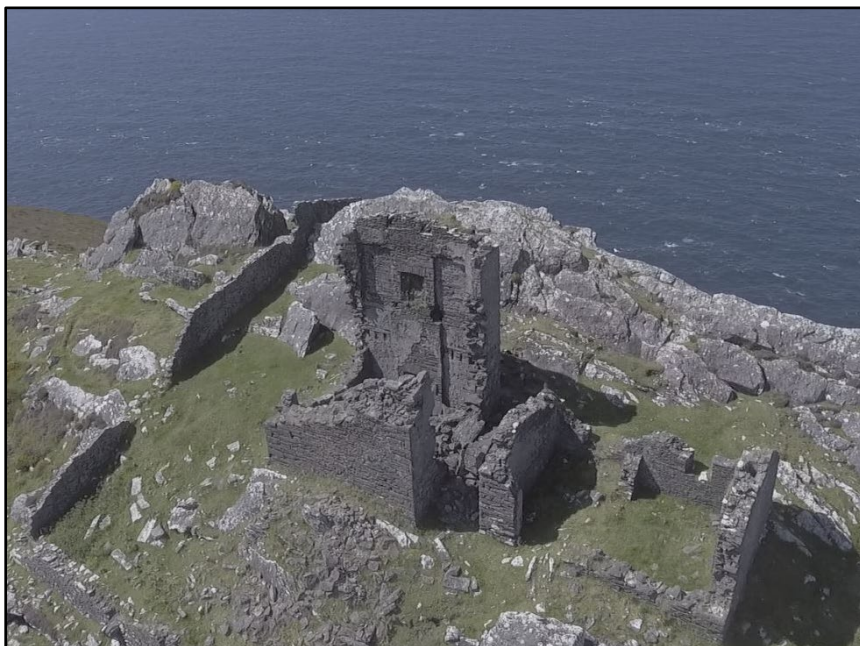
Figure F.38. Drone photograph of Ballydavid Signal Station, showing details of the signal tower and the adjacent gabled building, looking west. (Photograph courtesy of Dr James Bonsall).

A large rectangular side gabled building is located immediately to the NE of the signal tower. The building measures 7 m from north-east to south-west and 4.6 m from North-west to south-east. The gabled side walls at the north-east and south-west survive to close to their full heights, all though the apexes of both walls are missing. The north-west wall survives to approximately half its original height and only a low remnant of the south-east wall survives. The building is divided into two rooms internally, with a smaller room at the south-west and a larger room to the north-east. A door is located on the south-east wall, accessing the smaller room. A window is located on the north-west wall, illuminating the larger room. A chimney was built into the north-east gabled wall. The building is not depicted on the 1st edition Ordnance Survey map, surveyed 1841-42, and by the time du Noyer drew the site in 1856 it was a roofless shell. This suggests the building was only used for a short period of time in the 1840s and 1850s.

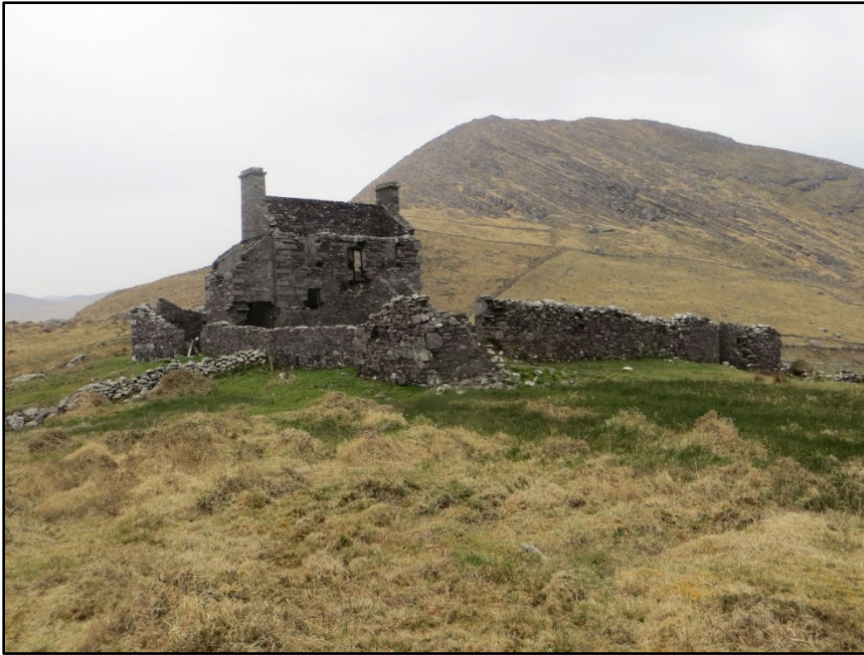
Figure G.2. Hog's Head Enclosed Barrack, looking west, with the western bastion in the foreground.

Hog's Head Enclosed Barrack is located on top of the steep sided east to west running ridge that forms the spine of the headland. The site has steep slopes to the north and south. Hog's Head Enclosed Barrack consists of an almost square enclosure that measures 24m north-east to south-west by 20m north-west to south-east. The enclosure has a square bastion at each corner. The enclosure wall is defined by a tall stone wall that survives to a height of 6 feet in places. The bastion walls are up to 10 feet tall in places. A complex two storey building is located along the north-east side of the enclosure, with its rear wall forming the boundary of the enclosure in this area. The building is built with roughly coursed rubble with traces of external render still visible, and well-preserved internal render. The building had a shed roof, now missing, that sloped steeply downwards towards the interior of the enclosure. The sloping side walls have tall chimneys extending from their peaks. On the ground floor level, the front wall features two small windows on either side of a plain central section of wall. The first floor features two larger windows arranged on either side of a central doorway. The first floor doorway was accessed via a large freestanding stone stairway located to the south-west. The gap between the top of the stairs and the door was presumably spanned by some sort of retractable bridge. Each side wall is abutted by a two storey addition, with the north-west example surviving to a much greater extent than the south-east example. The additions have steeply sloping roofs and both are entered at ground floor level through a door on their SW walls. The interior of the main section features three rooms on each floor. The rooms at each side feature fireplaces and alcoves which have the impressions of shelves in their render lining. The central rooms both feature plain alcoves and no fireplaces. Each of the rooms within the additions featured a fireplace. Access into the main building from the additions was through doors on the side walls of the main section, at ground floor level from the south-east addition, and on the first floor level from the north-west addition.

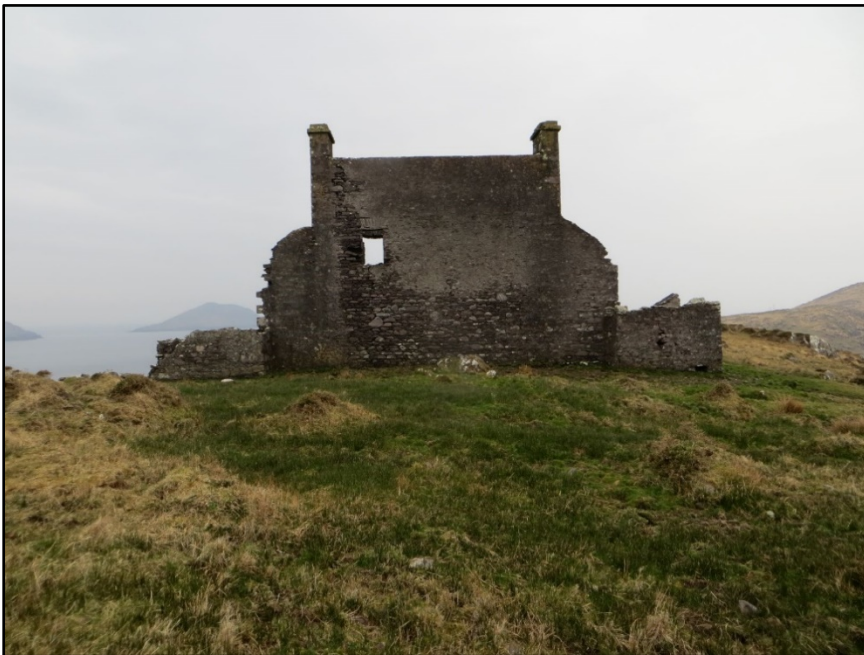
Figure G.3. The imposing rear wall of the two storey building at Hog's Head Enclosed Barrack, County Kerry, looking west. This wall formed part of the perimeter along the eastern side of the enclosure.

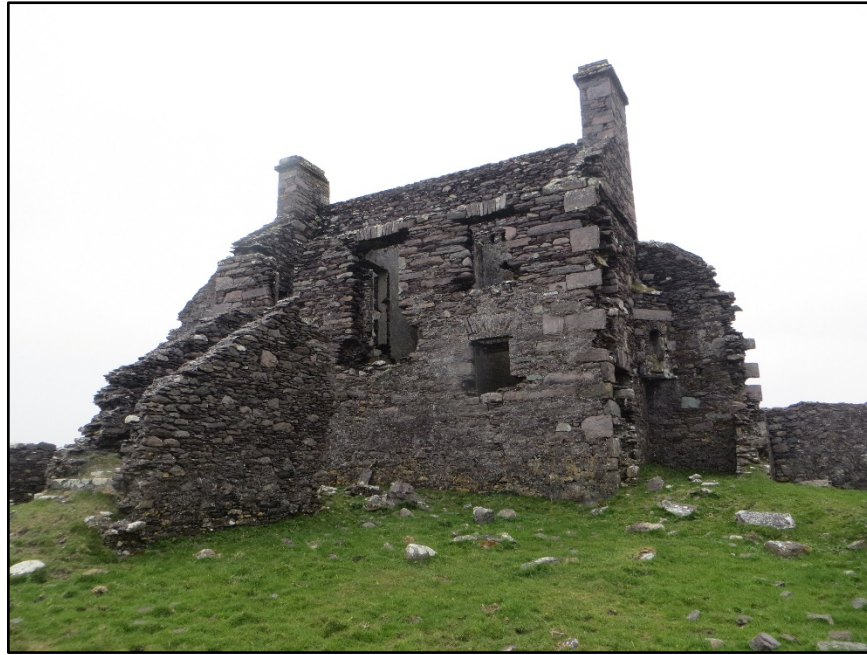
Figure G.4 Oblique view of the steps leading to the first floor entrance.

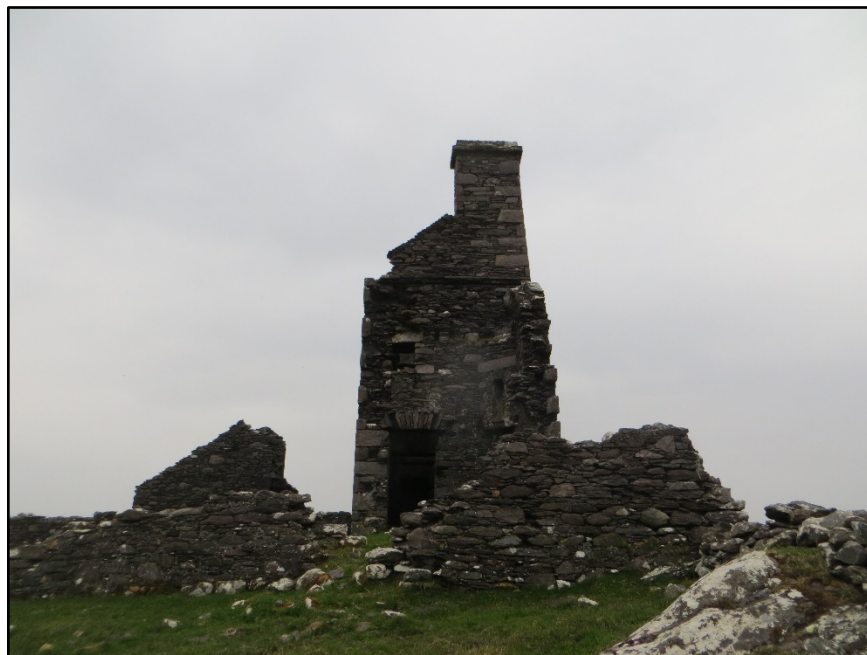
Figure G.5. The southern end wall of the two storey building at Hog's Head Enclosed Barrack, County Kerry, with the collapsed addition projecting from the wall and the free-standing external stairs to the left, looking north.

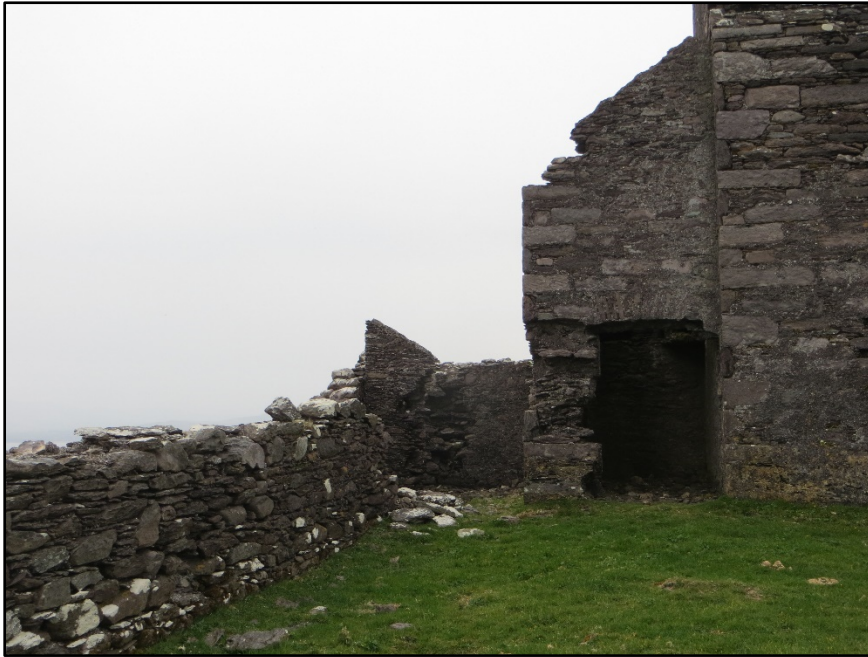
Figure G.6. The addition on the north-west side of the building, with ground floor entrance.

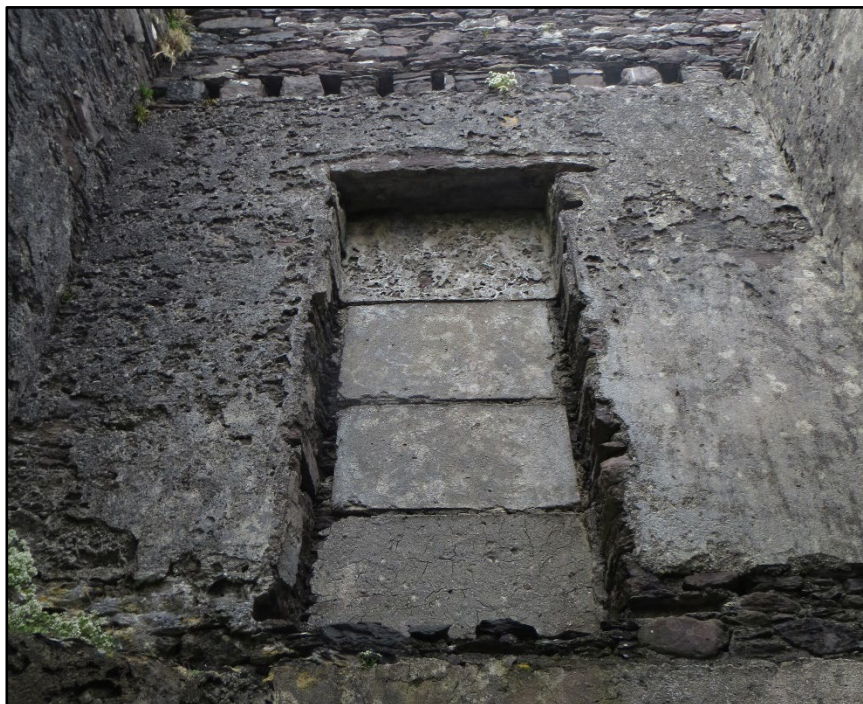
Figure G.7. Alcove with shelf impressions on the first floor of the building.

Whilst this building was larger than the signal towers of the standard design, it was clearly built using similar techniques. The use of a first floor doorway and the presence of the alcoves with impressions of shelves provide particularly compelling illustrations of the links between the two building types (Figure G.7).

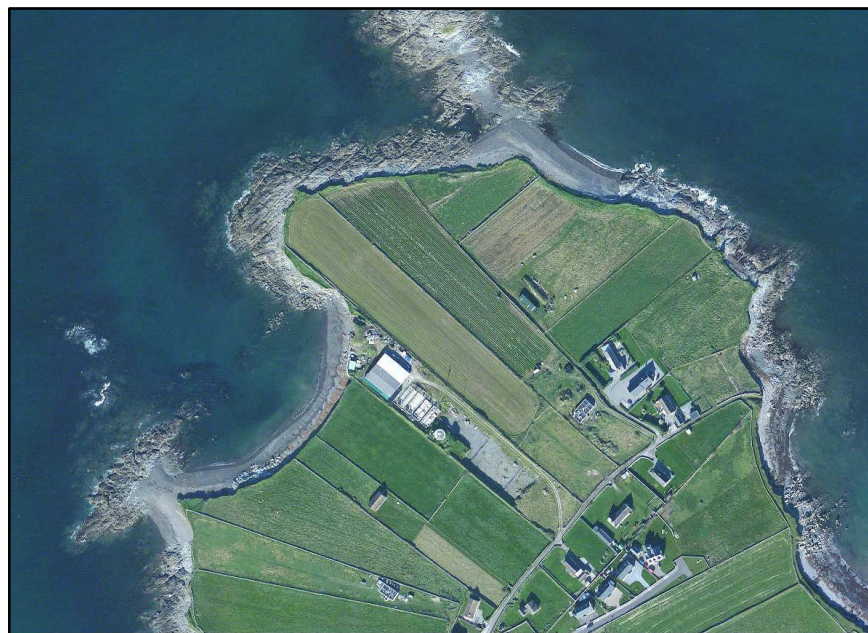
Figure G.13. Modern aerial image showing the location of the Rough Point Enclosed Barracks, which is now covered by a cluster of residential buildings (Bing Maps).
